Butterley Tunnel

Written by and using photographs taken by Tina Cordon between 15th October and 9th November 2006

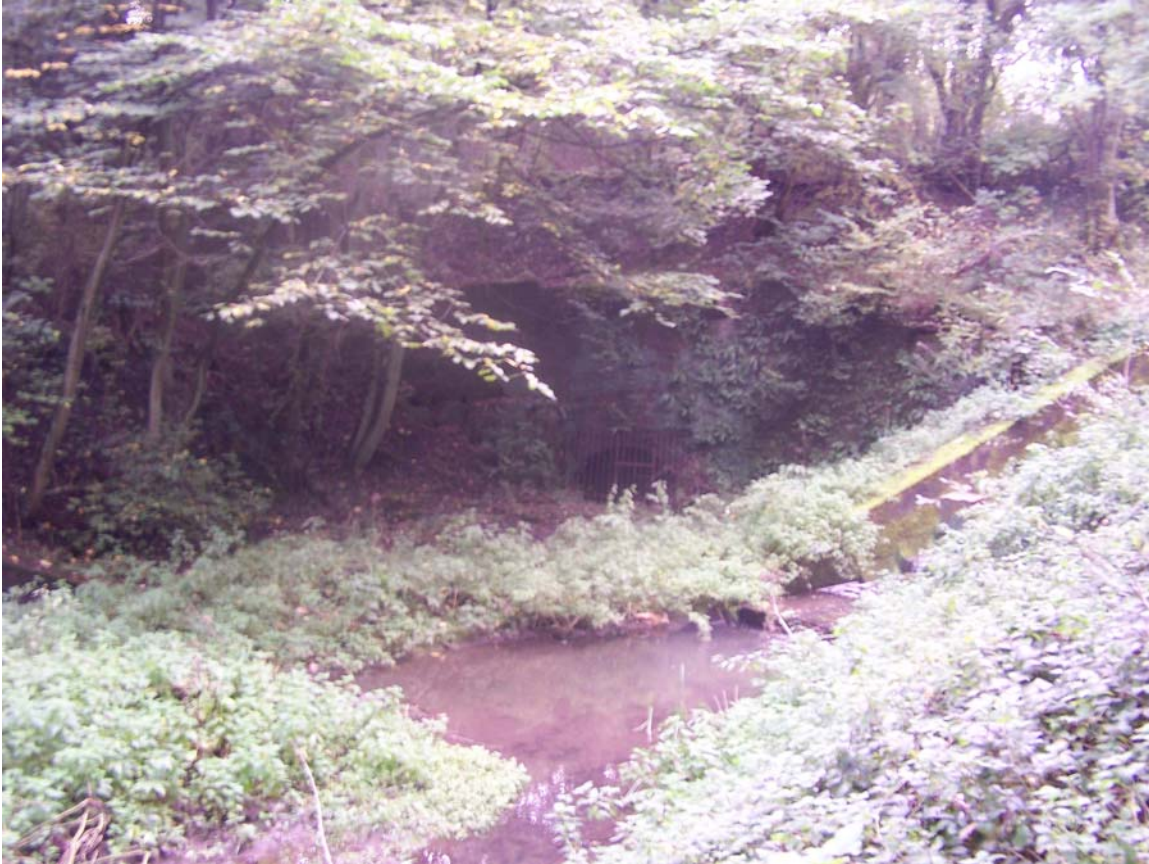
View of the Eastern Portal. 2006. Water is entering via a spillway from a stream in the right foreground. This stream passes under the line of the Golden Valley Light Railway at the top of the spillway. 53°03'26.0"N, 1° 22'22.8"W according to my GPS.

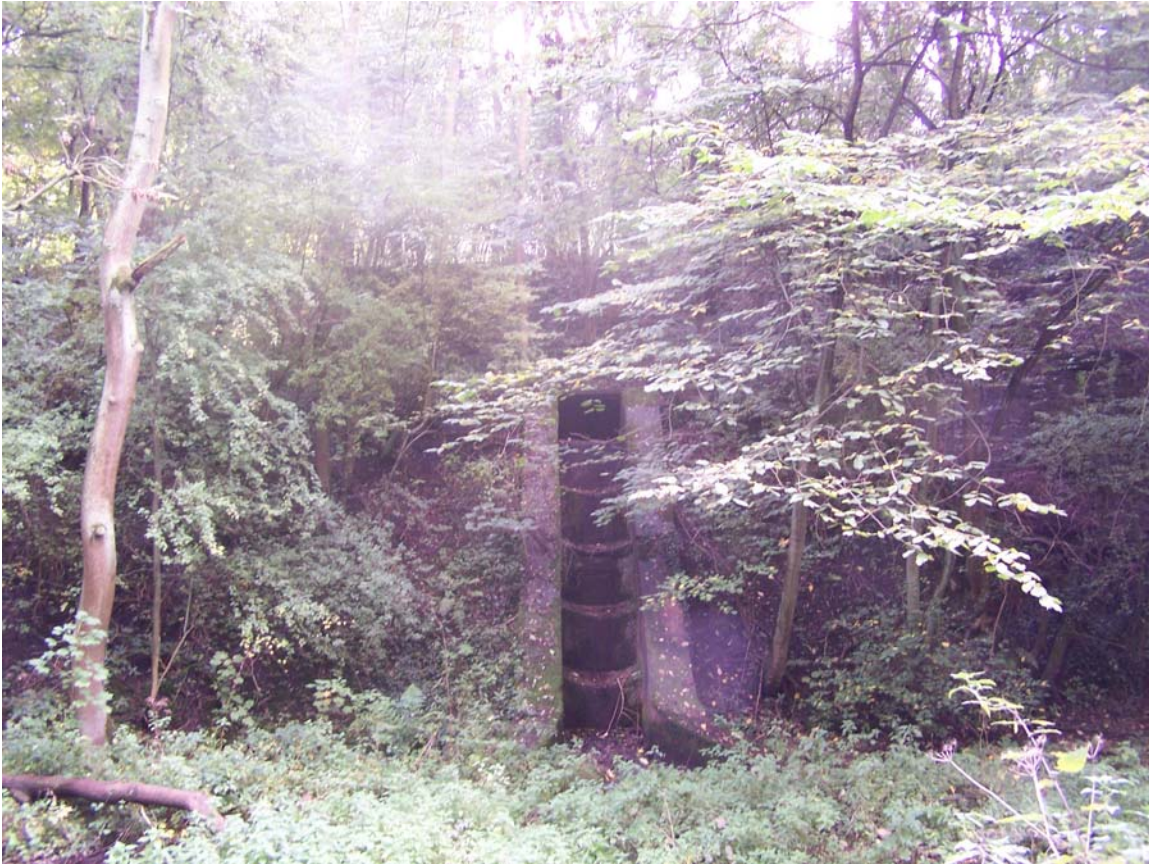
This spillway is to the left (South) of the tunnel portal when facing the portal. At the top of the spillway is a culvert leading off to the right facing the way the picture is taken. The culvert is below a well maintained path with park benches leading towards the Midland Railway Centre. It once brought water from the Butterley Park Reservoir.

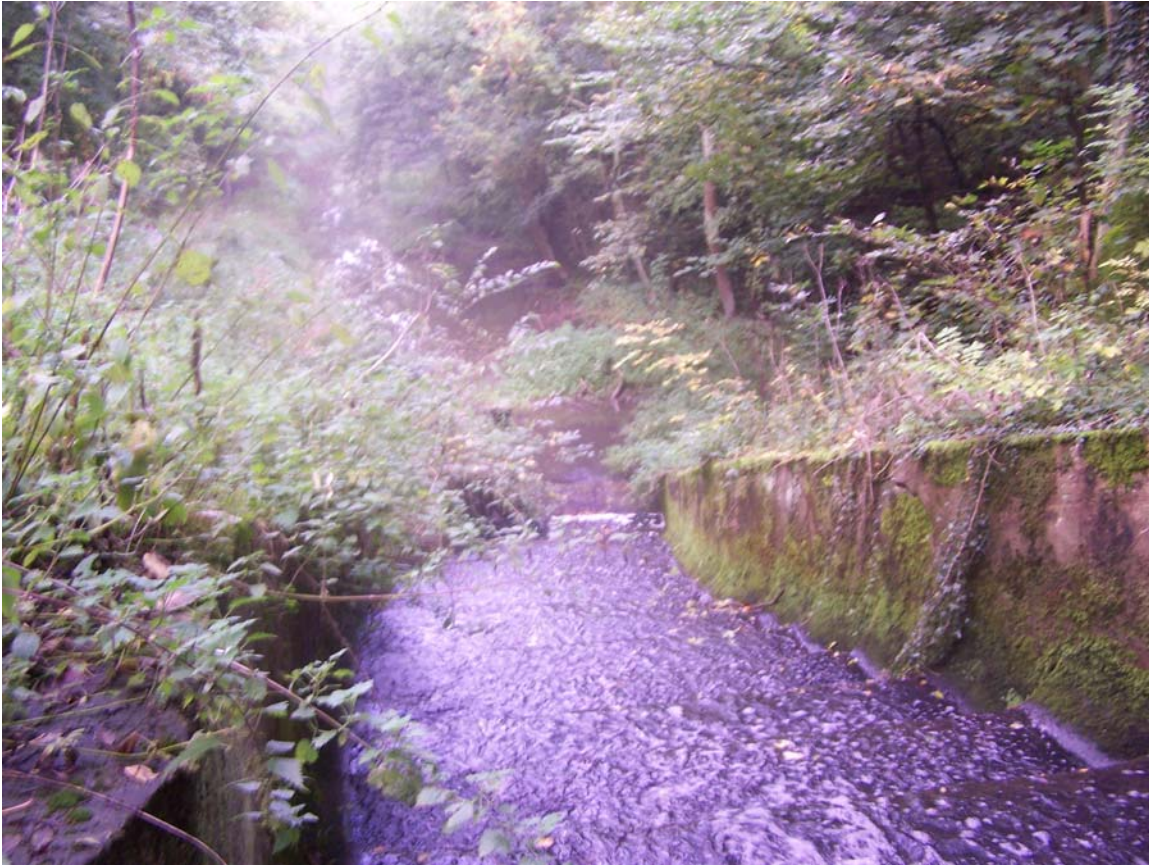
Water flowing down the spillway to the right (North) of the tunnel portal when facing the portal.

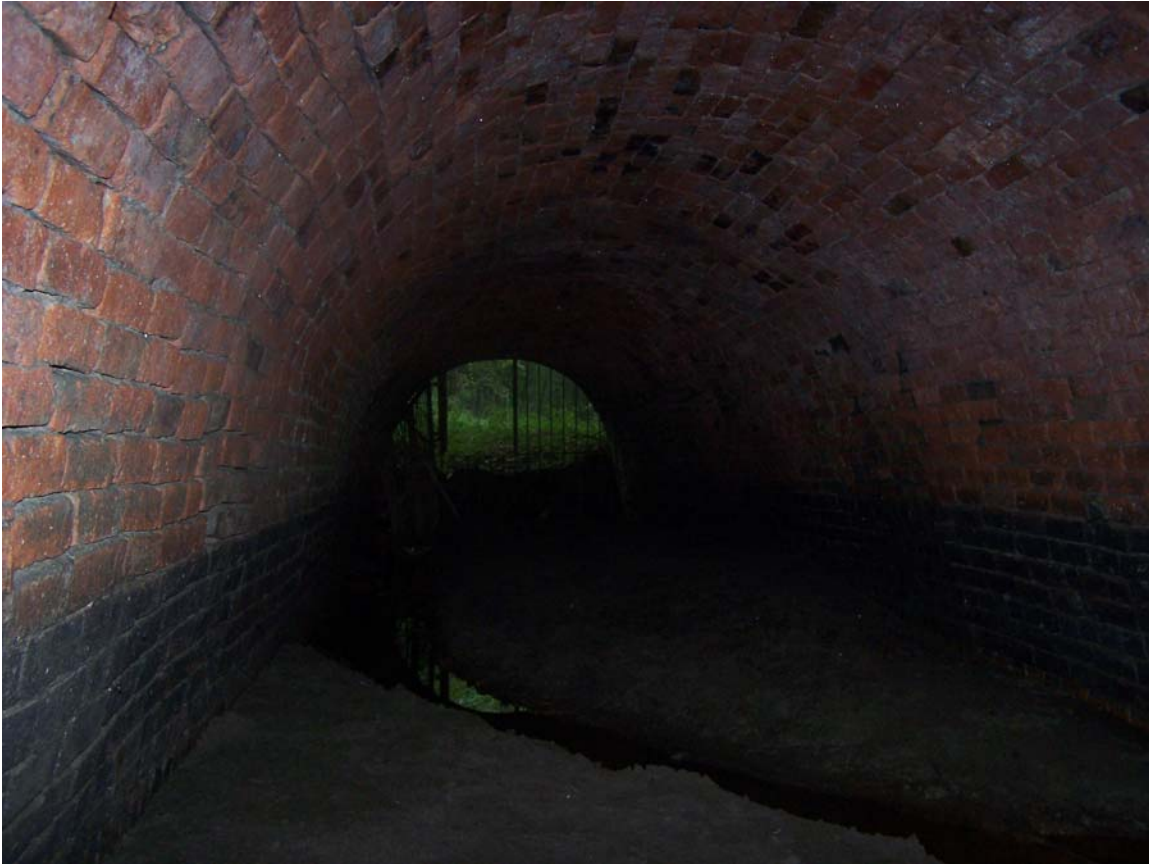
View from inside the tunnel through the Eastern Portal. The grill covering the entrance is not locked. The silt here is well packed and supports a person's weight. Other footprints are evident here so others do visit although there is little rubbish (drinks cans, crisp bags, etc) present.

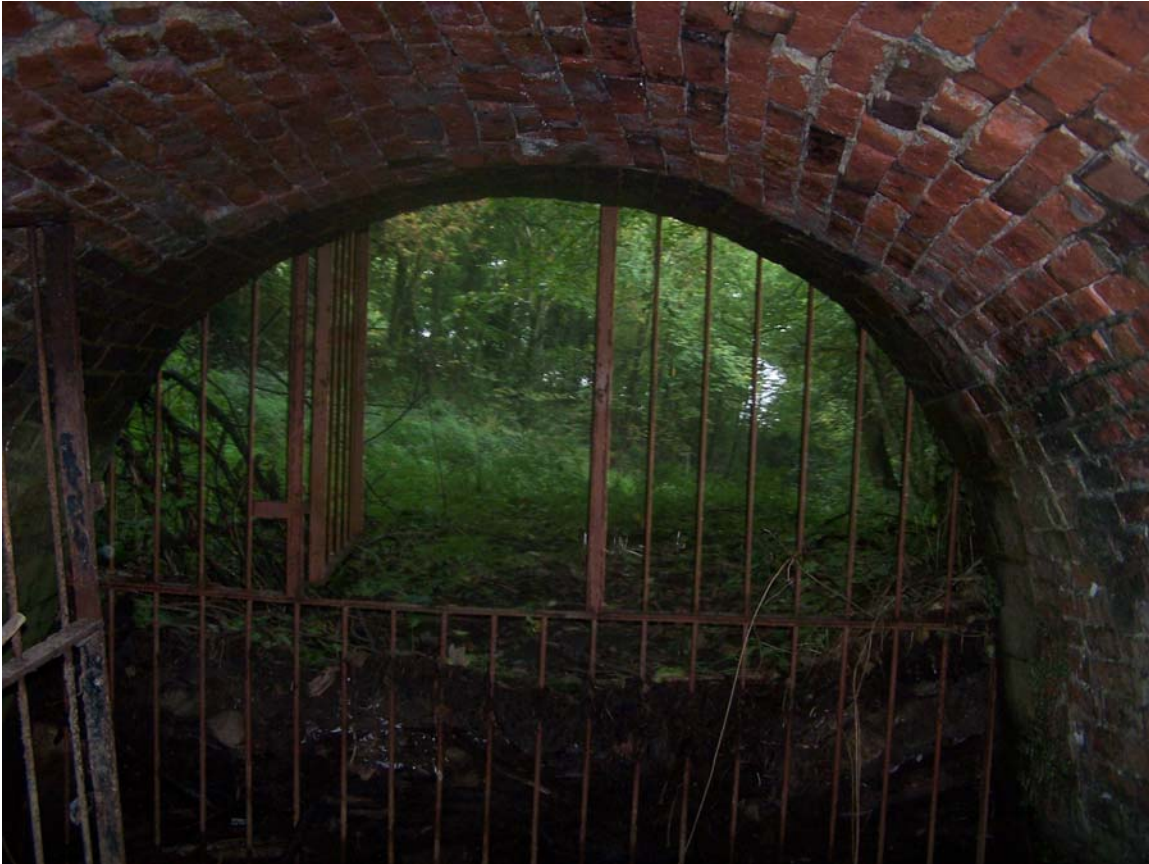
Eastern Portal from the inside. The silt within the tunnel at this point is greater than 4 feet 3 inches deep. This is the length of the auger used. The height of the tunnel above the silt is 5 feet 4 inches. The width of the tunnel at the level of the silt is 9 feet 6 inches.

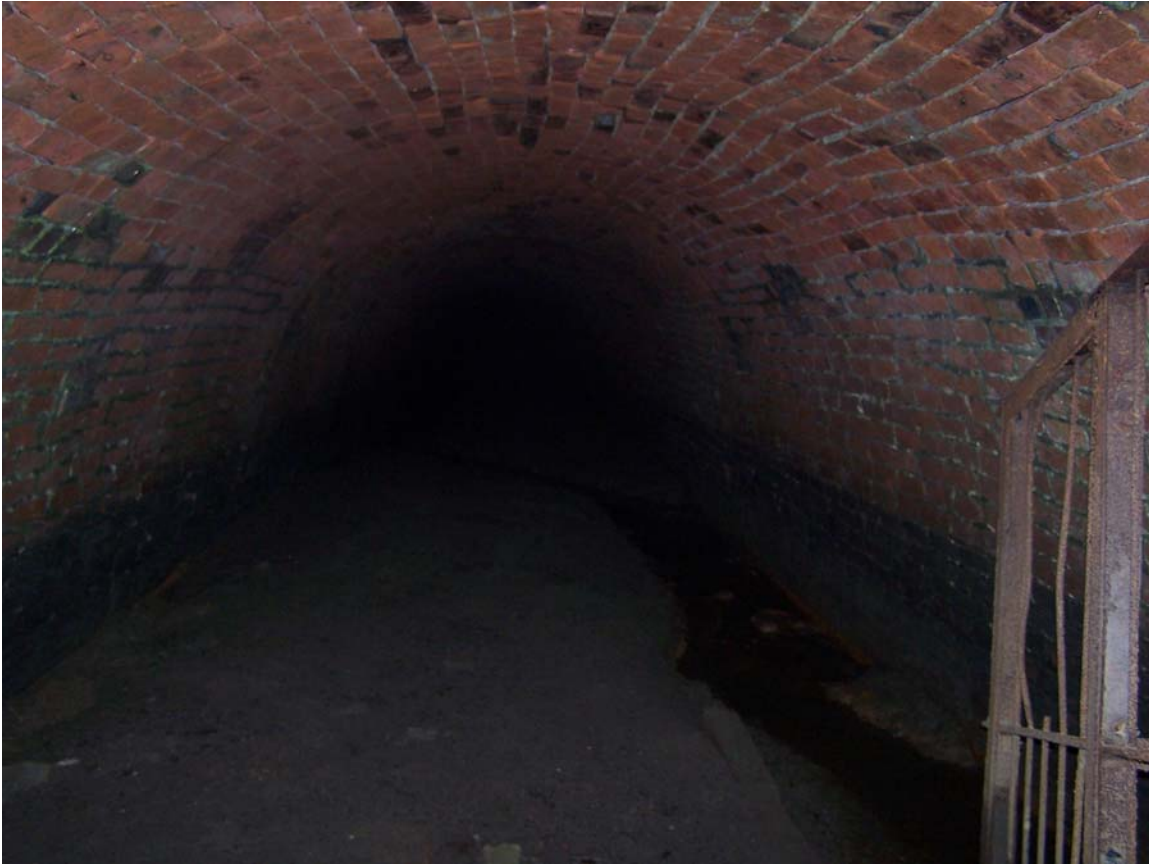
The silt at the Eastern Portal supports a person's weight for a short distance into the tunnel from the Eastern Portal. Water flows West along the tunnel in the channel which can be seen to the right of this picture. A small amount of rain increases this flow markedly.

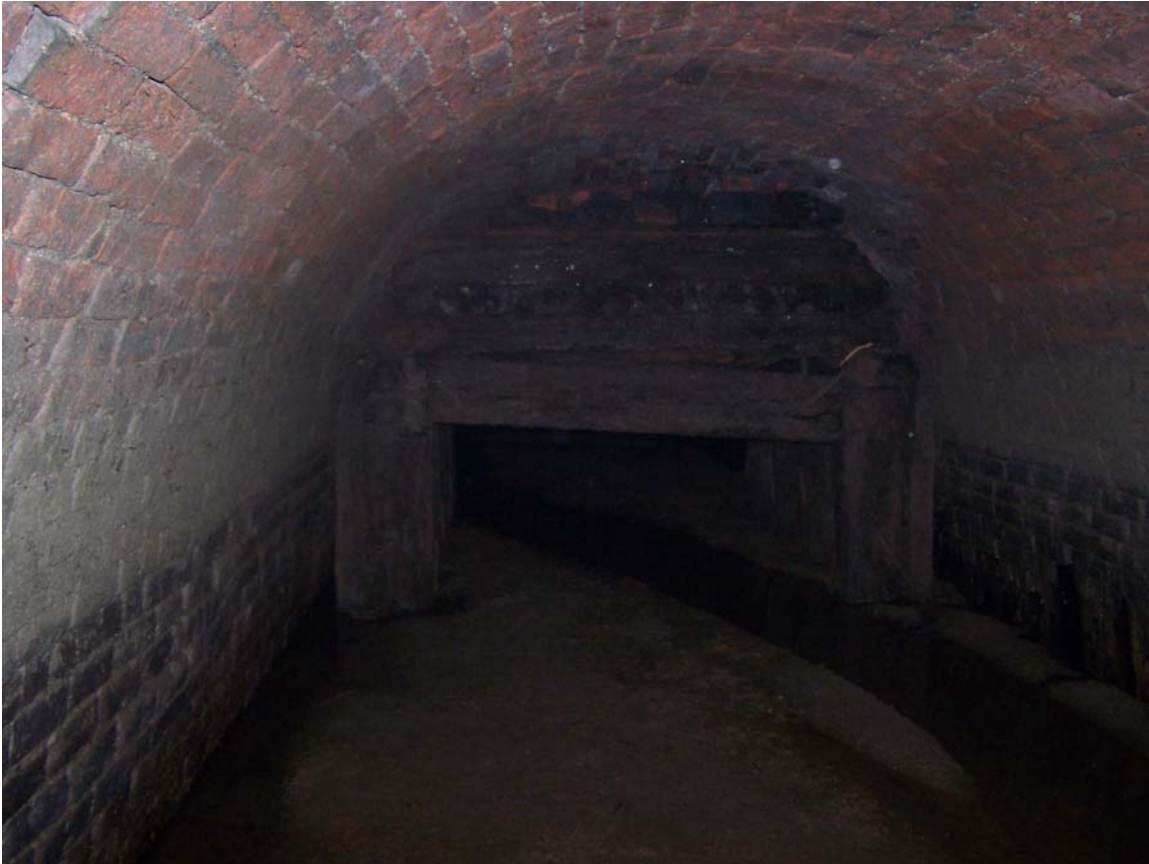
This is the roof shoring about 3 chains, 66yards from the Eastern Portal. You cannot safely proceed by walking along the tunnel from the Eastern Portal due to the softness of the silt. Subsequent photographs were taken utilizing a canoe for transport. On the silt the canoe was pushed with most my weight supported by the canoe; modern day legging.

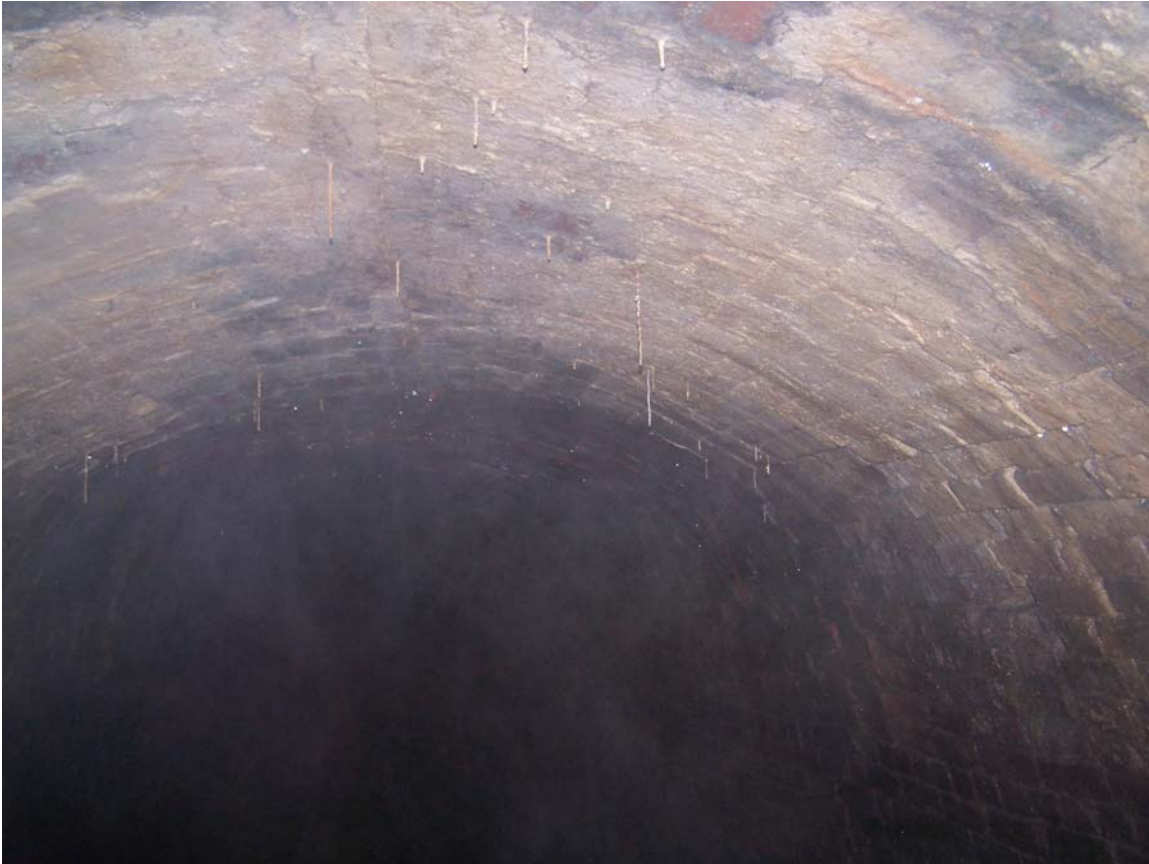
A section without shoring and with straw stalactites at about Chain 4 from the East. The vertical walls near to water/silt level are bowed inwards.

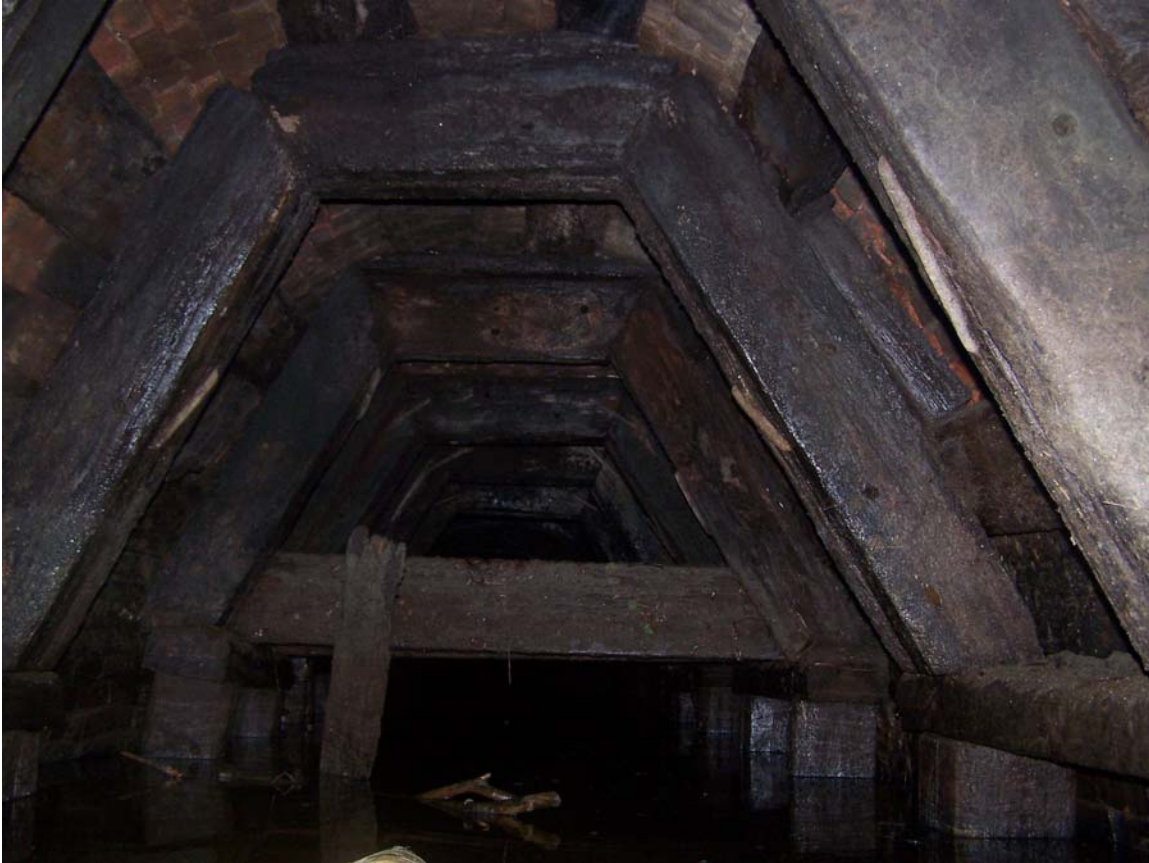
Second set of shoring in reasonable condition just before Chain 5.

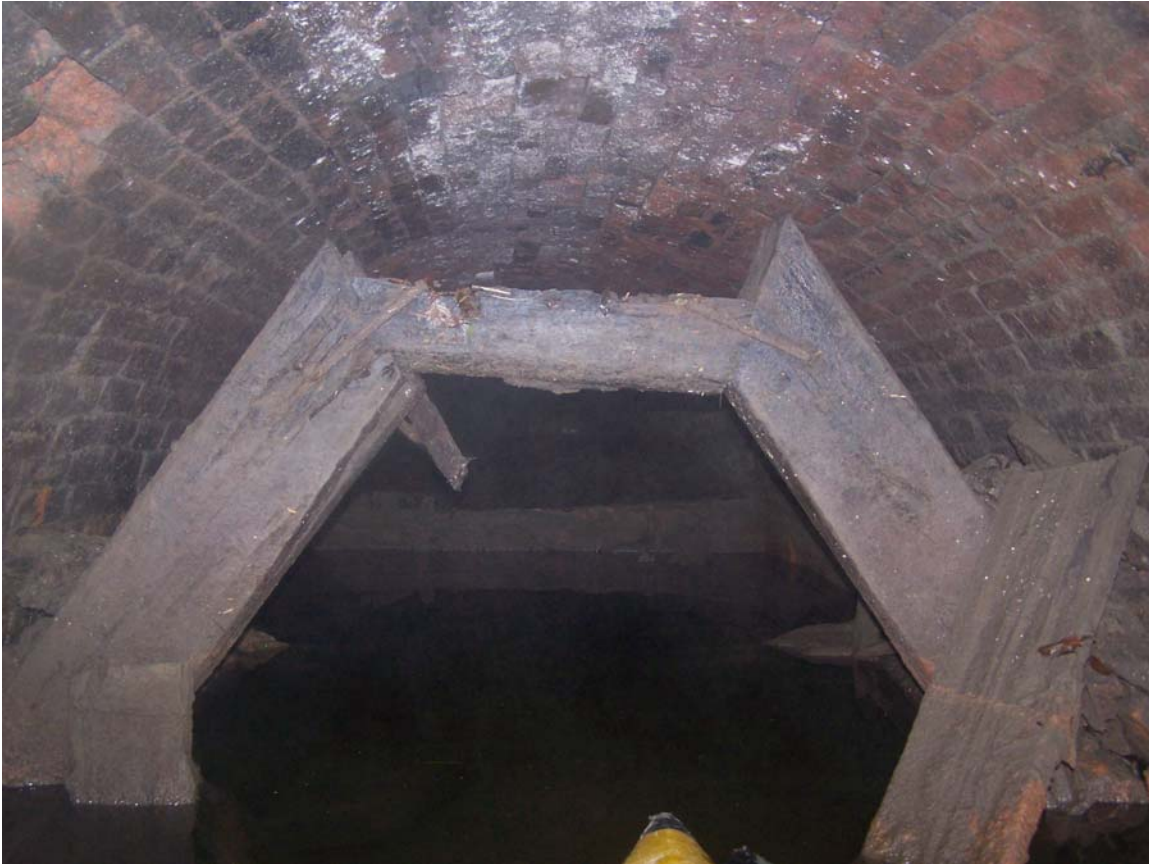
Some of the third set of shoring has collapsed. Much of that which is standing is no longer supporting the roof.

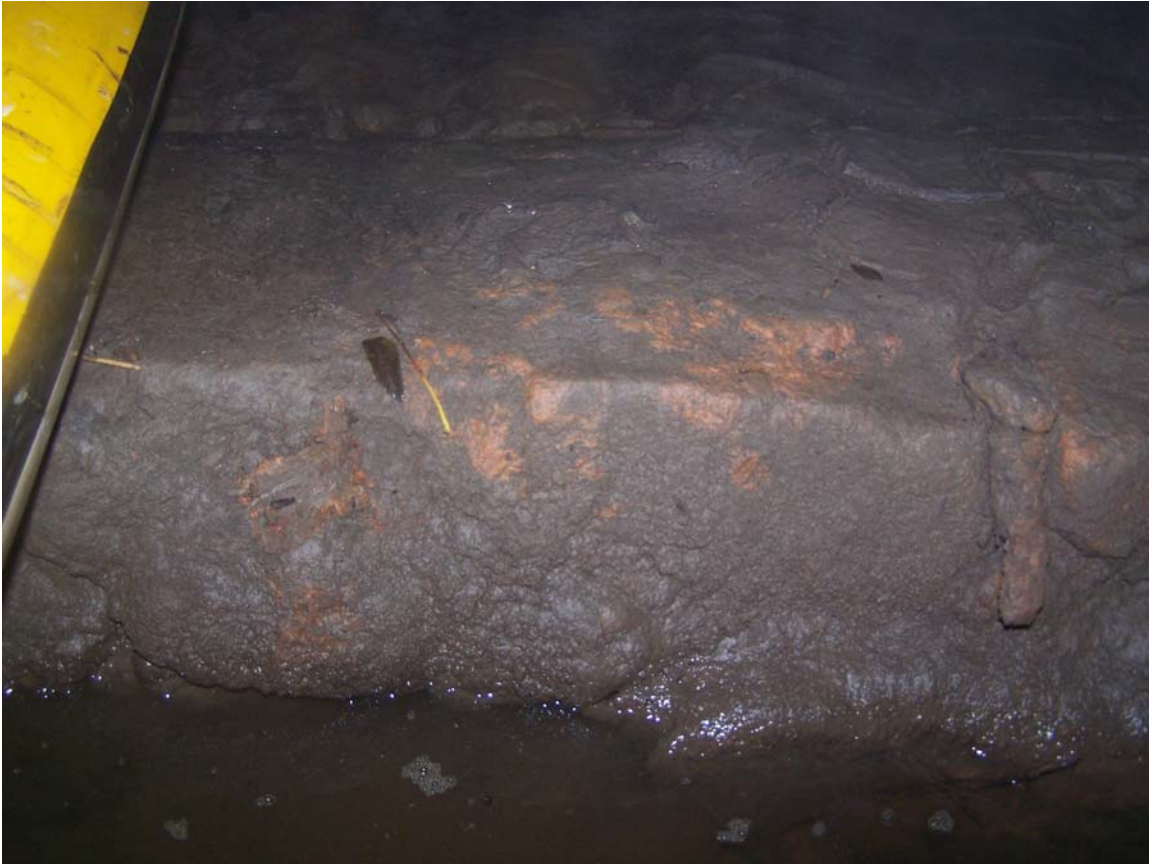
This stone or concrete cofferdam (called a stank in the 1915 Wide Hole drawing) is across the tunnel with the tunnel floor behind it backfilled with rubble. I got out of the canoe and walked from here.

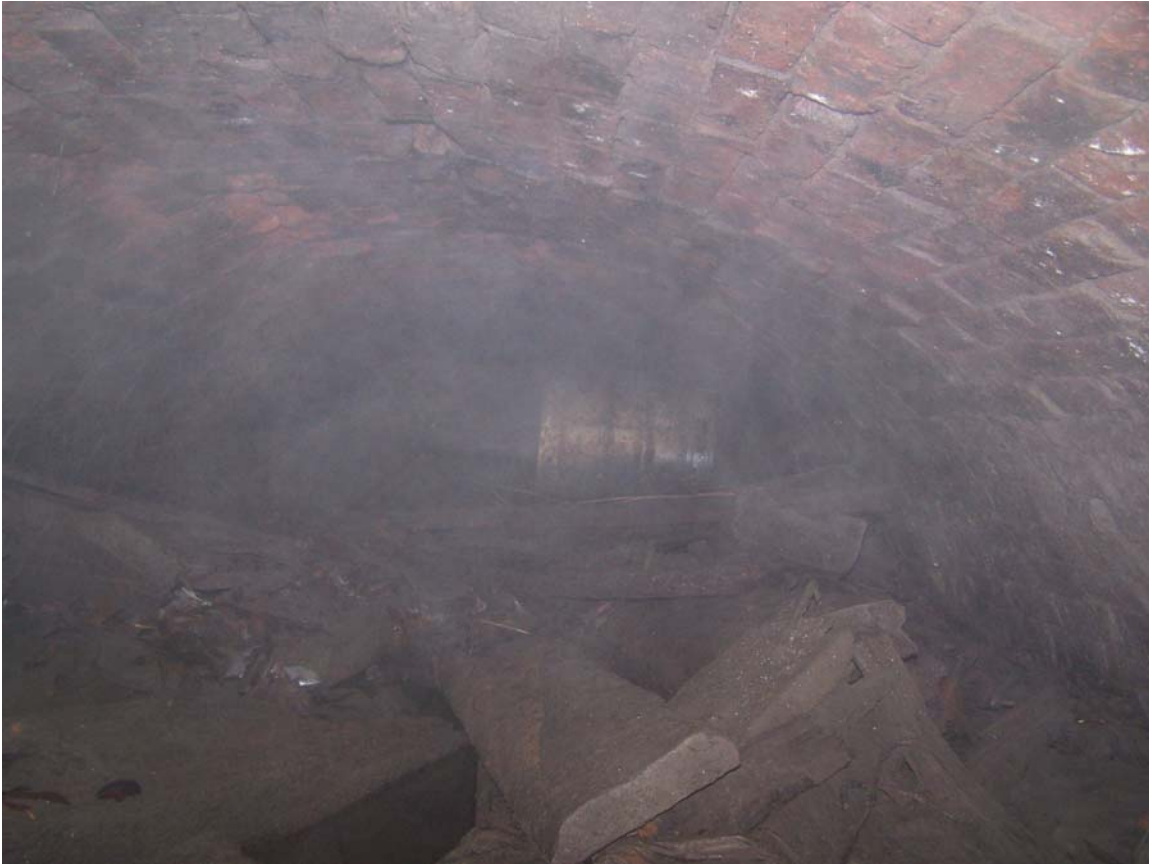
The tunnel is blocked at about Chain 10. This does not appear to be a roof fall. What I see is shoring timbers and other debris which has been washed against other partially collapsed shoring timbers blocking the tunnel. The roof appears to be in place.

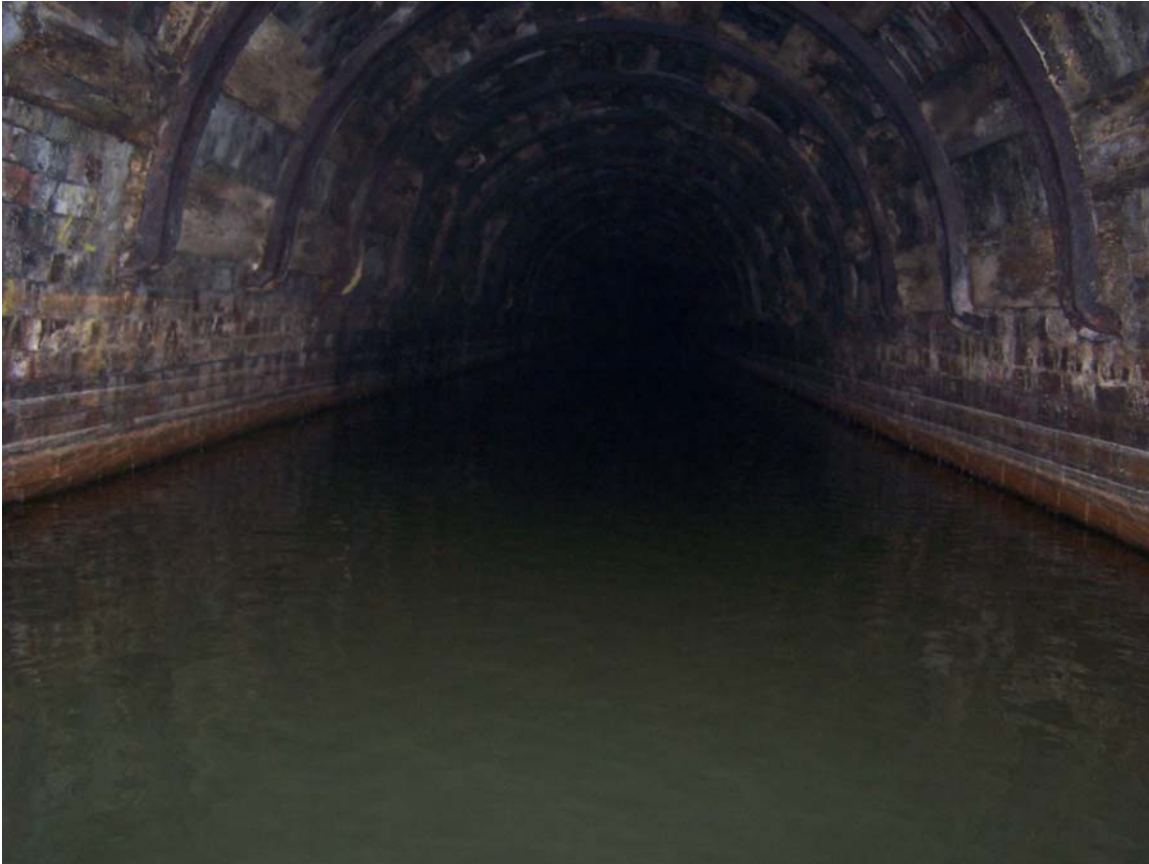
Once through the conduit you enter the section added when the railway was built over the Western Portal. It is brick lined, but also has iron arches which support timber shoring supporting the brickwork. The water is 5 feet deep here and walking is slow and cold. There are 116 of these iron arches supporting the roof up till marker 7, 18 more to marker 8 and 8 more to a change in tunnel size.

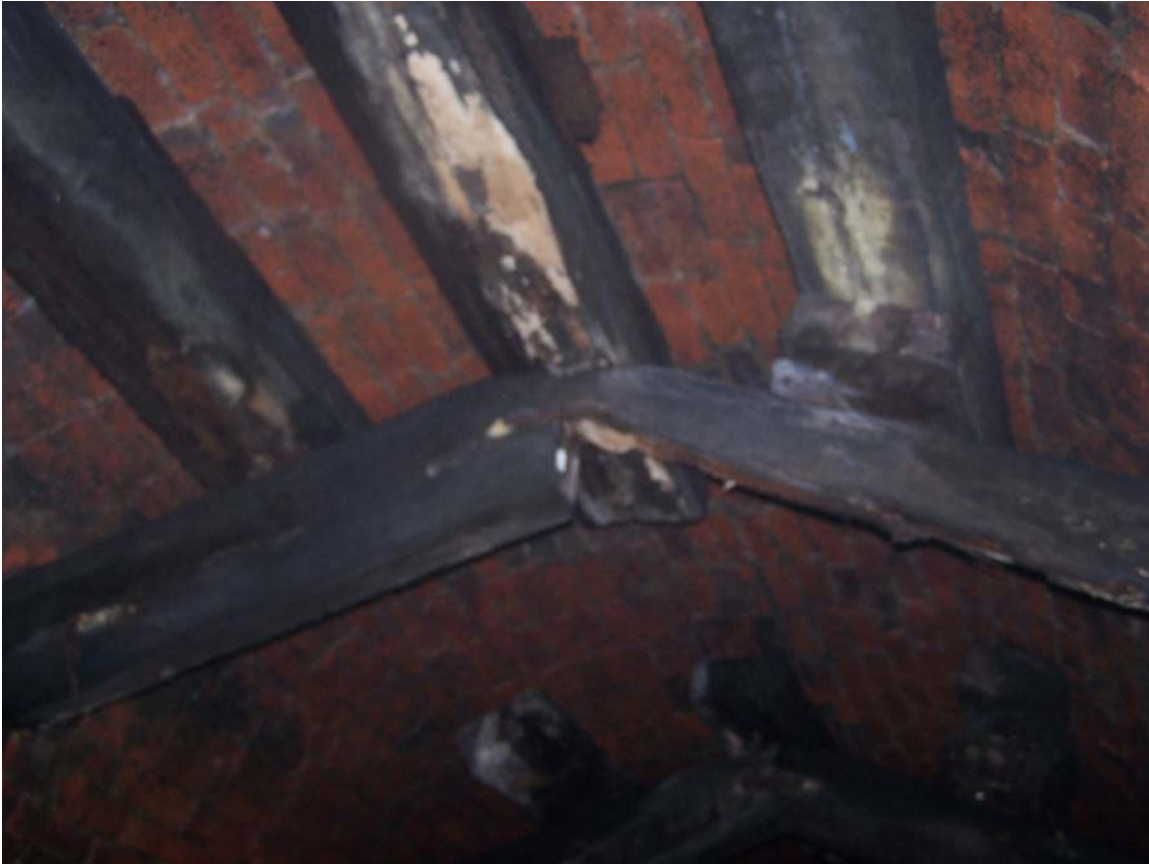
Close up of shoring showing slight damage to one beam.

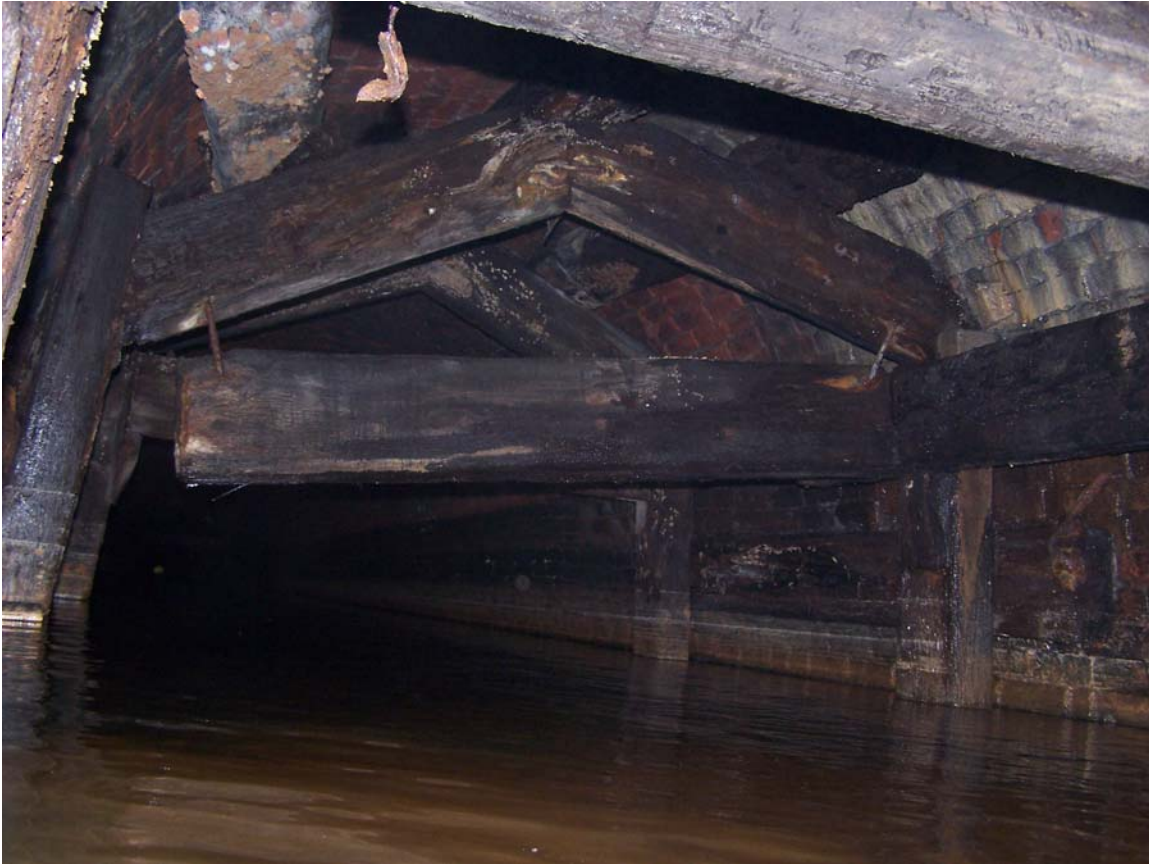
Further along the tunnel the shoring is less secure. This set of 8 wooden shoring timbers starts at marker 11. The second (shown) and third cross beams are loose. This shoring finishes 30 bricks length (these bricks including mortar are about 10 ½" long) before marker 12. The Western Portal can be seen.

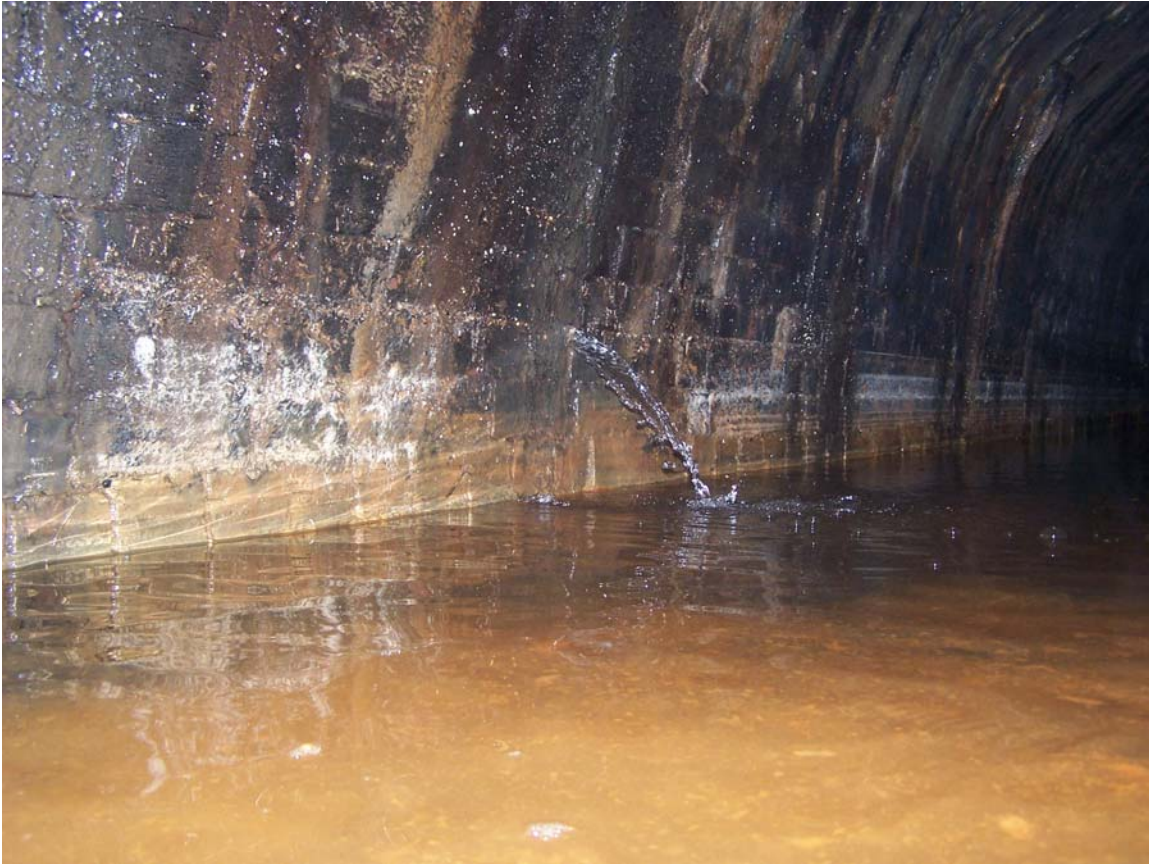
A leak in the Southern wall showing that the water level outside the tunnel is greater than that inside. This is just after marker 14. There is water coming from the roof from before marker 14 to where the tunnel increases in size again just before marker 16. 6 iron arches 4 bricks apart start at marker 18.

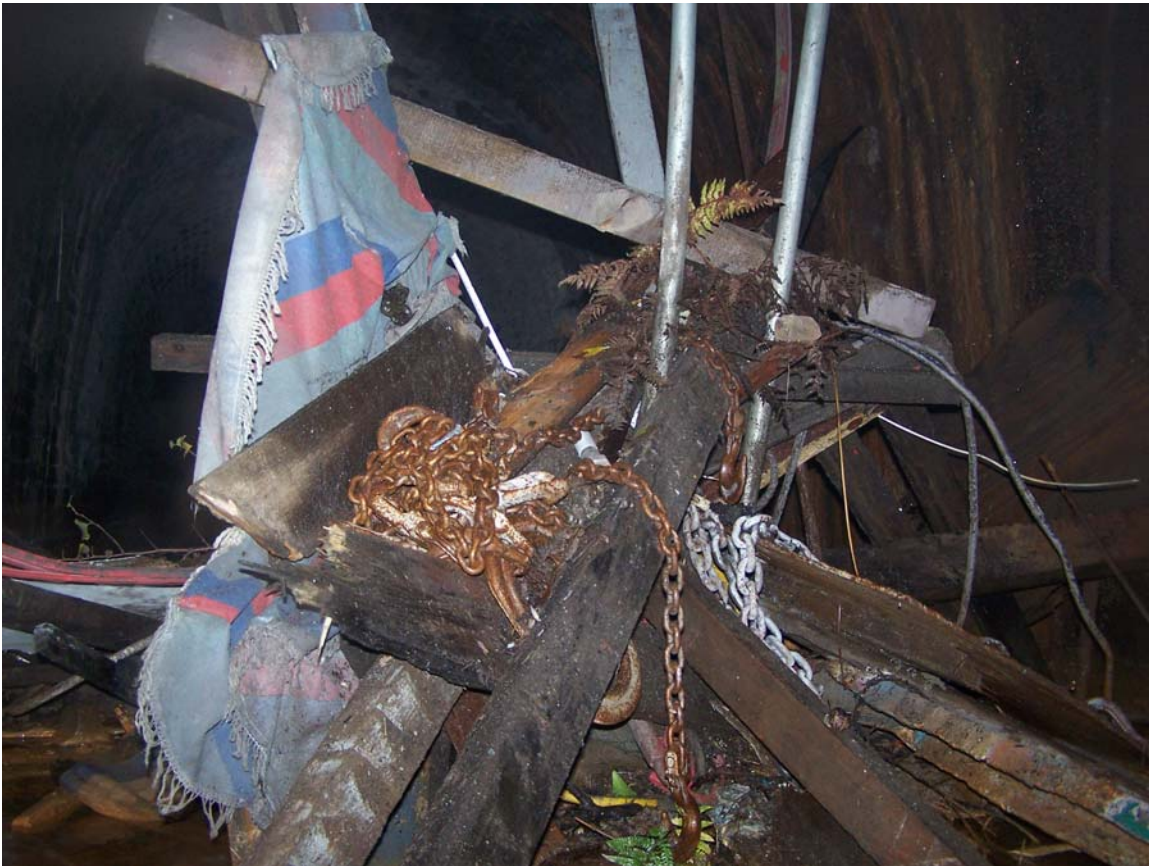
This rubbish has been thrown down the first airshaft encountered when walking from the West. This airshaft is at marker 19. I have found that wood released from this pile and left in the canal makes its own way to the gate. I'll clear it out when it arrives.

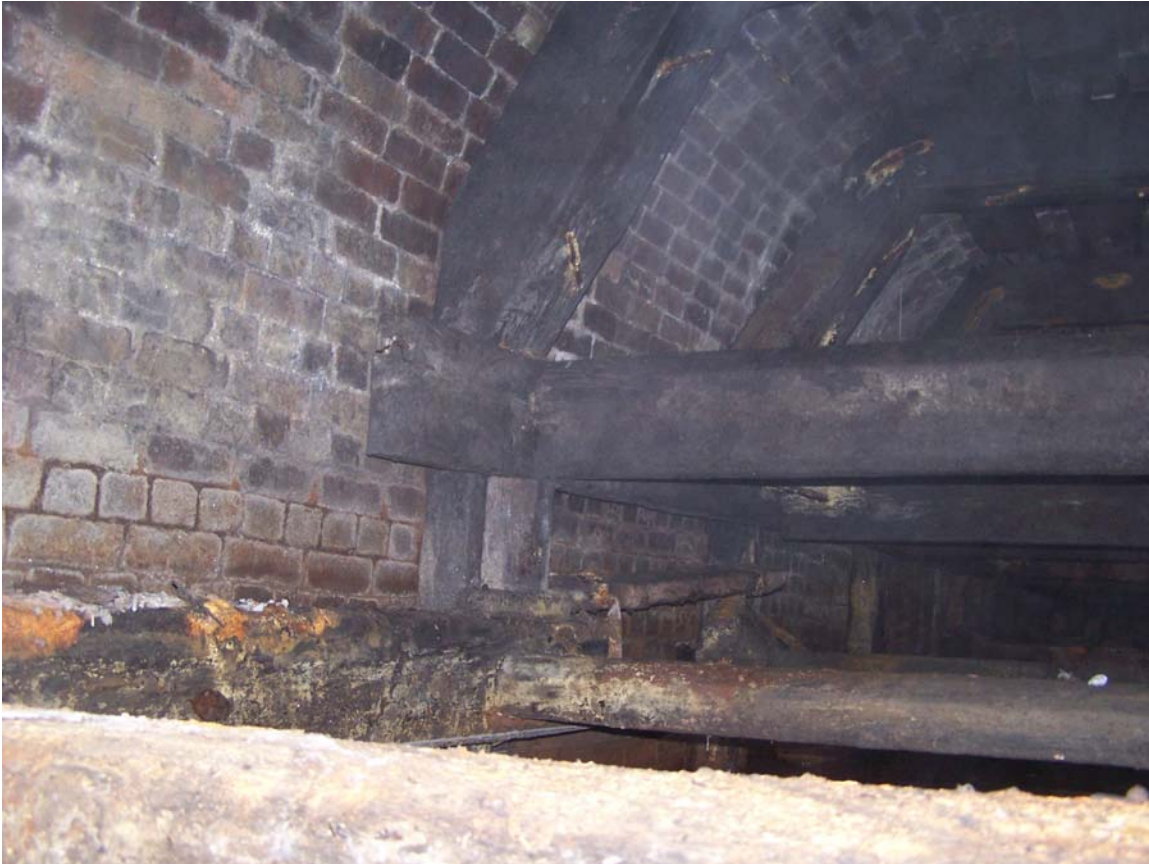
More timber shoring. This time with just a 1 foot gap between the lowest timbers and the water. There are 15 of these sets of shoring 7 bricks (about 6') apart.

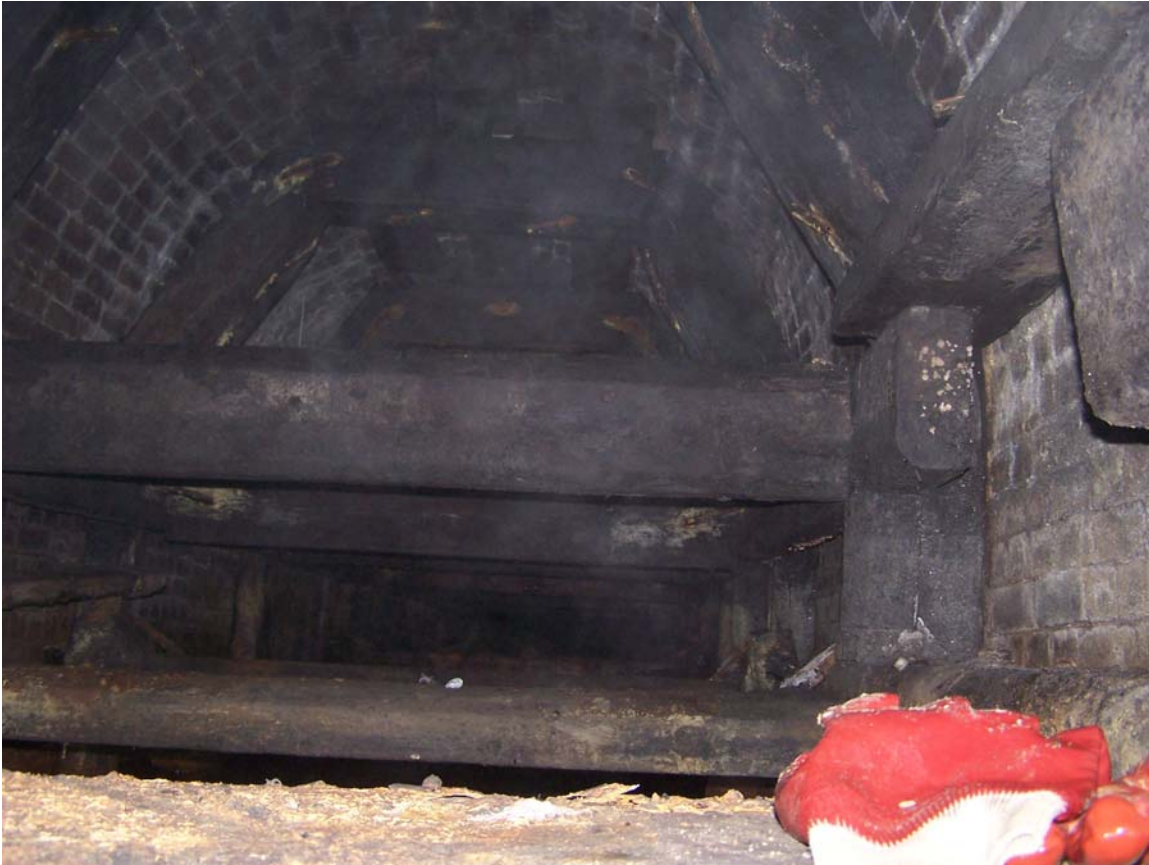
This shoring is in reasonable condition but very low to the water, it is necessary to get out of the canoe here. There is room under the horizontal beams for the canoe but not for me. Anyone who decides to enter from the West will need to take account of this and wear appropriate clothing for immersion in 5 feet of water. Sorry about the gloves.

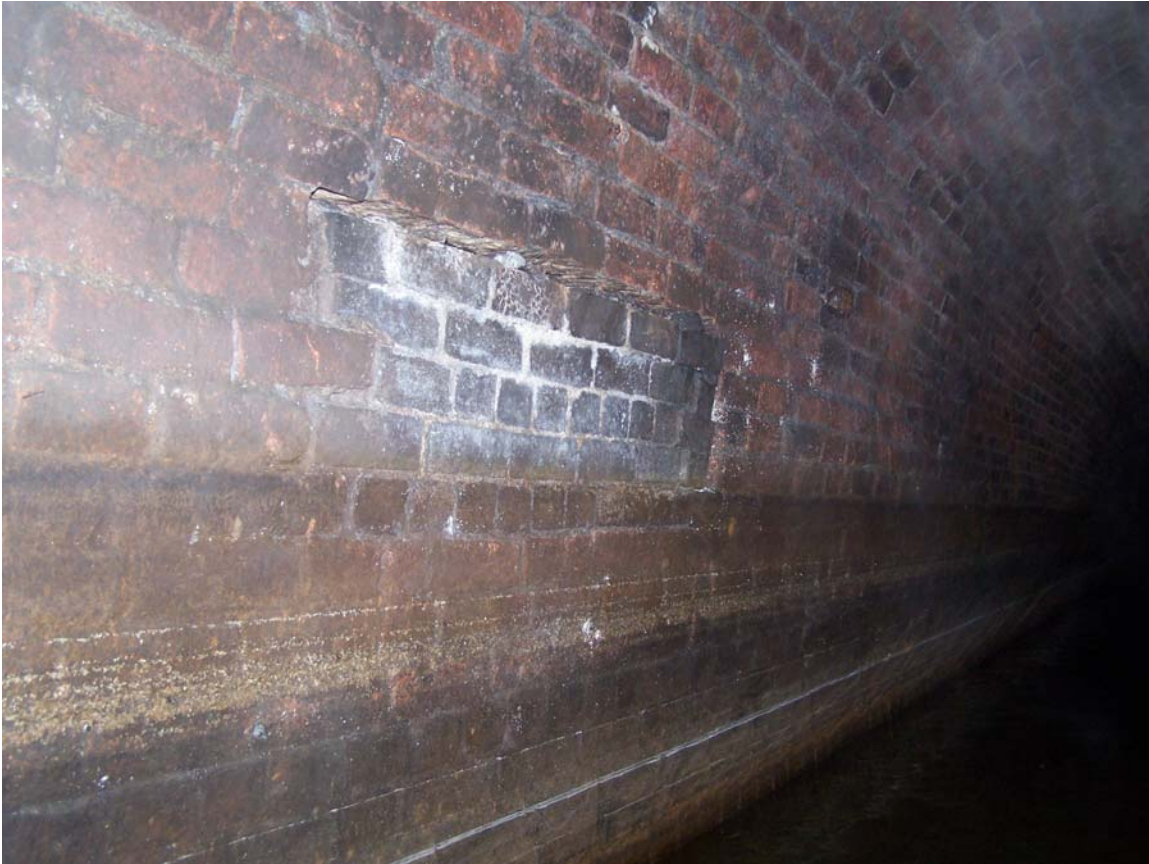
The blue bricks in the centre are a not very well bonded brickwork patch at marker 28. At marker 29 there is water dripping through the roof.

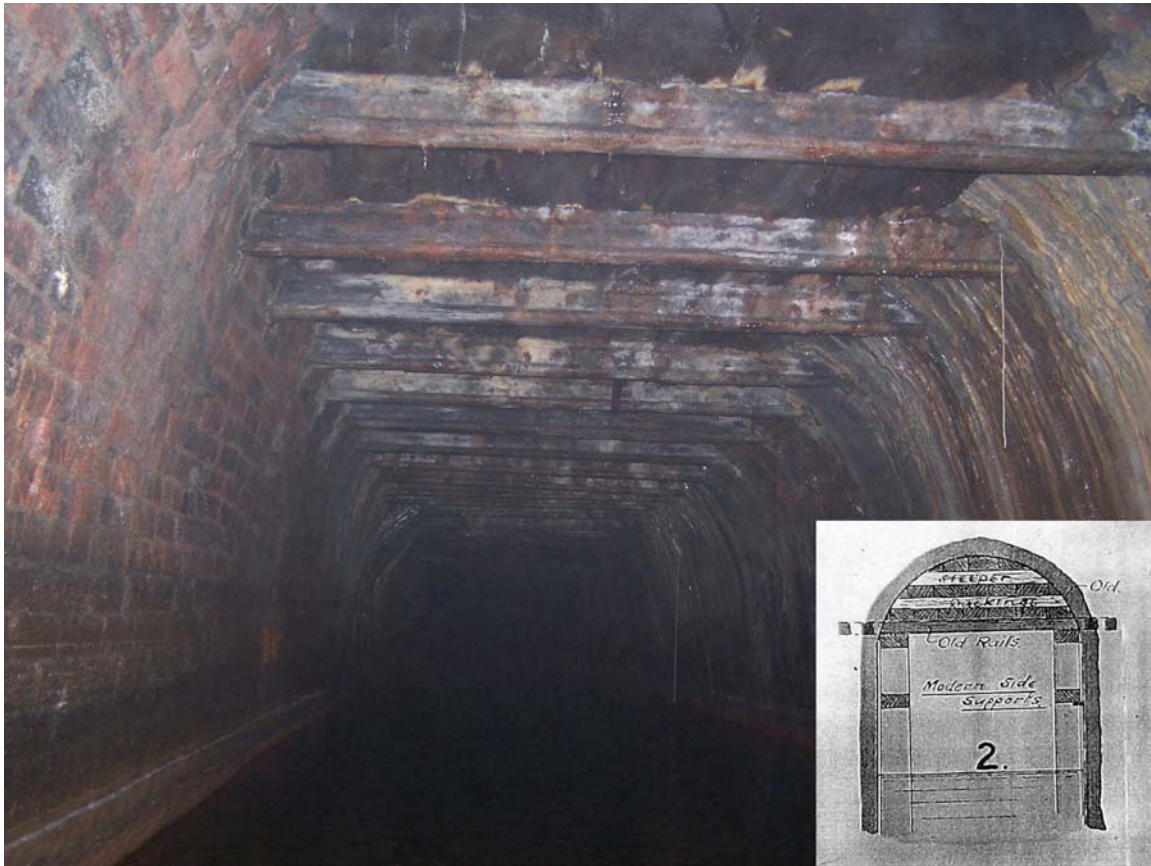
The roof supports here are iron and high enough to allow boats to pass. This section is at marker 36. The Northern wall under this shoring appears more vertical than the Southern as if the top of the tunnel had moved about 1 foot Northwards. The cross-section is from a 1919 Midland Railway drawing of the tunnel.

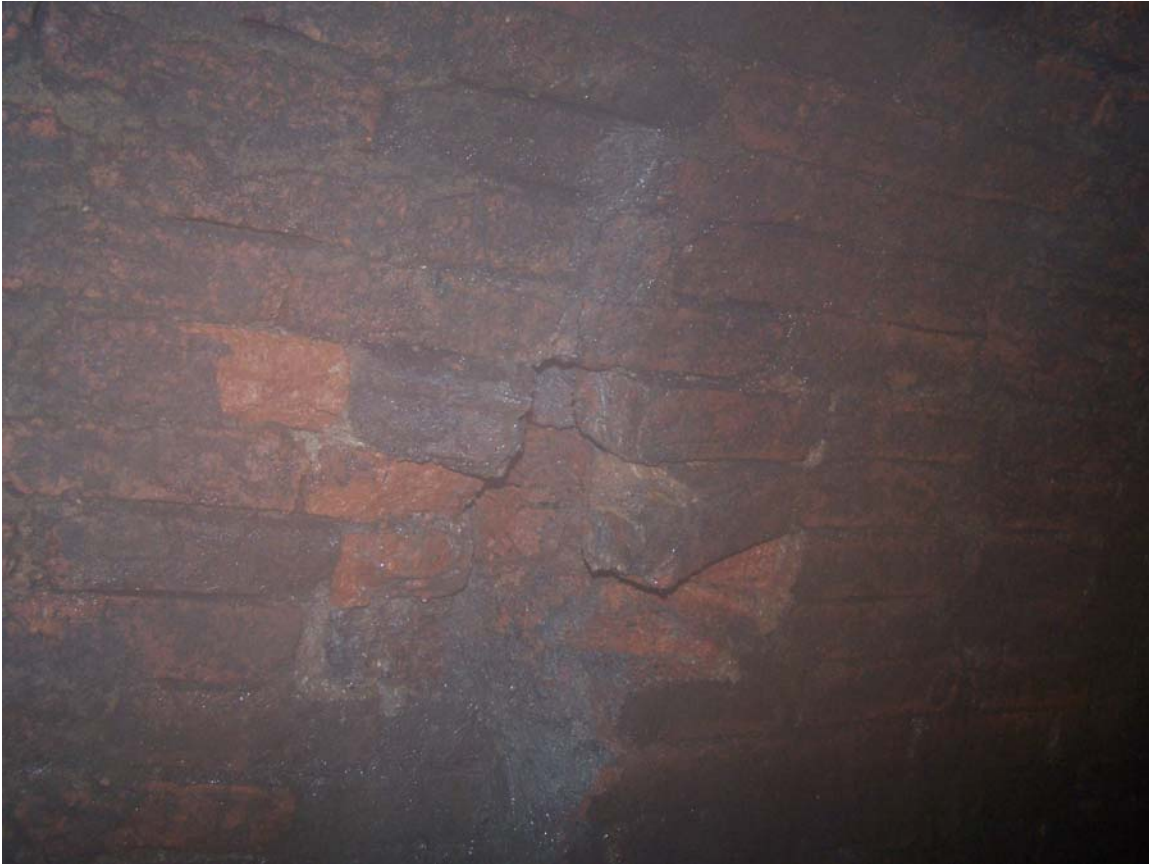
Damaged South wall just after Robin Witter's bulge.
