Butterley Tunnel

Written by and using photographs taken by Tina Cordon between 15th October and 9th November 2006

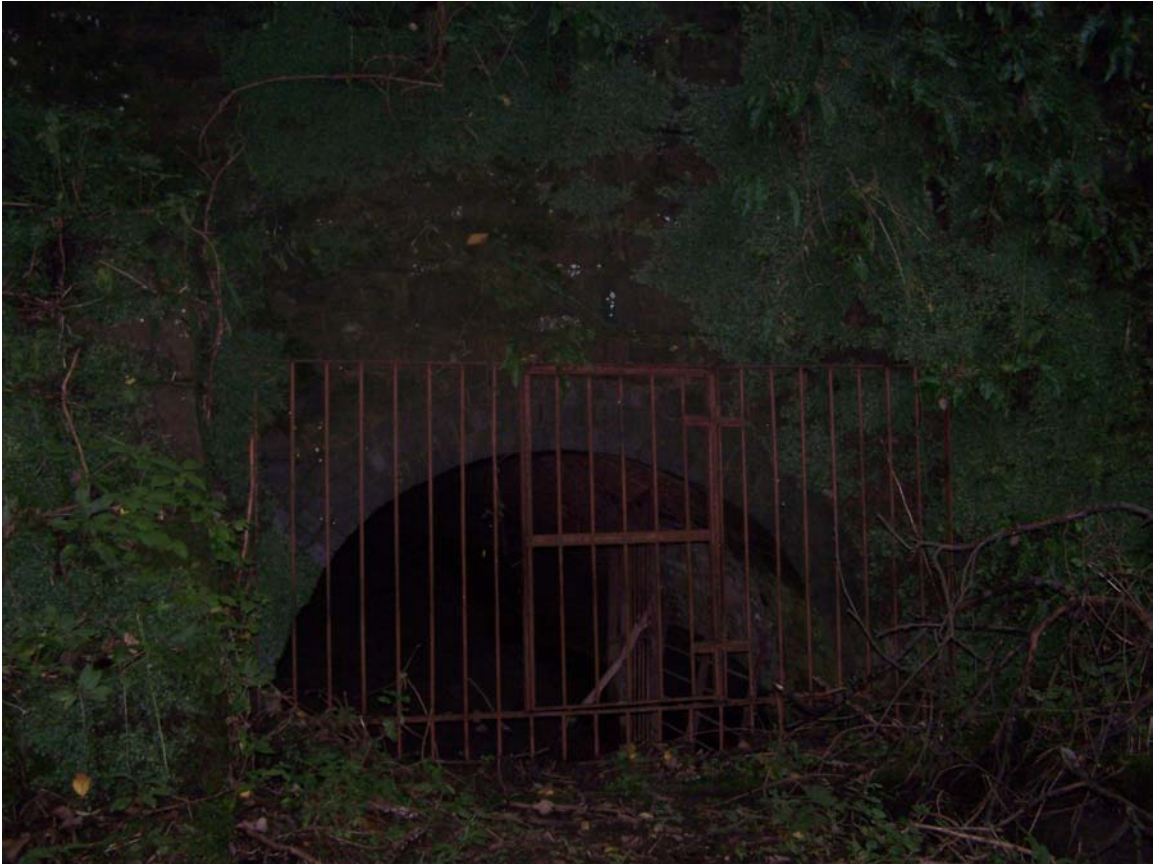
Closer view of Eastern Portal.

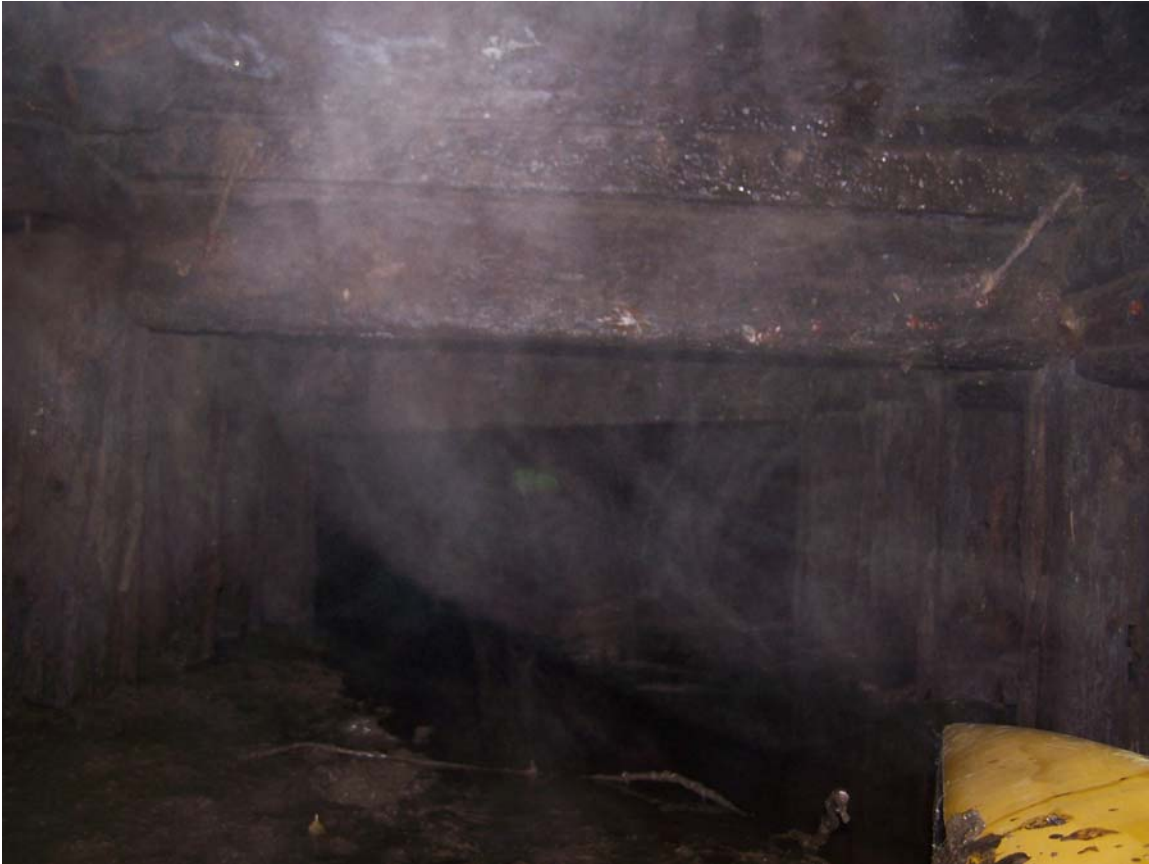
Looking backwards after passing the first shoring at Chain 3, the Eastern Portal can be seen. There is not yet enough water to float the canoe.

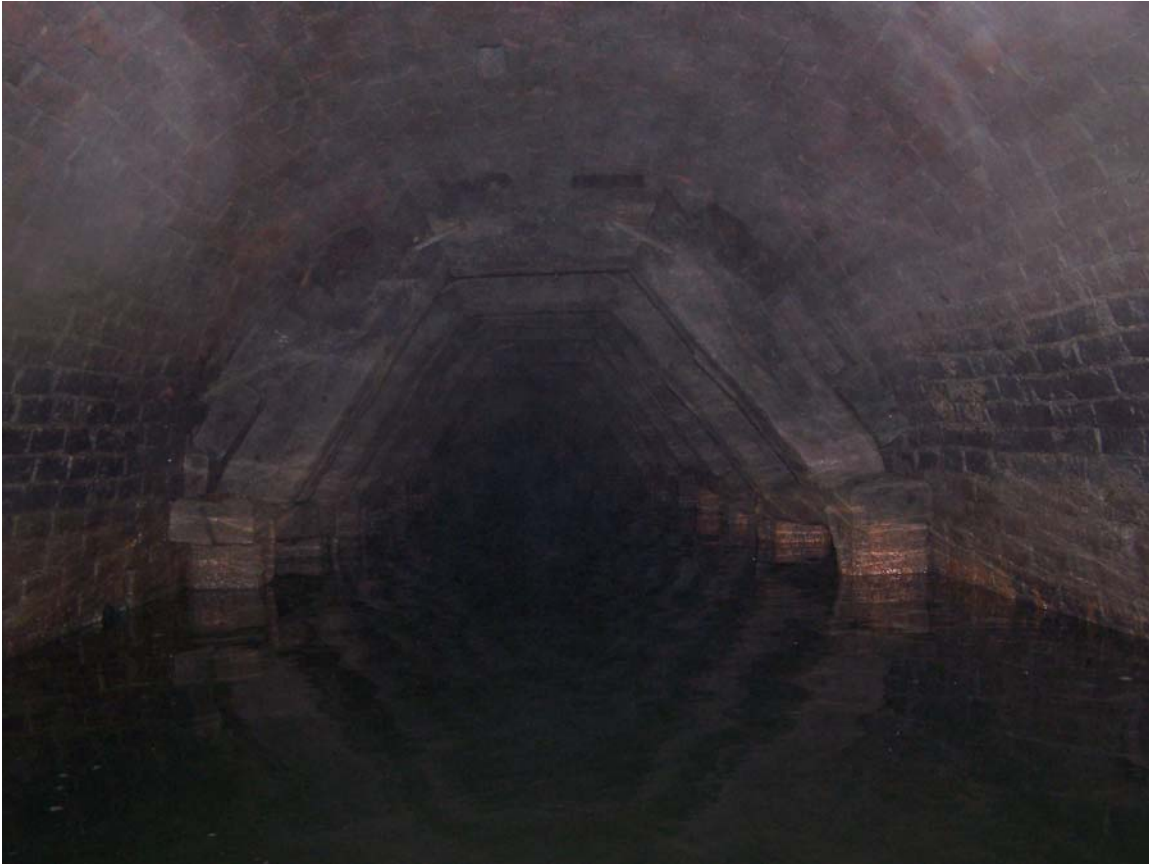
Third set of shoring starts at about chain 6.

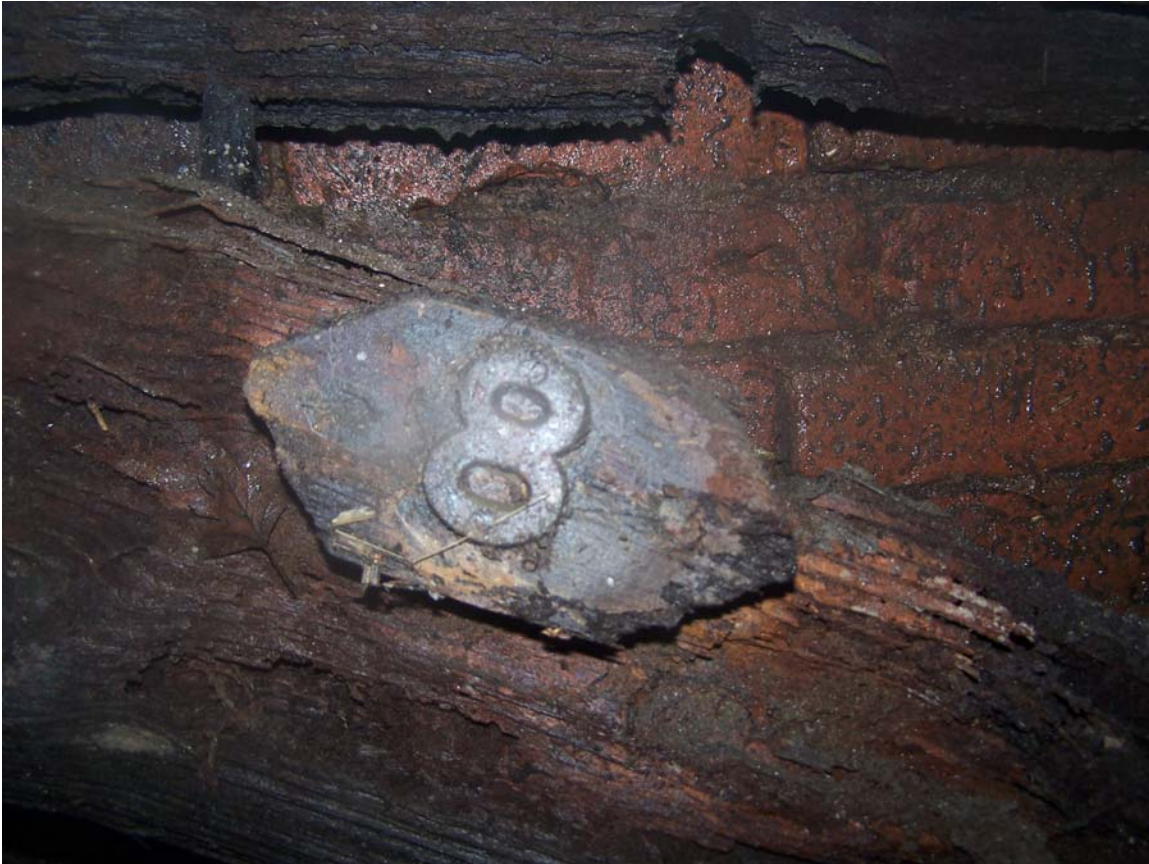
Chain 8 marker is within the third set of shoring. An iron number on a wooden back.

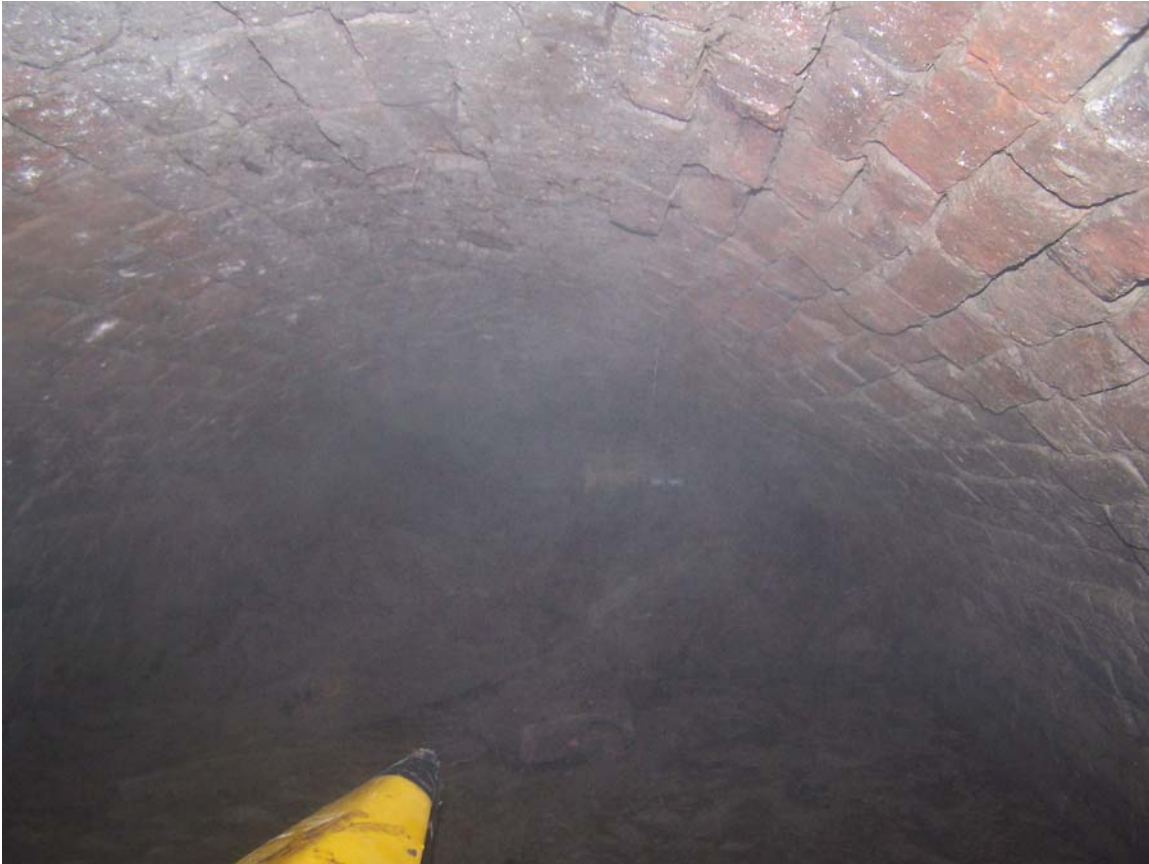
Floor filled with rubble, and the roof quite low.

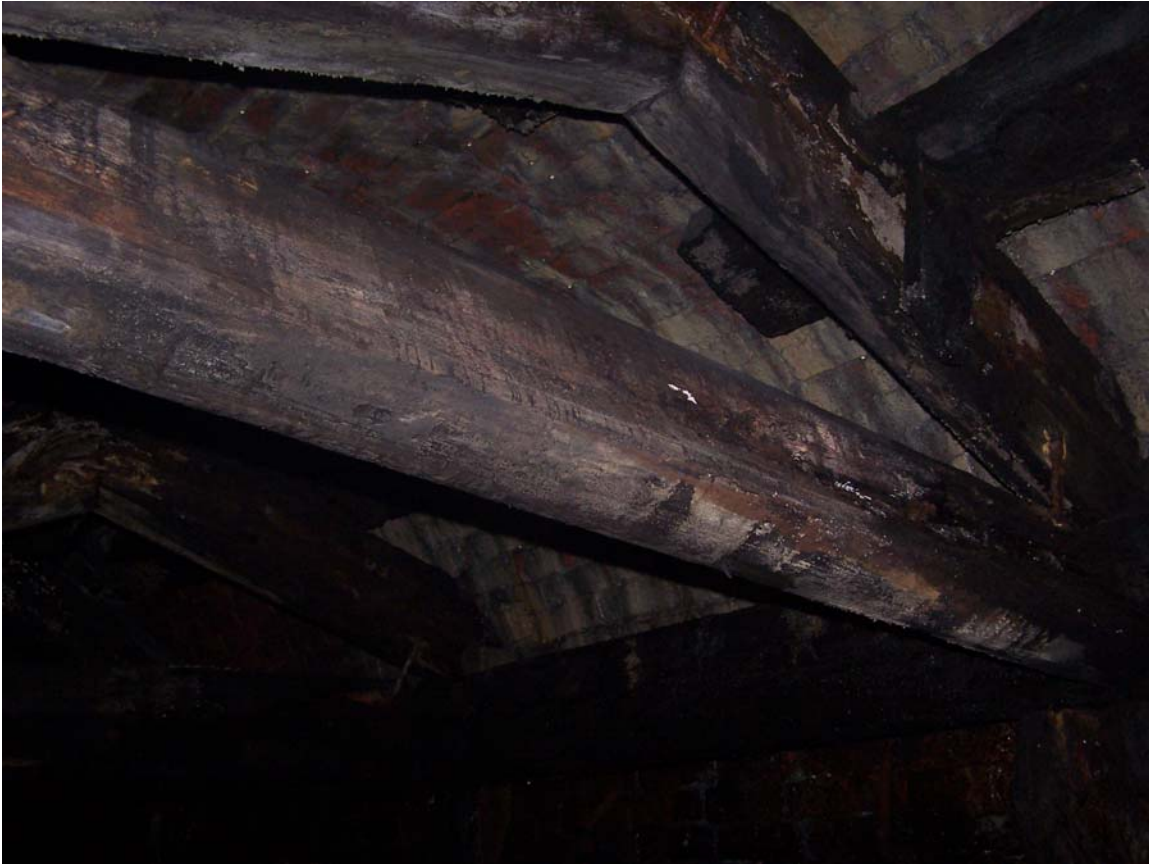
Shoring of the roof which might have allowed a narrowboat to pass.

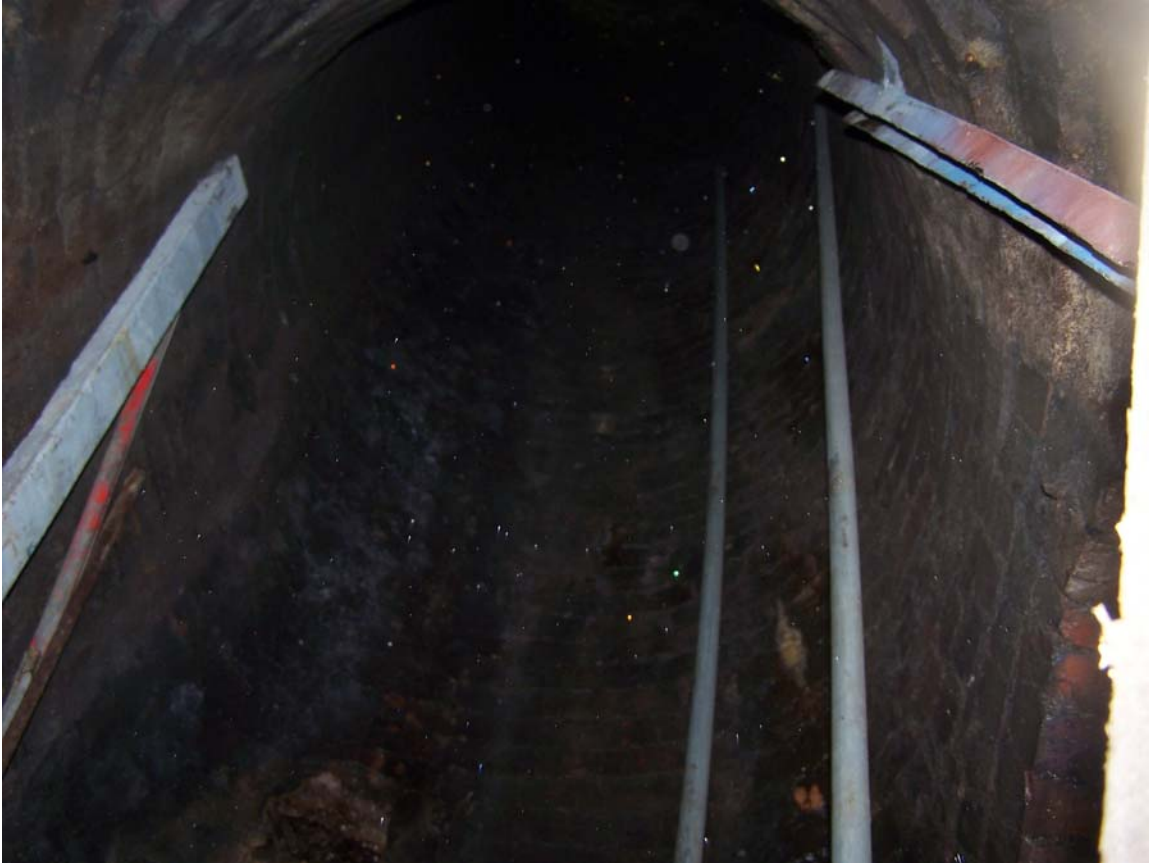
Looking up the airshaft, the items visible are RSJs and scaffold poles which have been thrown into the tunnel.

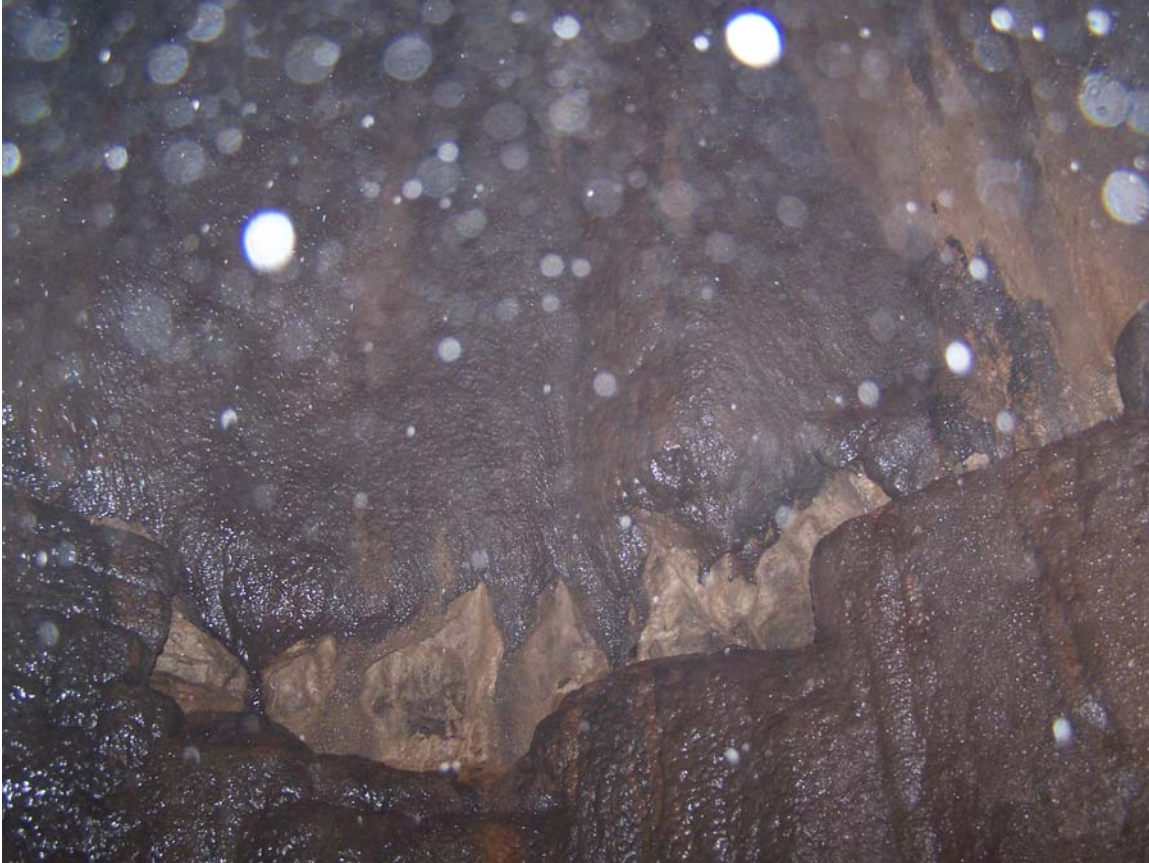
This is a view of the wall of the blast receiver shaft labelled 'I' in the diagram.

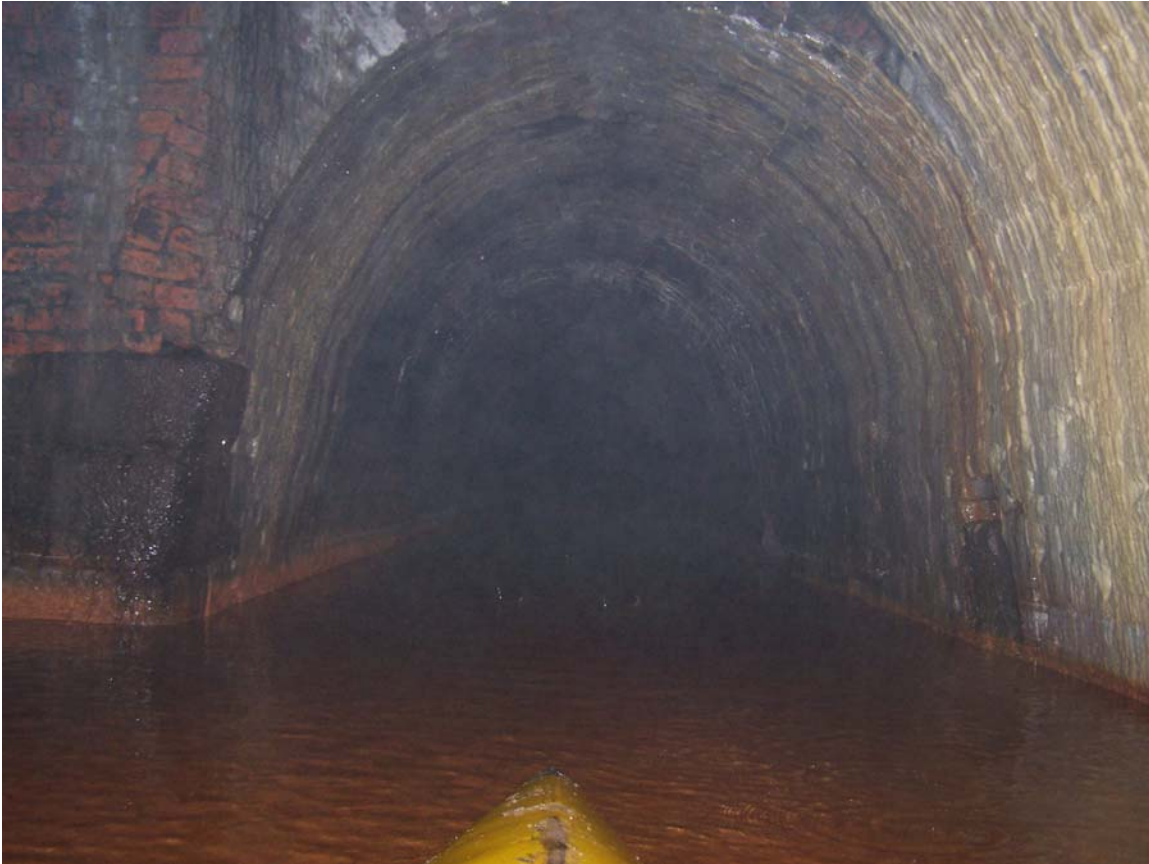
Looking back towards the Western Portal. Notice the small square hole on the North wall (right side of picture) about 2 feet above water level.

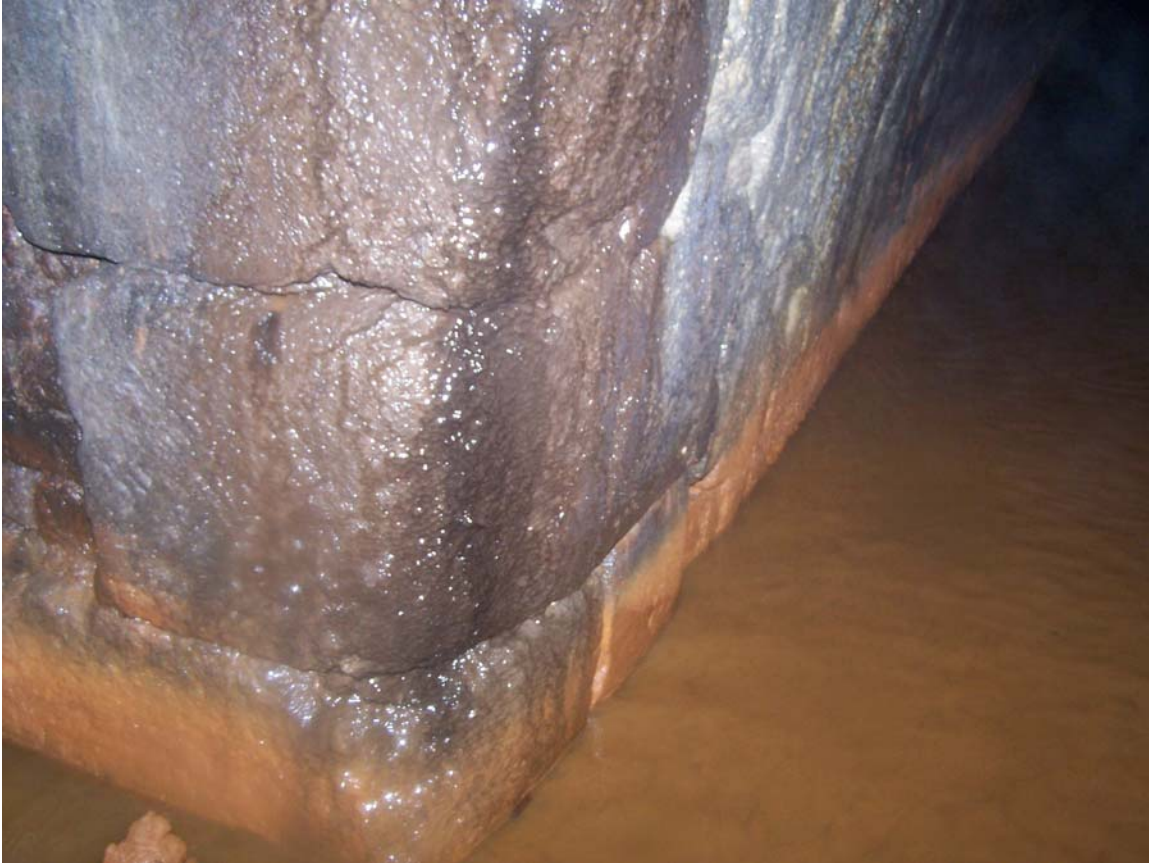
Close up of the masonry bumpers on the corner of the tunnel entering the wharf. Labelled point 'J' on the "Shaft under Blast Receiver" diagram.

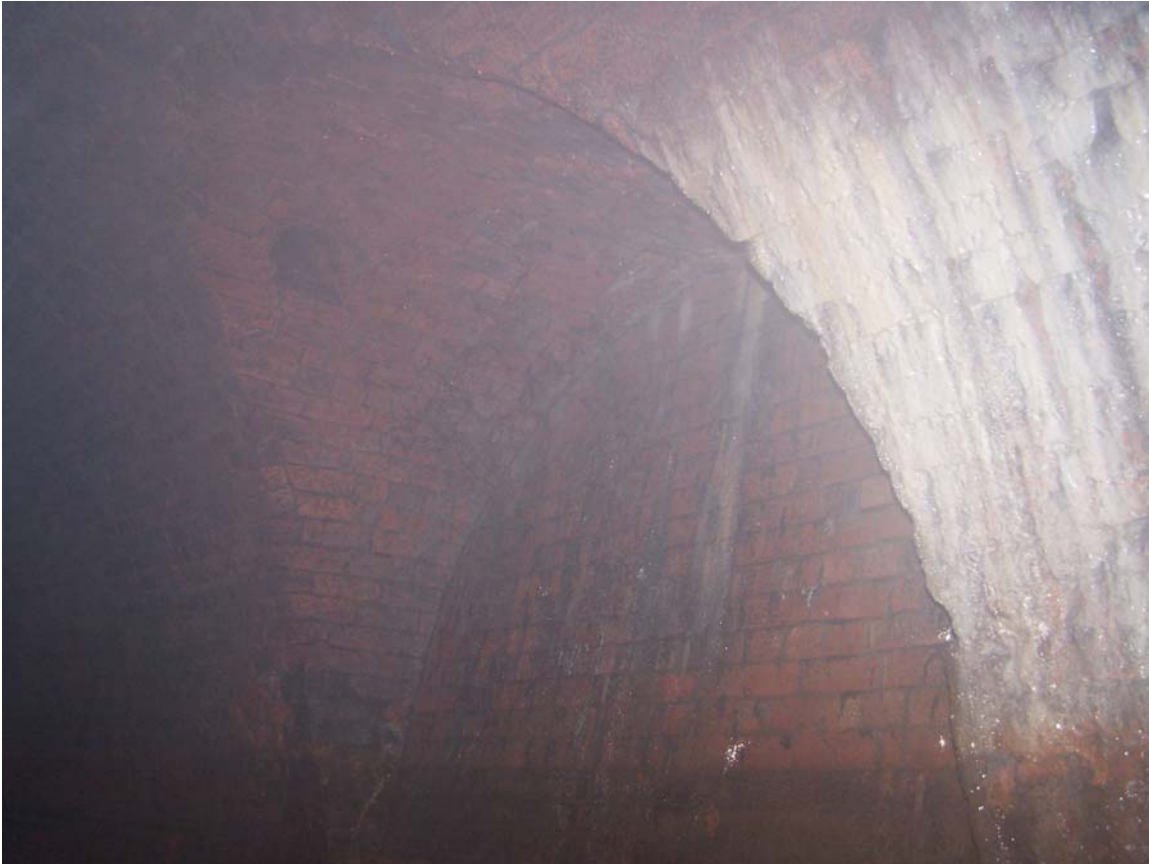
The bricked up entrance next to the main wharf. Labelled as point 'E' on the preceding drawing. The drawing also has a detail of this entrance.

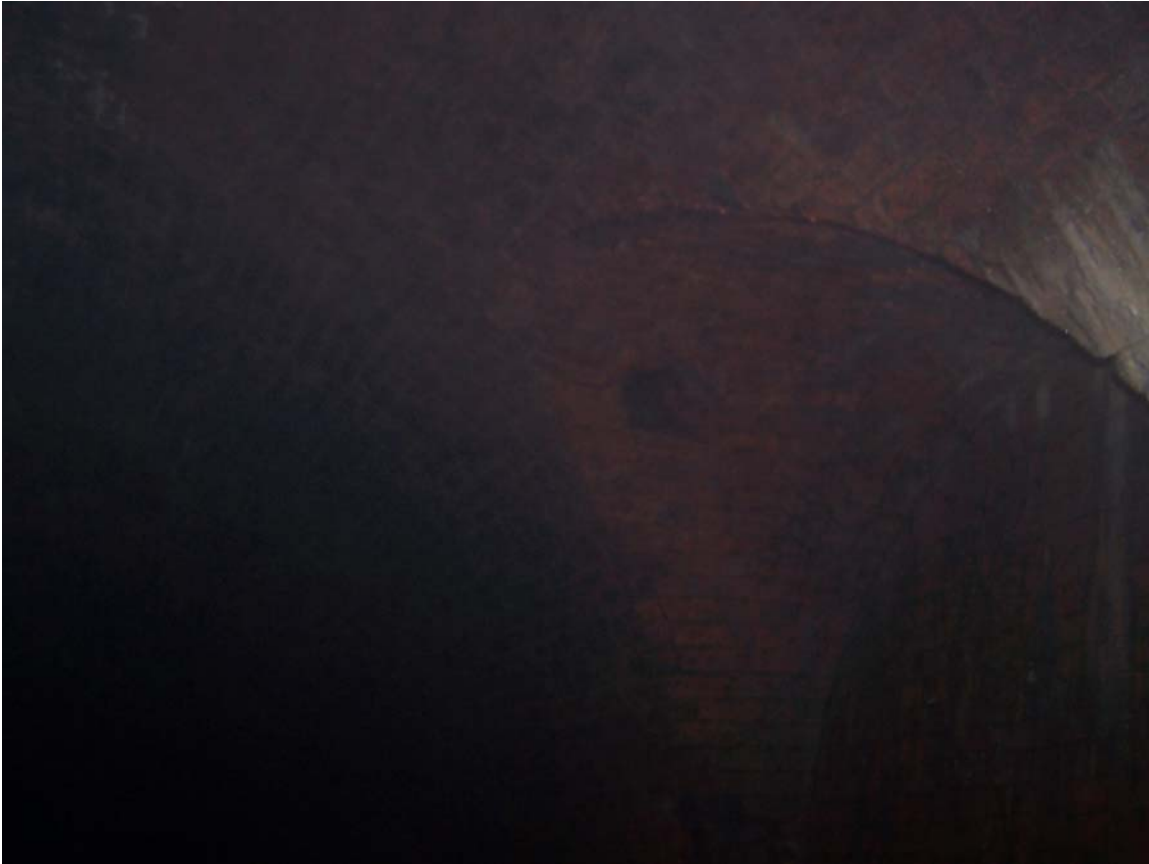
Another view of the bricked up entrance at point 'E'.

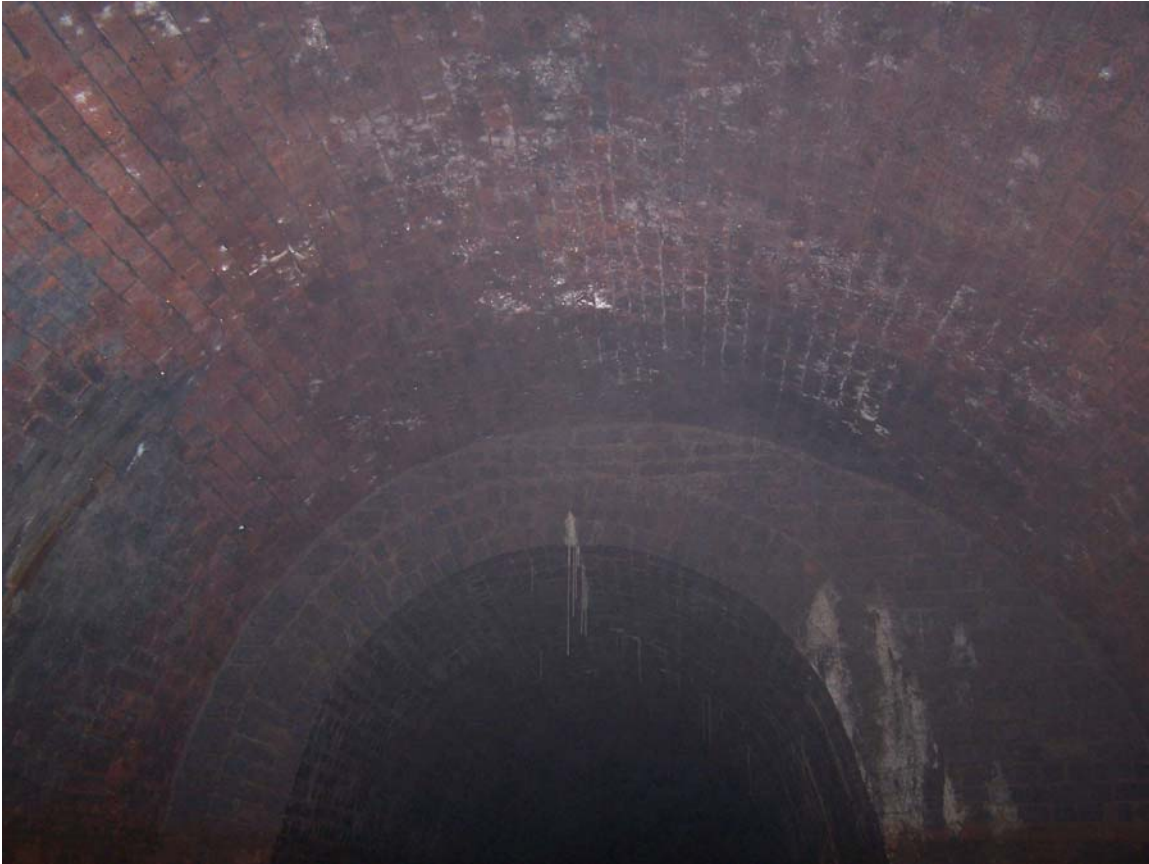
The brickwork put in when the Wide Hole was shortened.

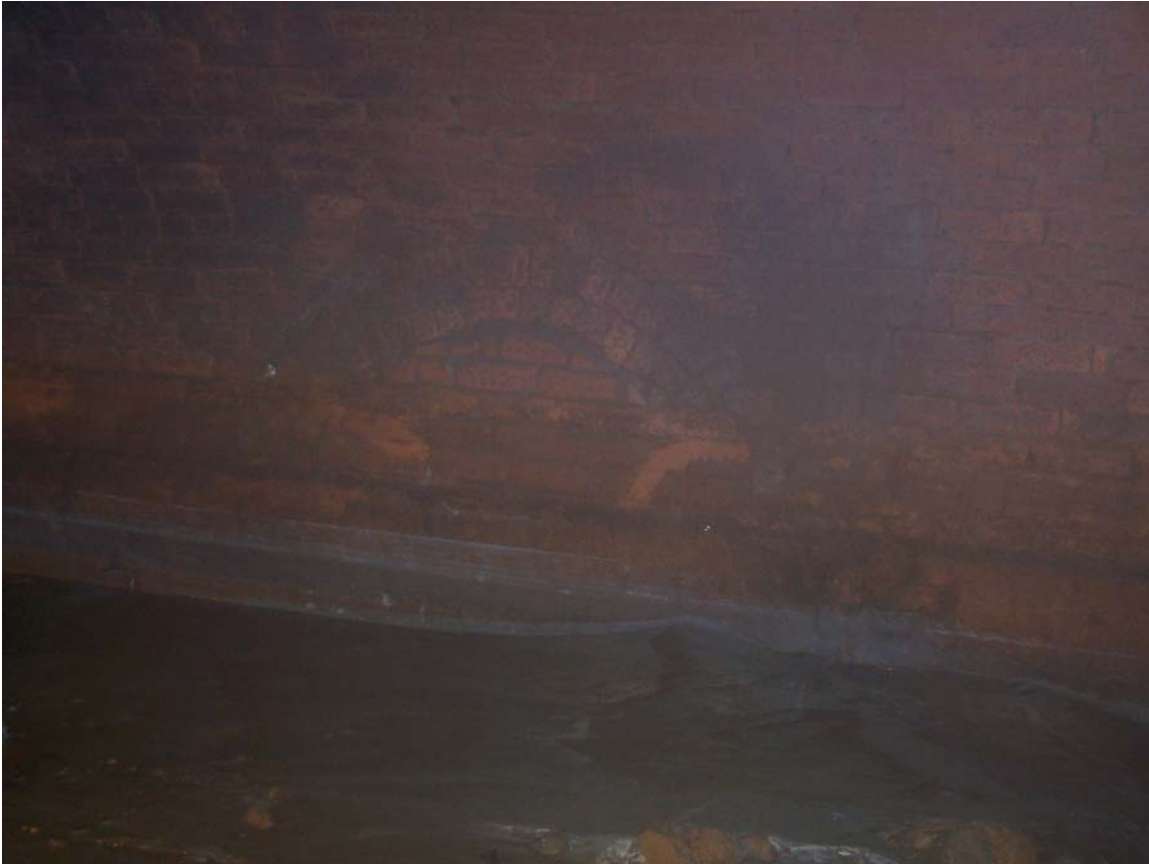
This bricked up arch is in the North wall just to the West of the Carr Pit exit and is labelled 'M' on the accompanying diagram.

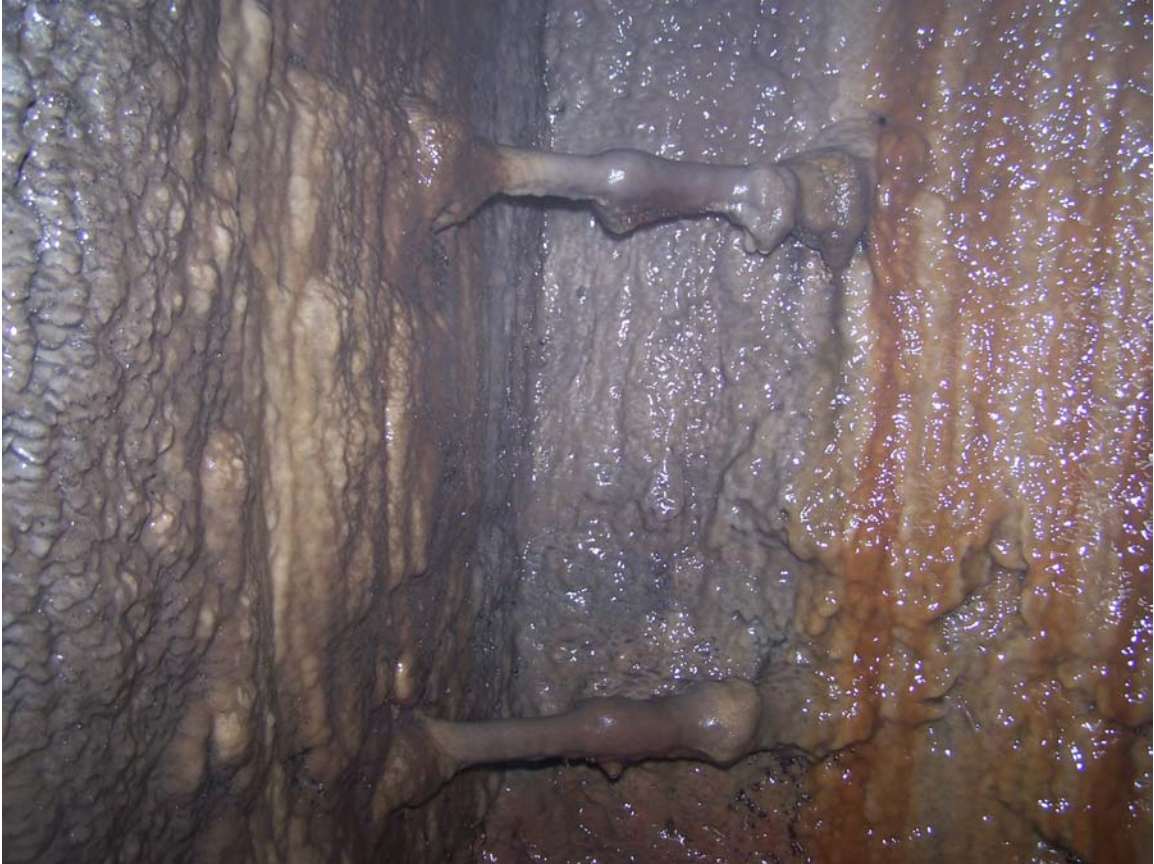
The Steps at point 'C'.

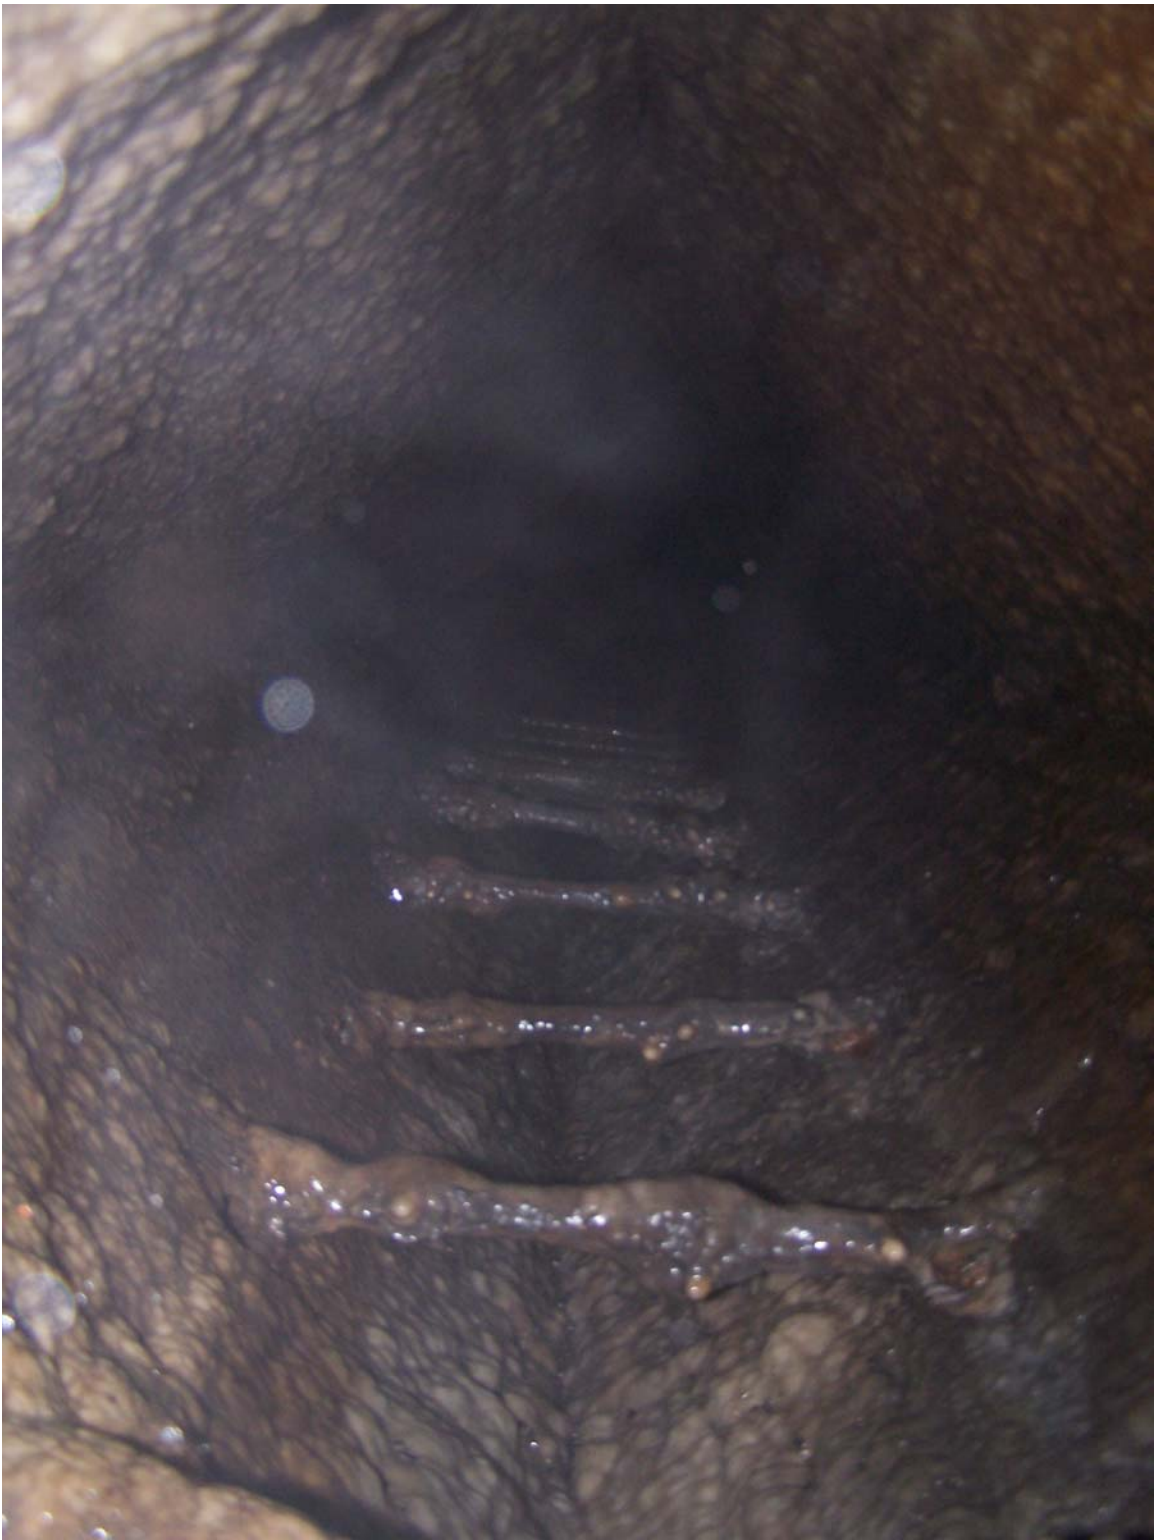
The ladder leading upwards from point 'C'. The 1915 Wide Hole drawing shows that this ladder leads to the base of the most westerly loading shaft. There are twelve steps 14 inches apart.

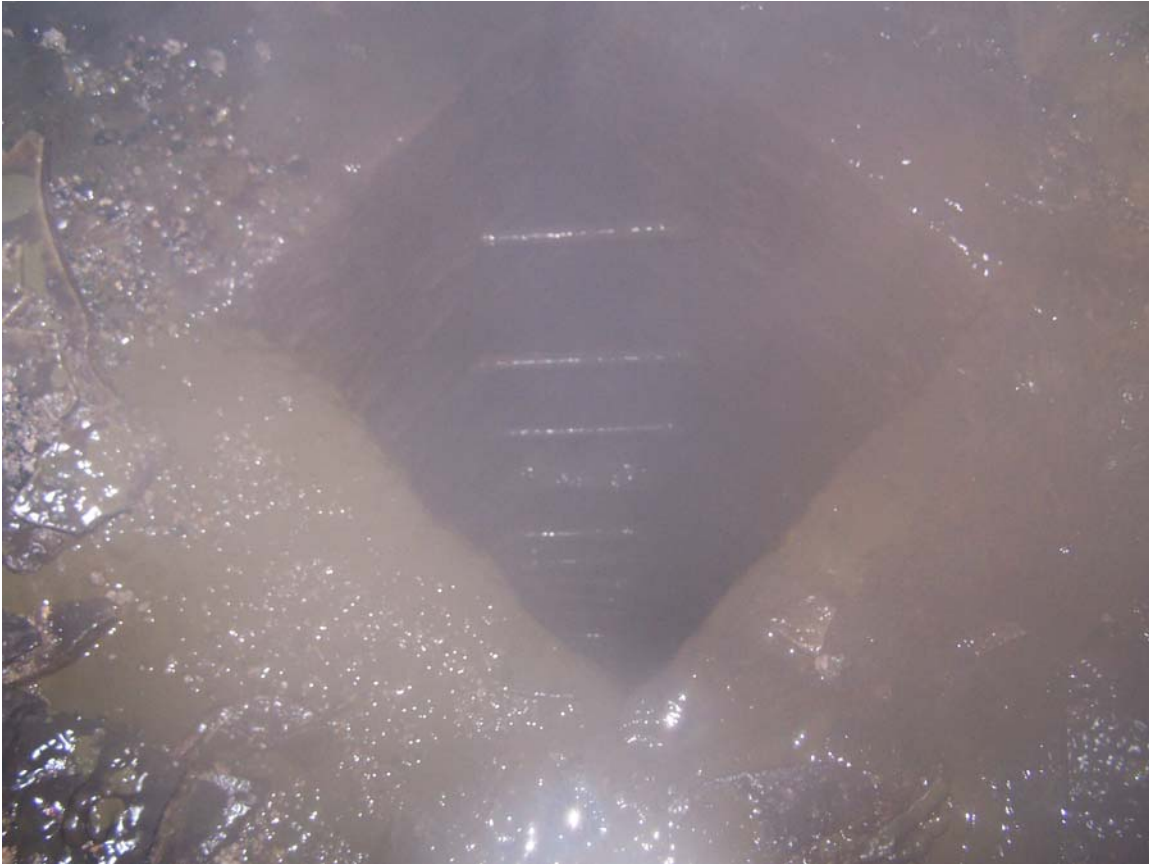
Above the steps in the Western loading shaft looking back down to point 'C'.

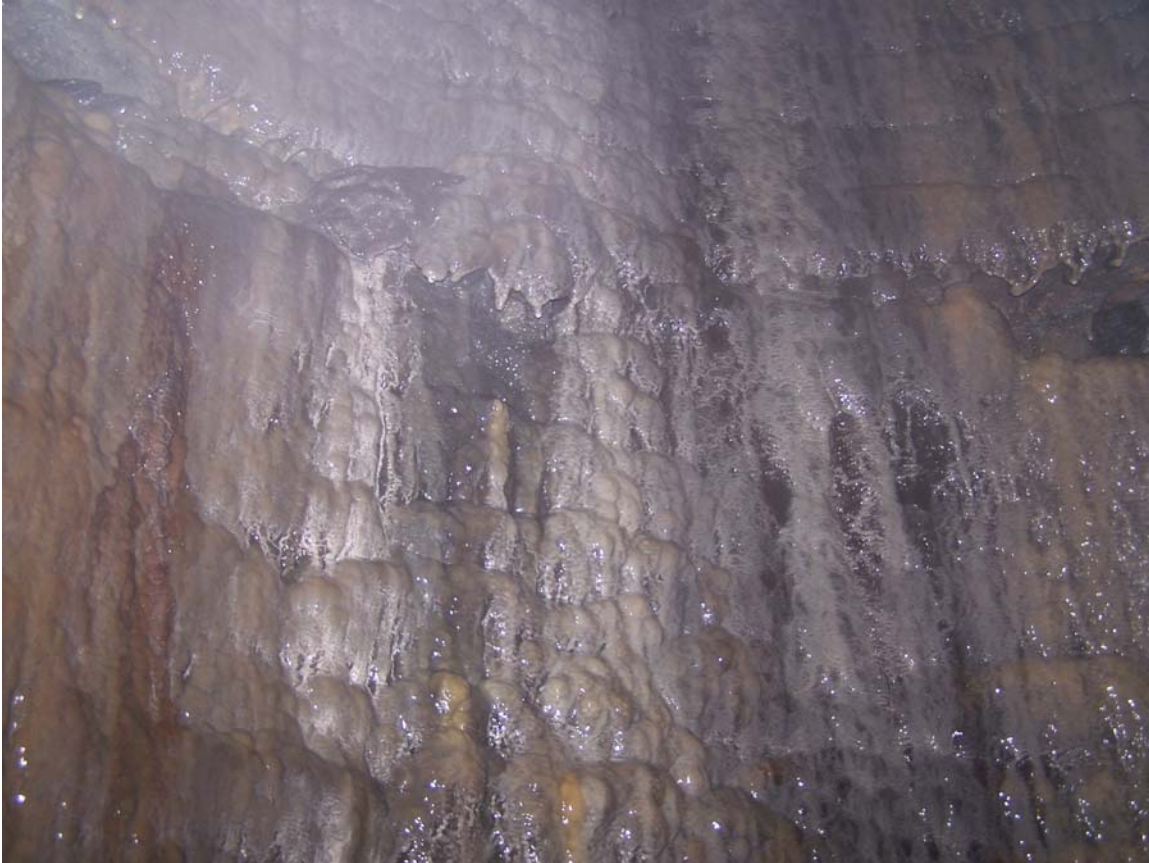
Flowstone on the wall of the loading shaft which is between 6' and 6' 6" not 7' wide.

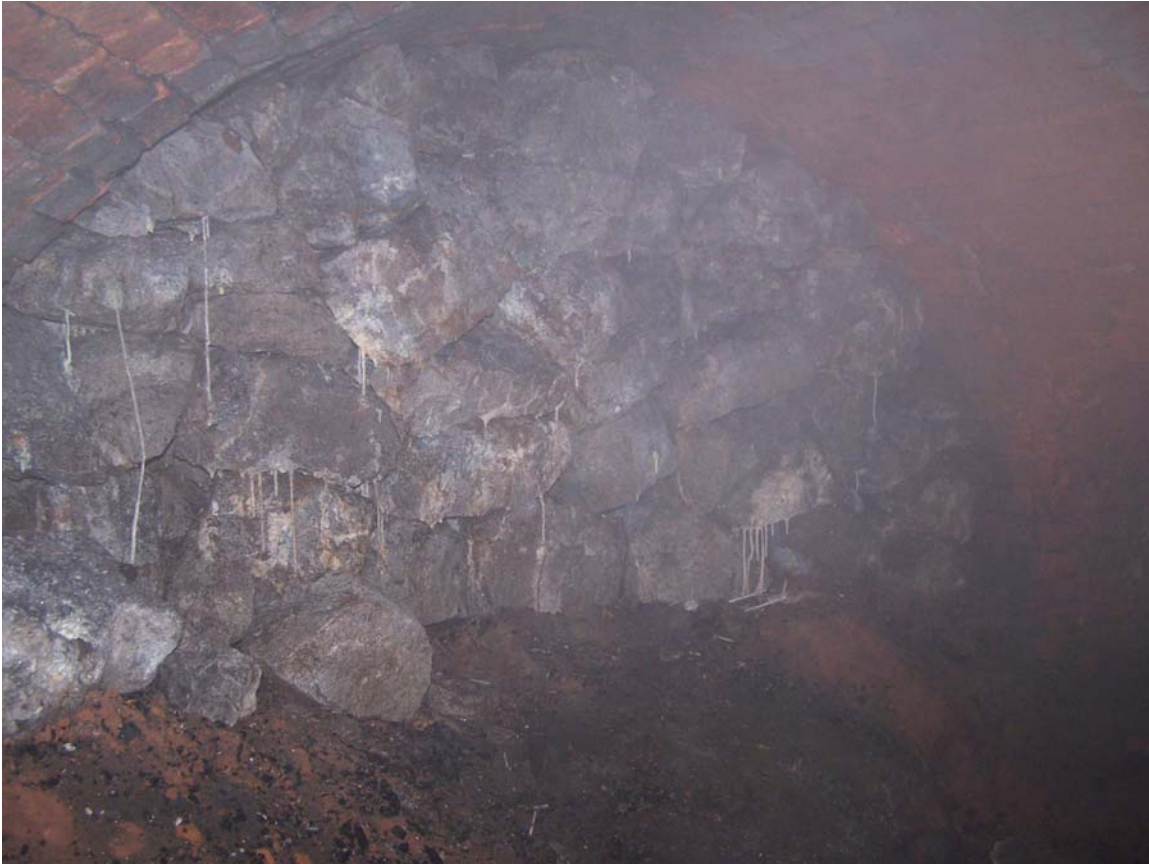
The stacked up stone closing off the shaft picture from the arched gangway. The canal entrance to this shaft is shown as the bricked up entrance earlier.

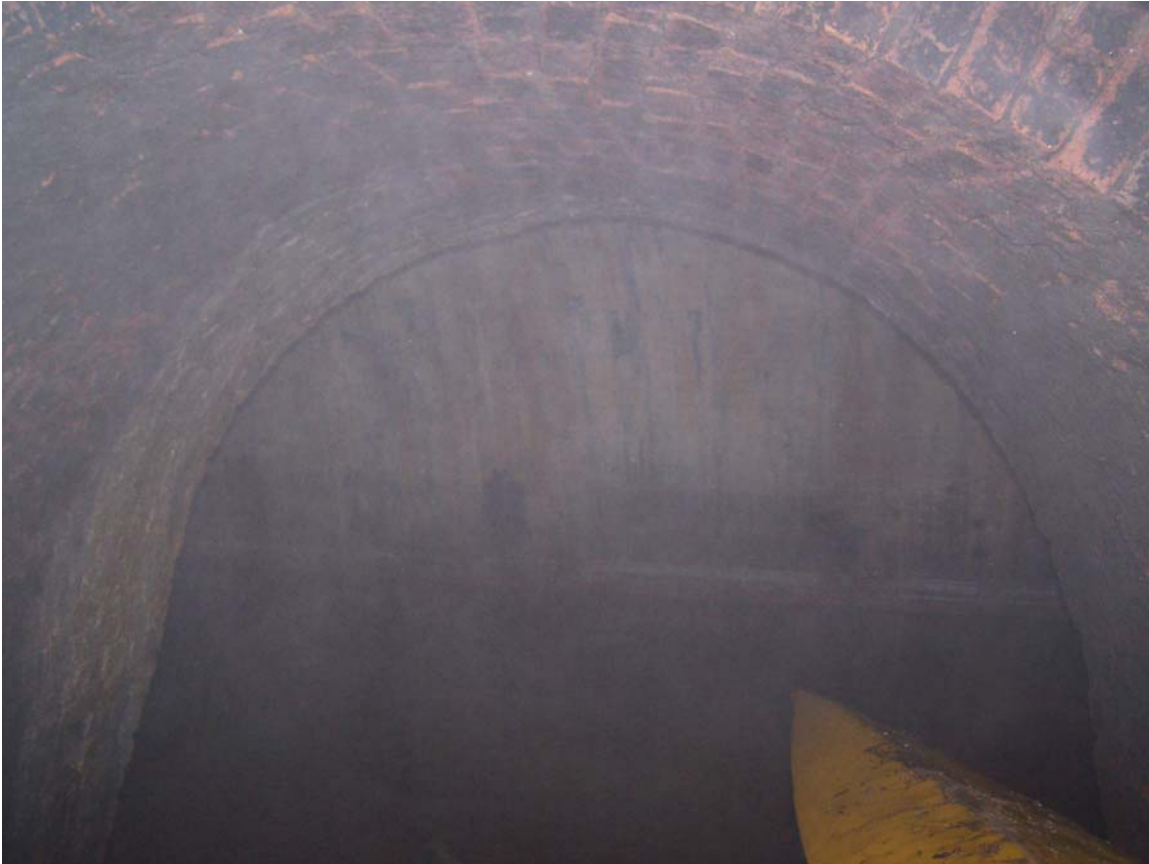
Looking out of the Arched Gangway to the Wide Hole. My canoe has been pulled up onto the wharf.

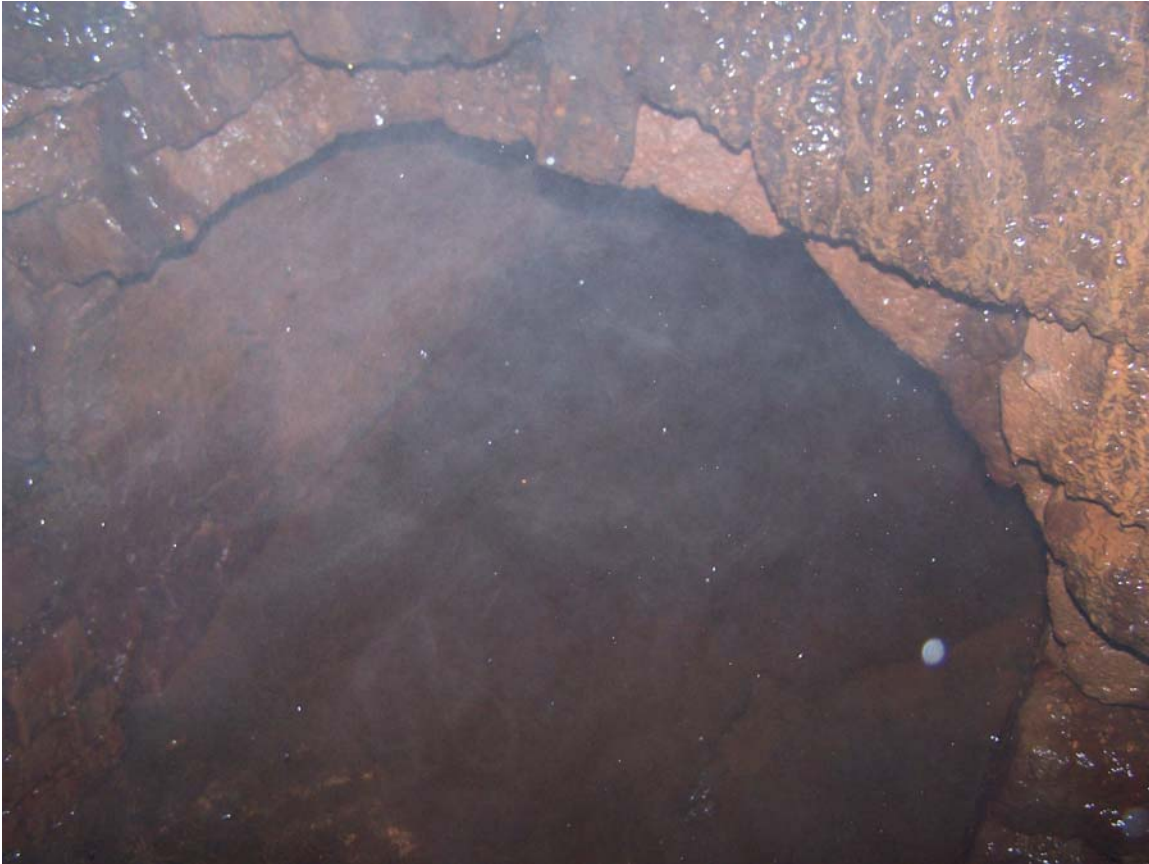
View from the shaft 'N' looking back at its entrance tunnel towards point 'P'.
