Butterley Tunnel

Written by and using photographs taken by Tina Cordon between 15th October and 9th November 2006

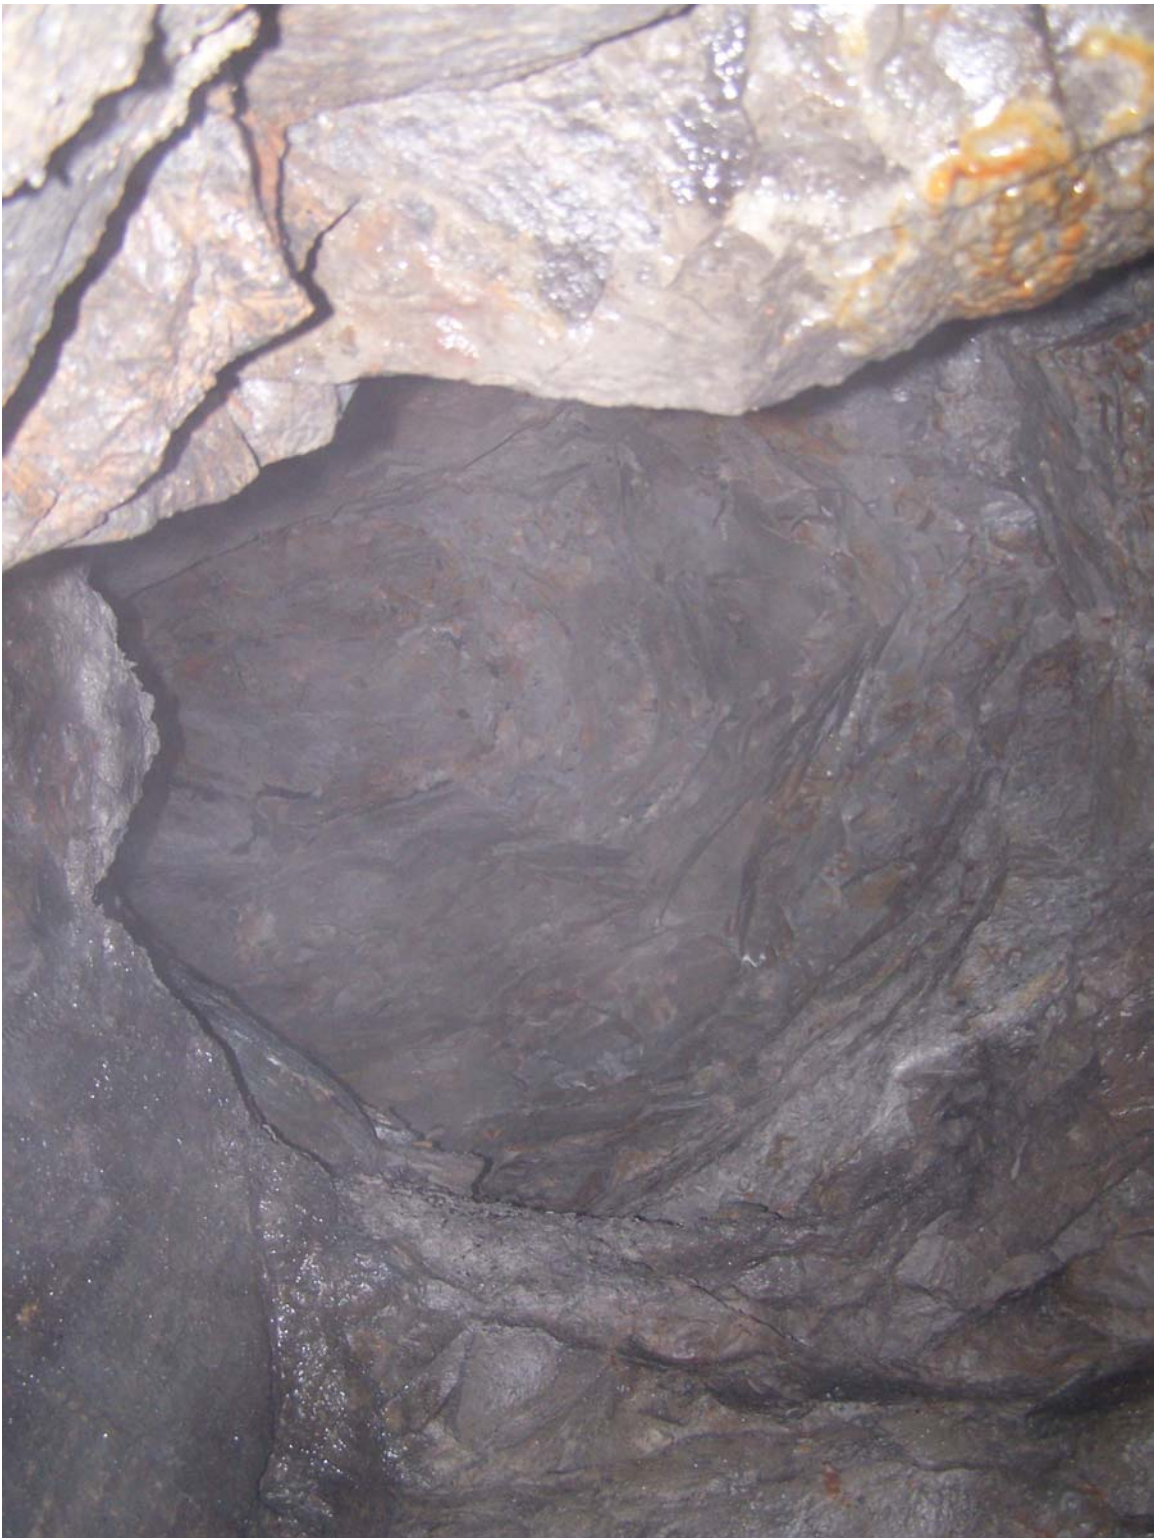
Looking up the old heading 'O'. This is not a horizontal view it is a view up the beginnings of a vertical shaft entirely in virgin rock, the siltstone earlier mentioned. About 20 feet of this shaft is visible from the base.

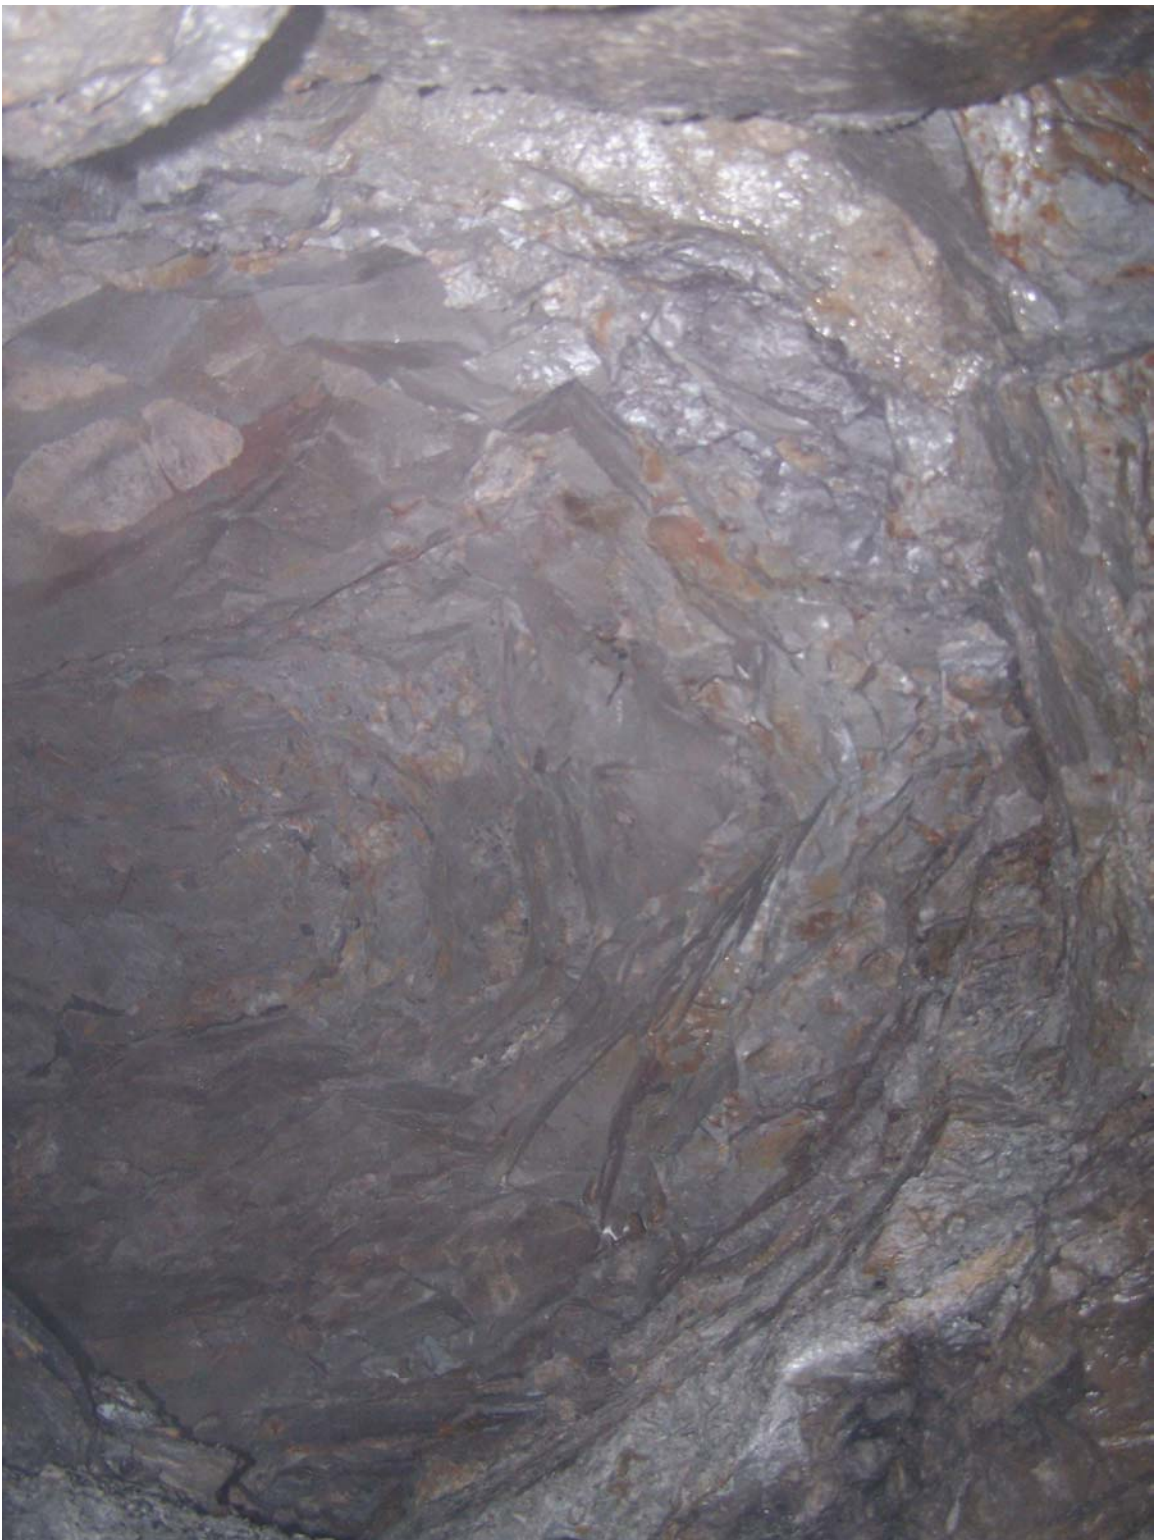
Another view of the old heading labelled 'O'.

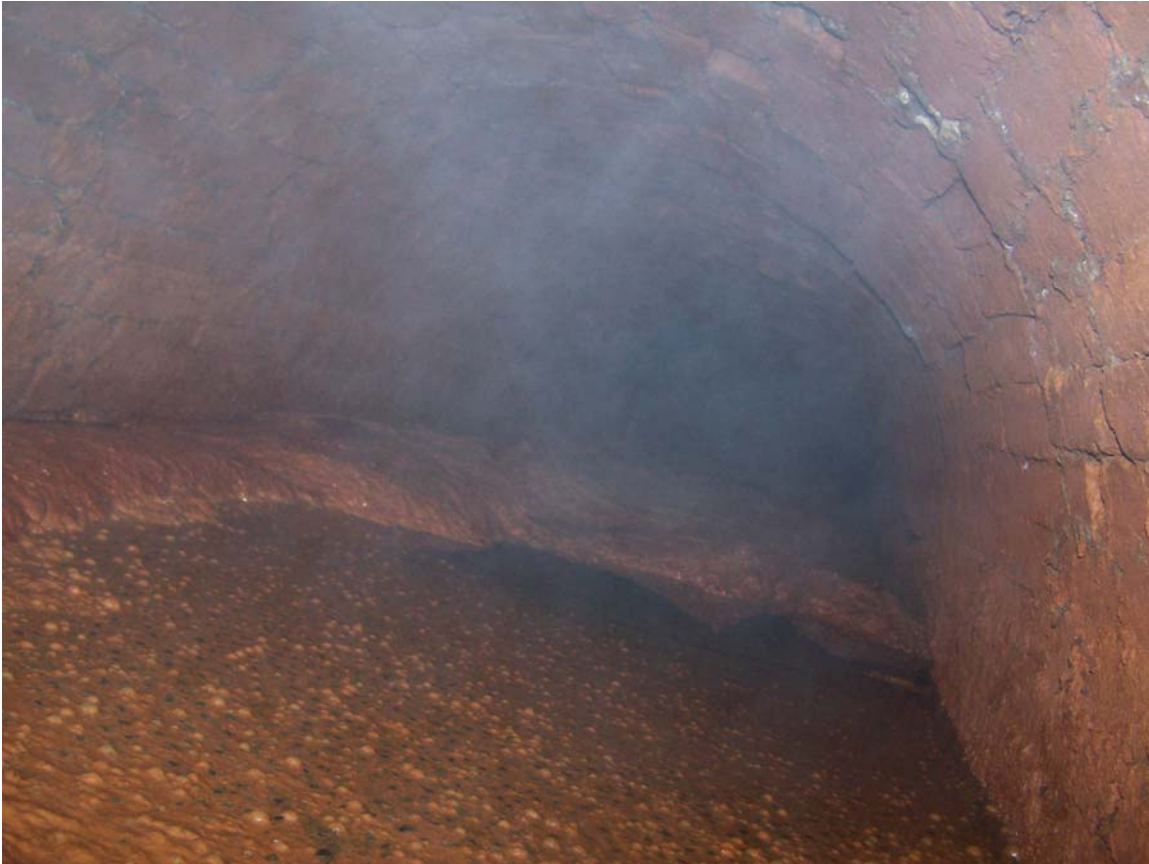
Looking South along the Carr Pit heading in the direction of point 'R'.

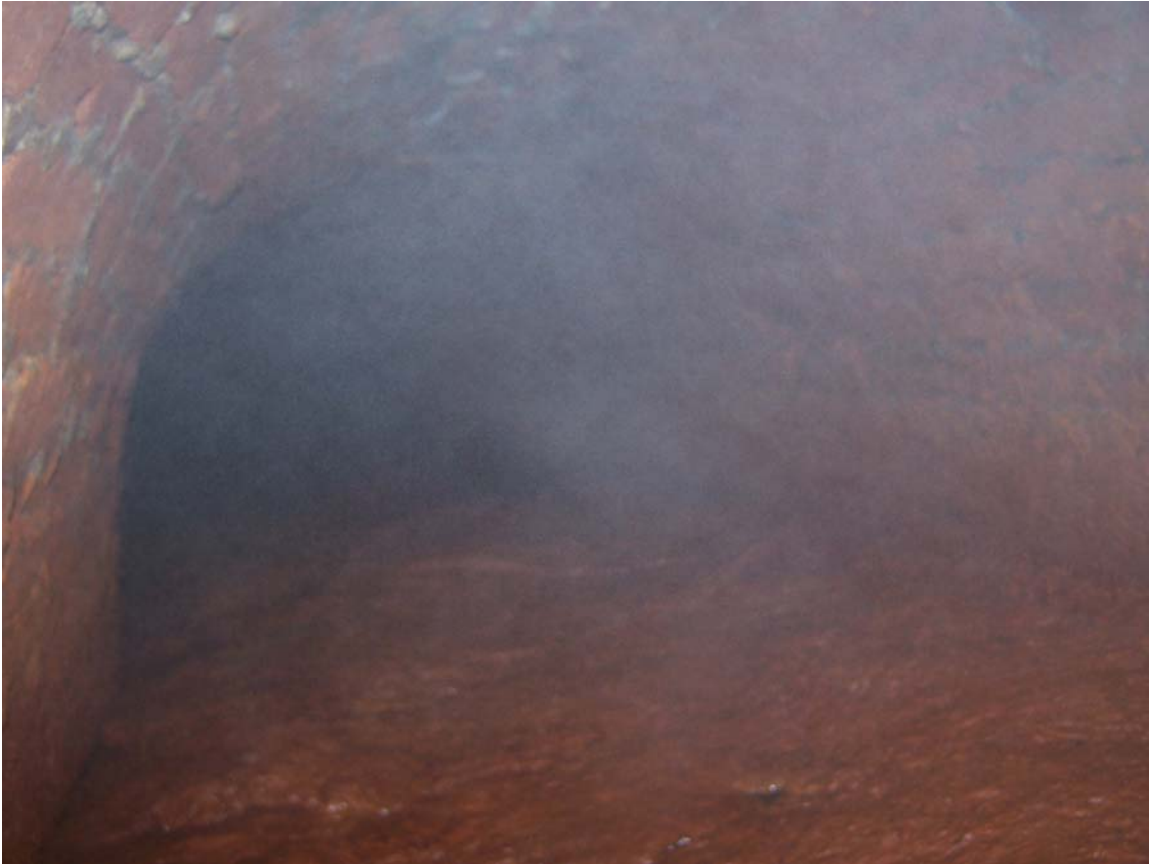
The Carr Pit heading looking towards point 'S', viewed from point 'Q'.

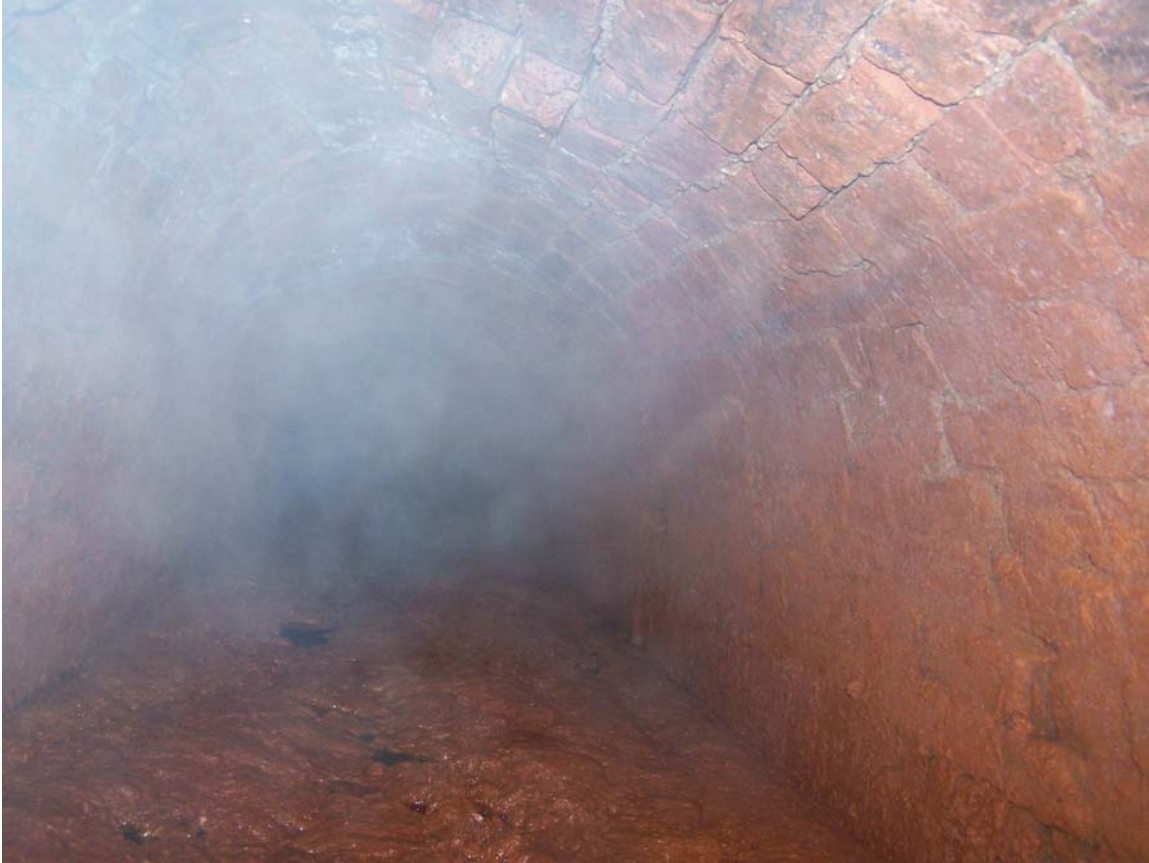
More Carr Pit Scum. This time photographed from the Wide Hole where the Car Pit heading enters at point 'L'.

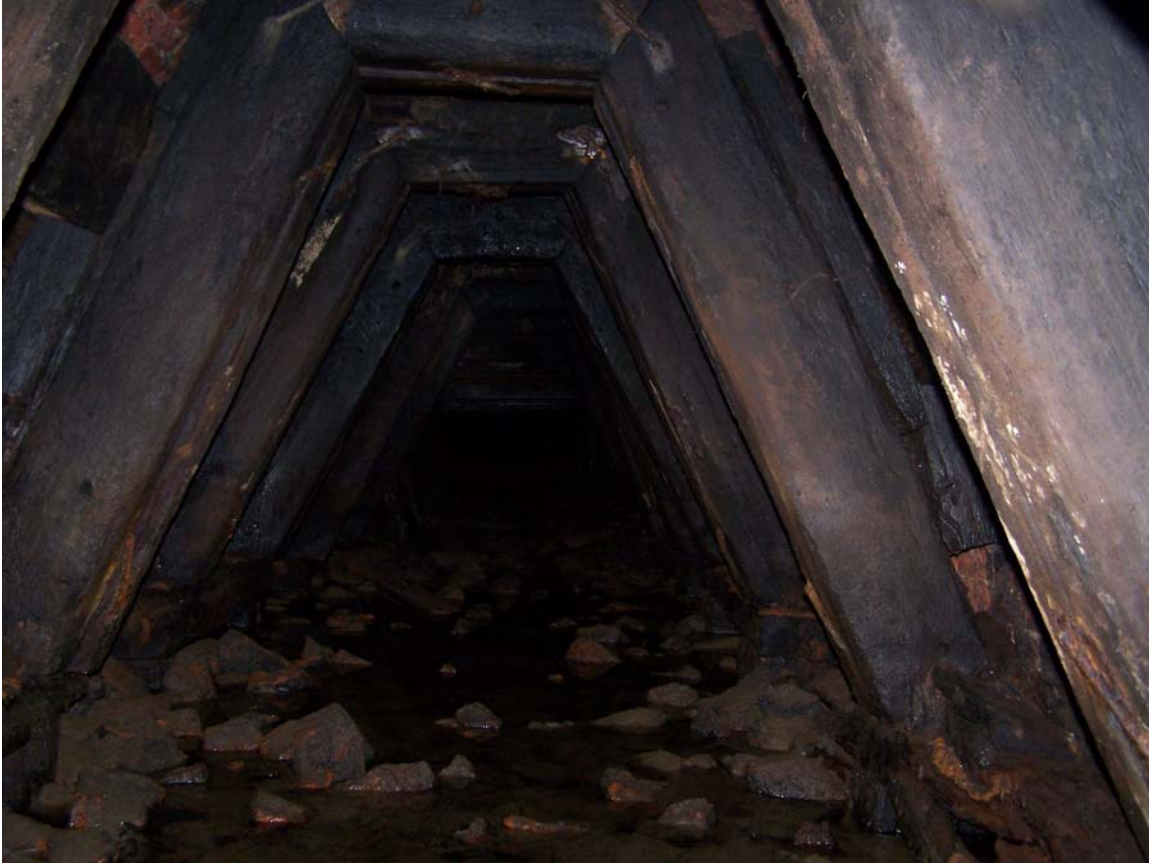
Shortly after the Wide Hole the floor of the tunnel is built up with rubble and the roof is heavily shored up.

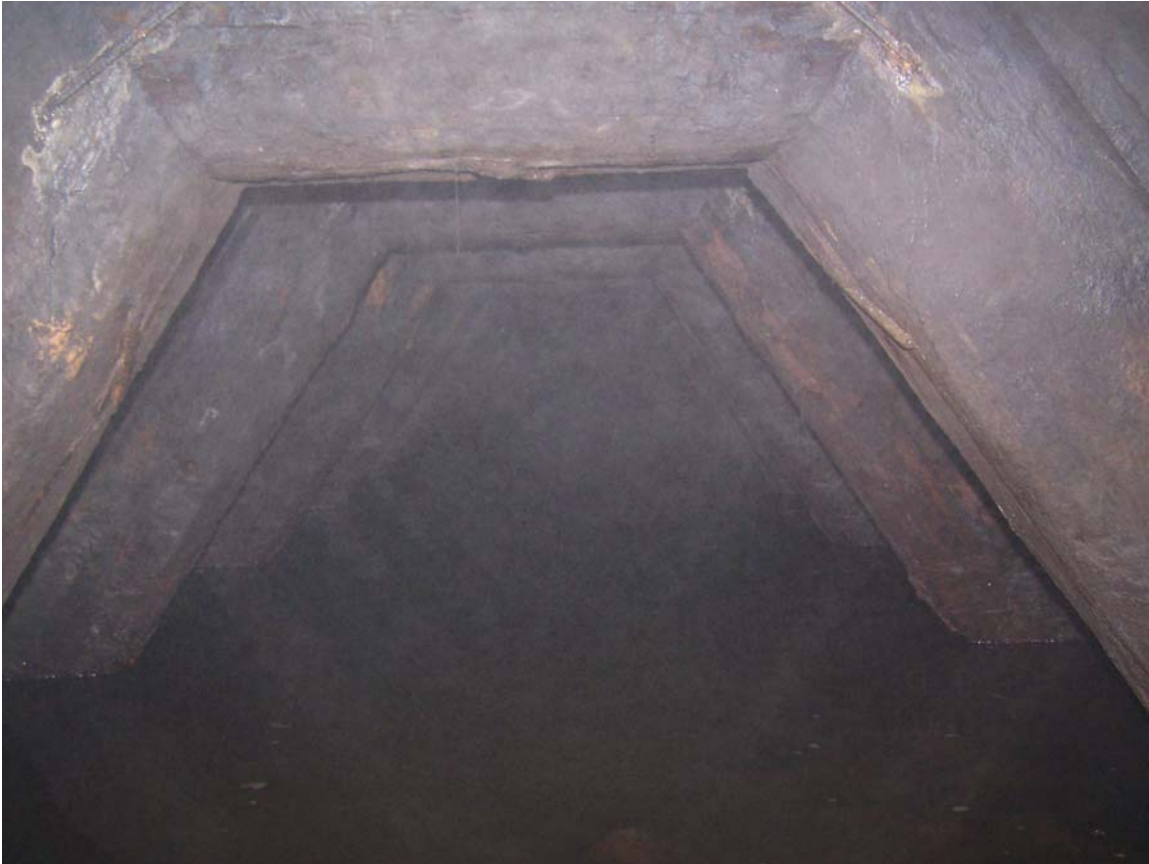
This is the style of shoring just before the collapse.

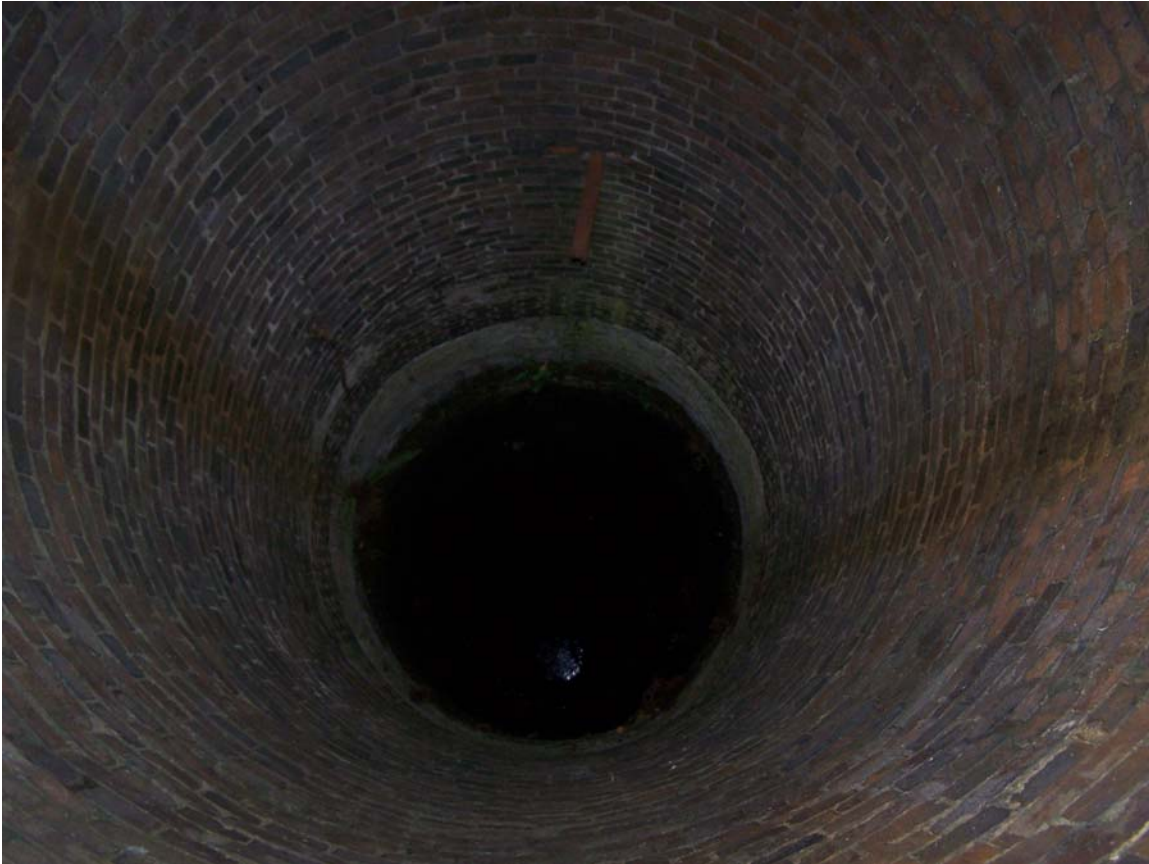
Looking down Shaft Two. Water is visible at the bottom.

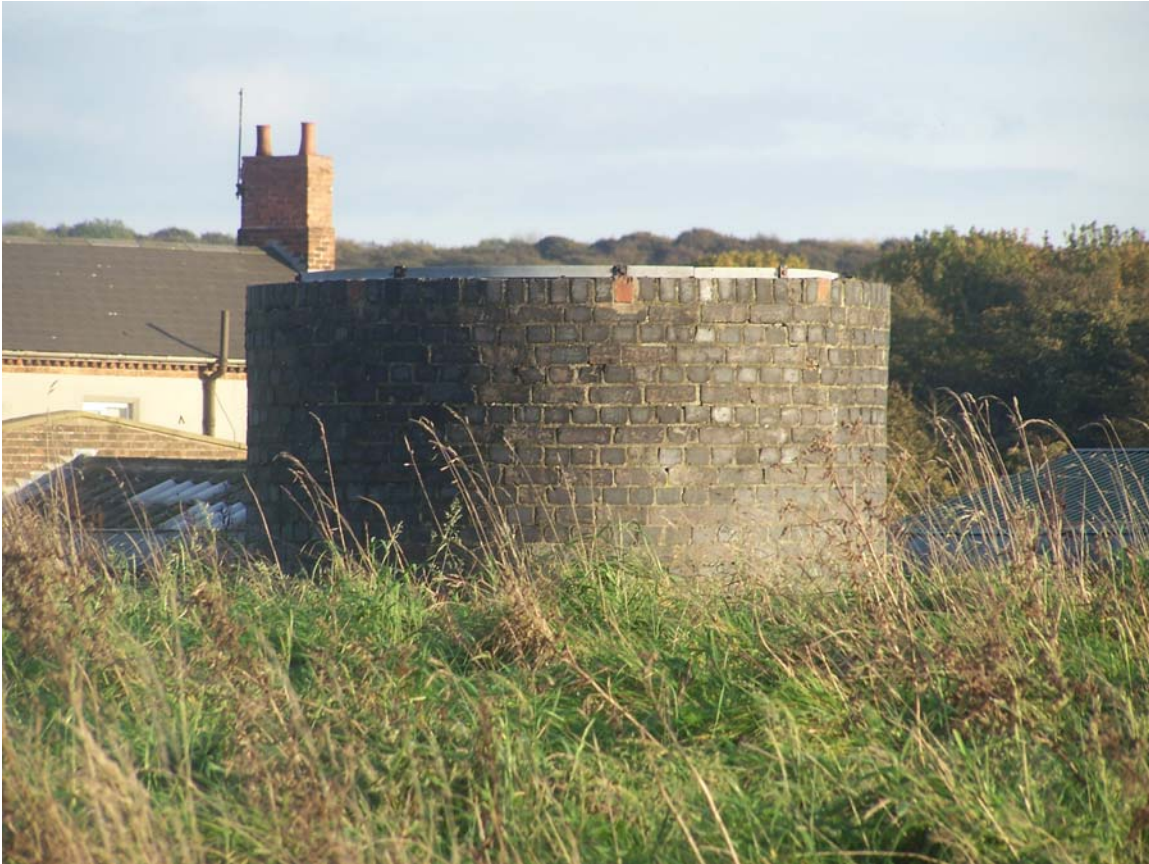
Shaft Four at the surface on the other side of the Coach Road. 53 degrees 3.487' N, 1 degree 22.917' W.
