Butterley Tunnel

Written by and using photographs taken by Tina Cordon between 15th October and 9th November 2006

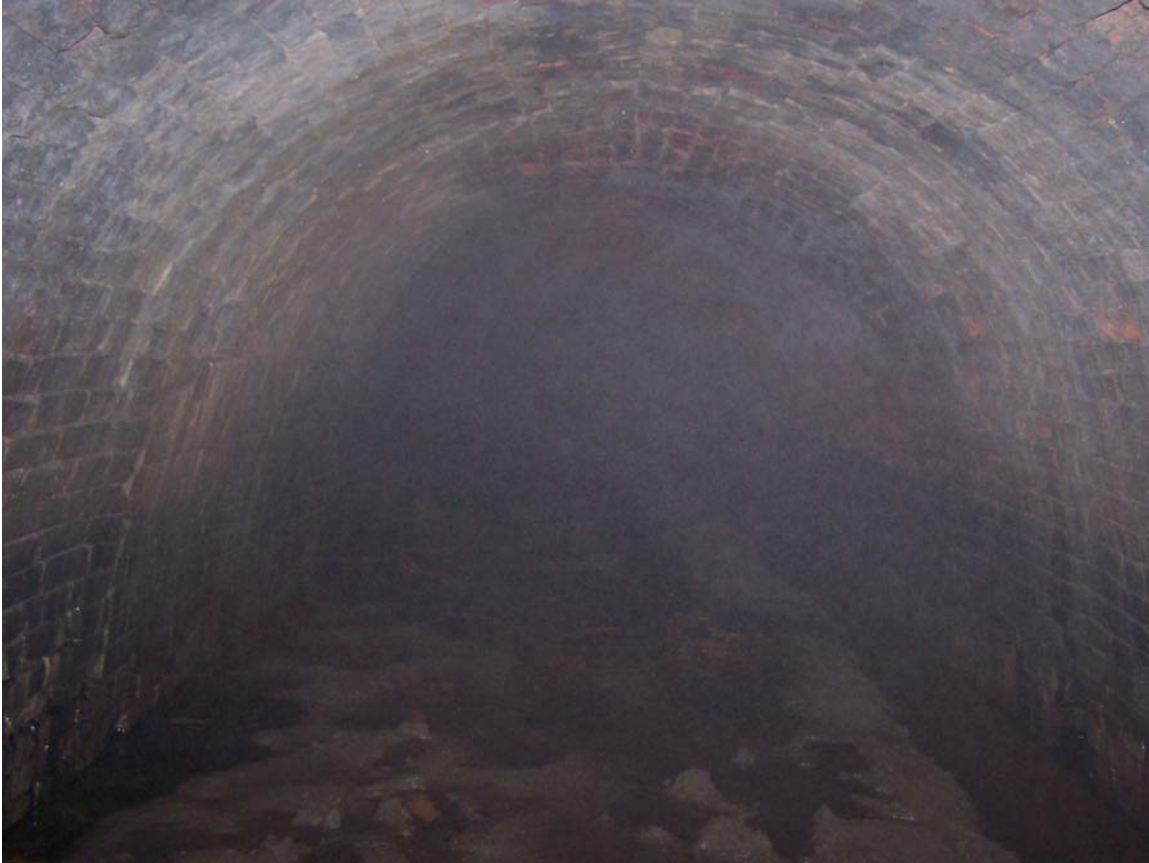
The silt gets softer and more dangerous as you proceed and other people's footprints become less evident.

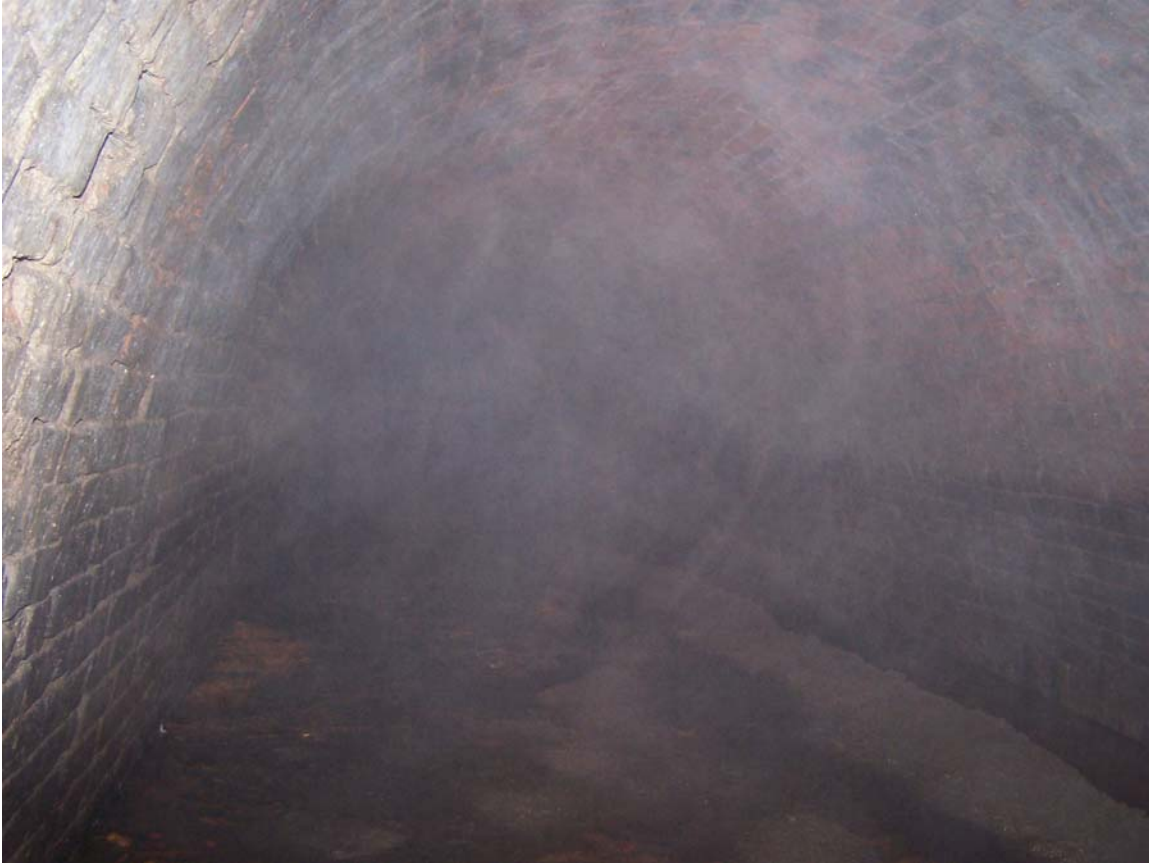
This is almost the safe limit for walkers into the Eastern Portal. The silt is too soft and sucks your feet down if you struggle. Near to the “Chain 2” marker.

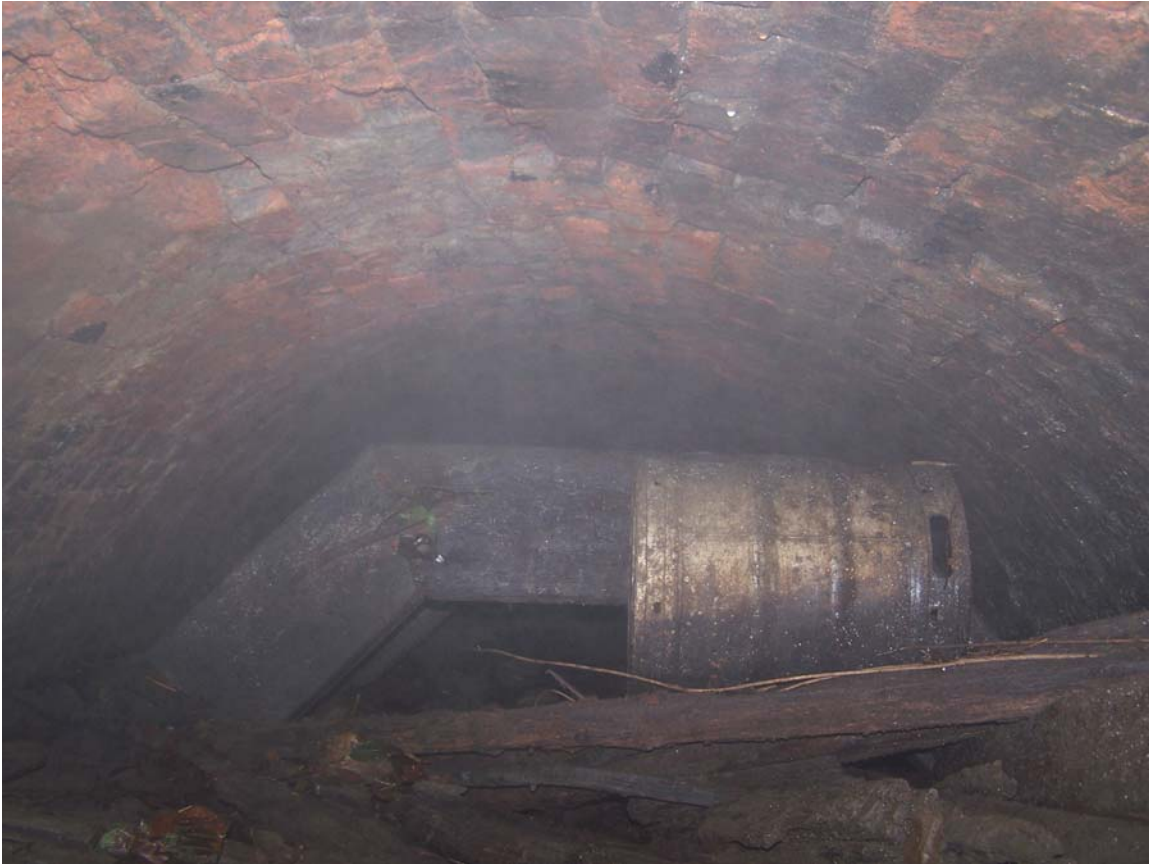
The end. I'm fairly certain that the Beer Barrel is empty otherwise I would have got closer. Subsequent photos are from the Western Portal inwards.

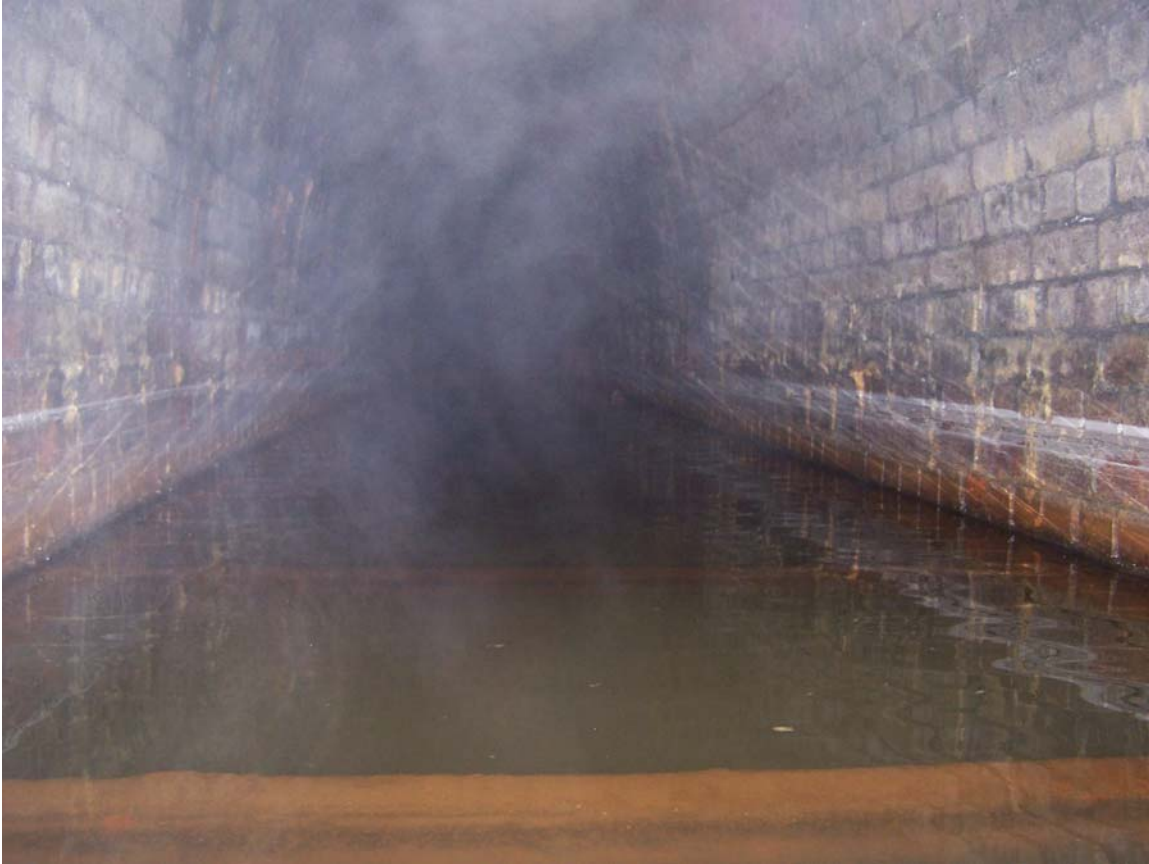
This is a view along the Butterley Reservoir adit. There are iron beams across the adit just below water level. My theory is that they are there to support scaffold batons to facilitate servicing. This adit is halfway between markers 23 and 24.

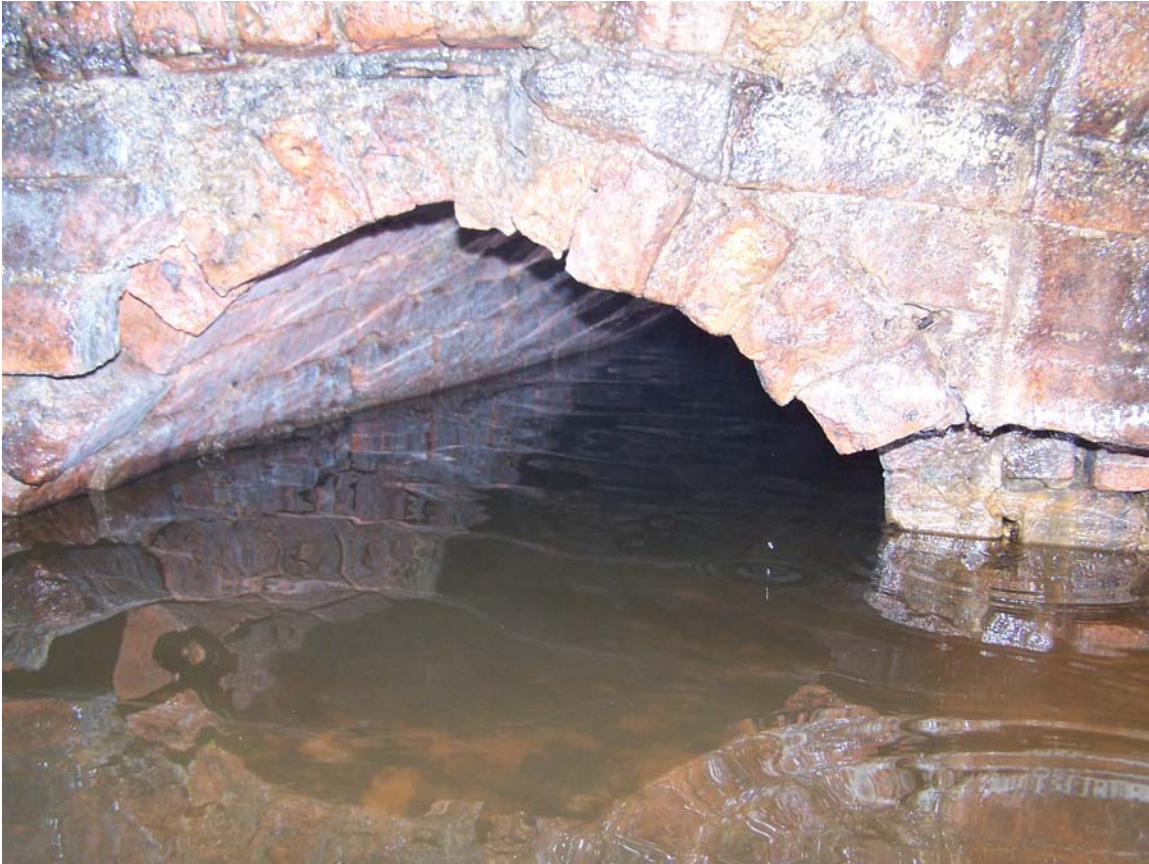
This tunnel on the North wall of the tunnel is the one which leads to the shaft under the Butterley Company's blast receiver. The sound of water falling can be heard from the far end of this tunnel. This photograph was taken from point 'G' in the following diagram.

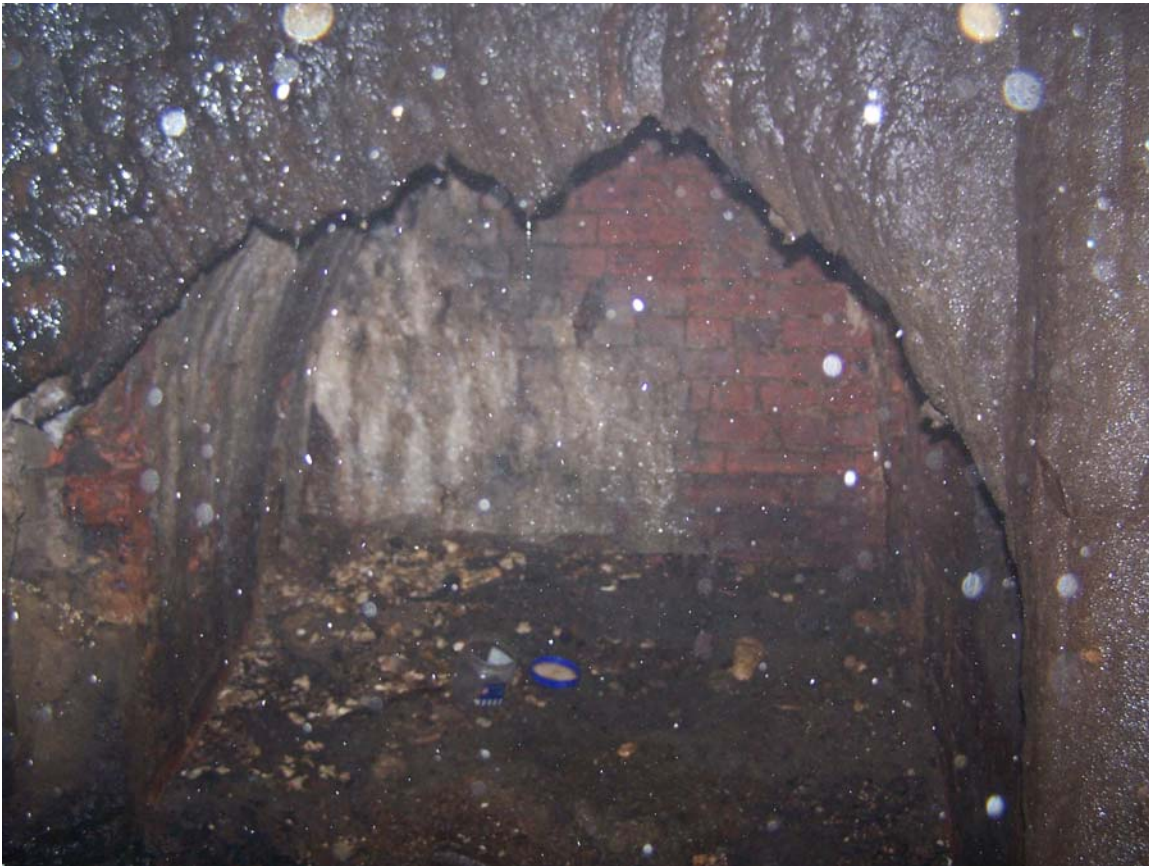
This approximately 5 feet long passage leave the bottom of the blast receiver shaft. The plastic peanut jar is mine. I use it to keep my camera dry. There is evidence of other people here recently. To the right is a polystyrene cup, there was also an empty lighter fuel tube, a broken plastic lighter and a neatly folded up Walkers crisp packet. I suspect that these were left when the shaft was capped in the 1980s. This is the Brick Heading labelled 'H' in the diagram.

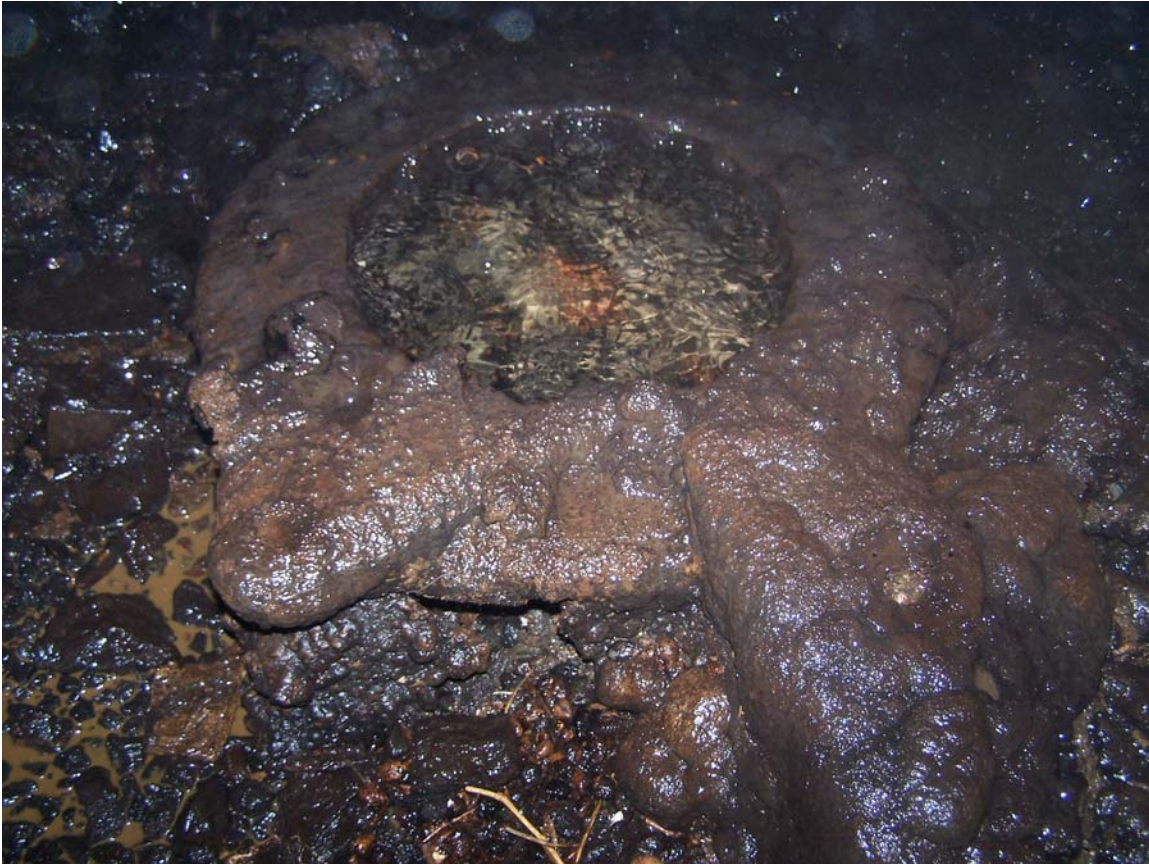
This flange plate is fixed to the floor of the blast receiver shaft. Labelled 'J' in the diagram.

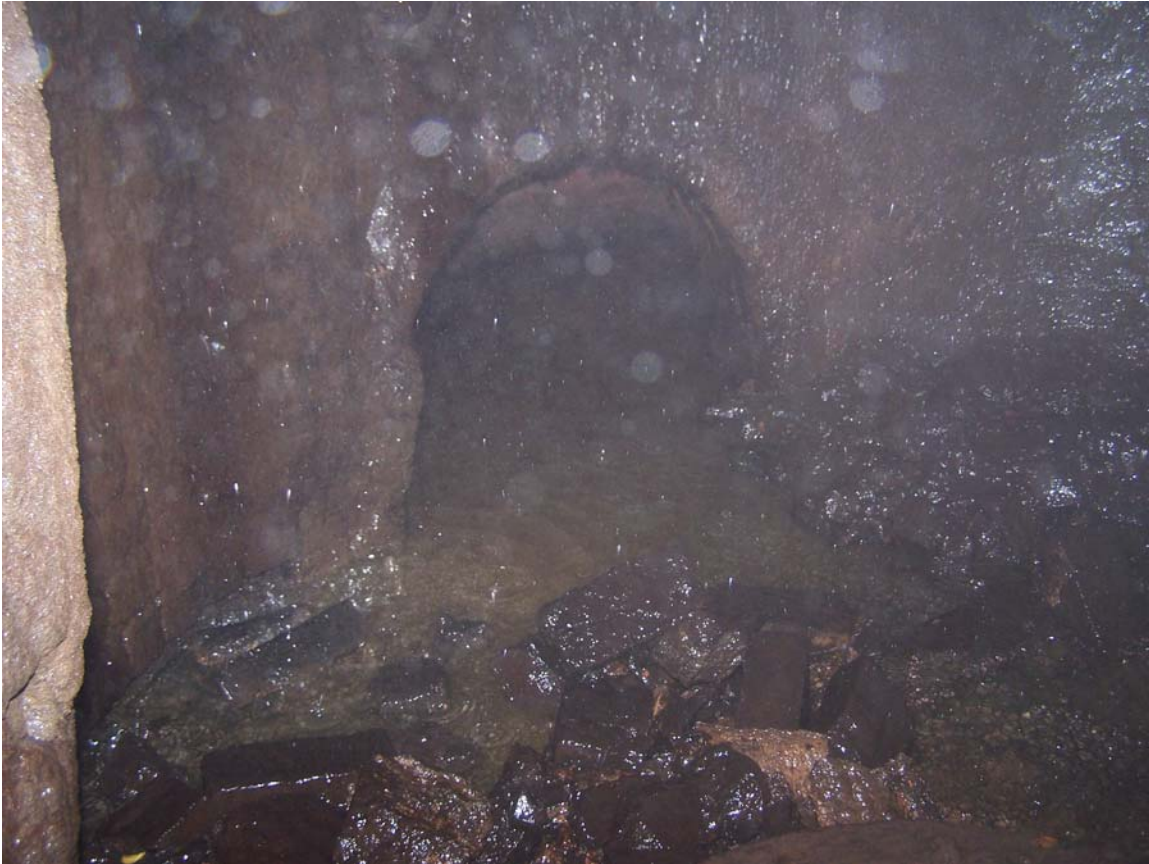
This is the entrance tunnel to the blast receiver shaft leading back to point 'G' in the Main tunnel. On the floor of the shaft there are bricks. Mr. Hatfield of Butterley, an eye witness of the shaft capping in 1985 reported bricks on the floor of the shaft and water flowing East. This shaft fits the description of the shaft near the old Brass foundry reported by Des Greenwood in "Portal to Portal".

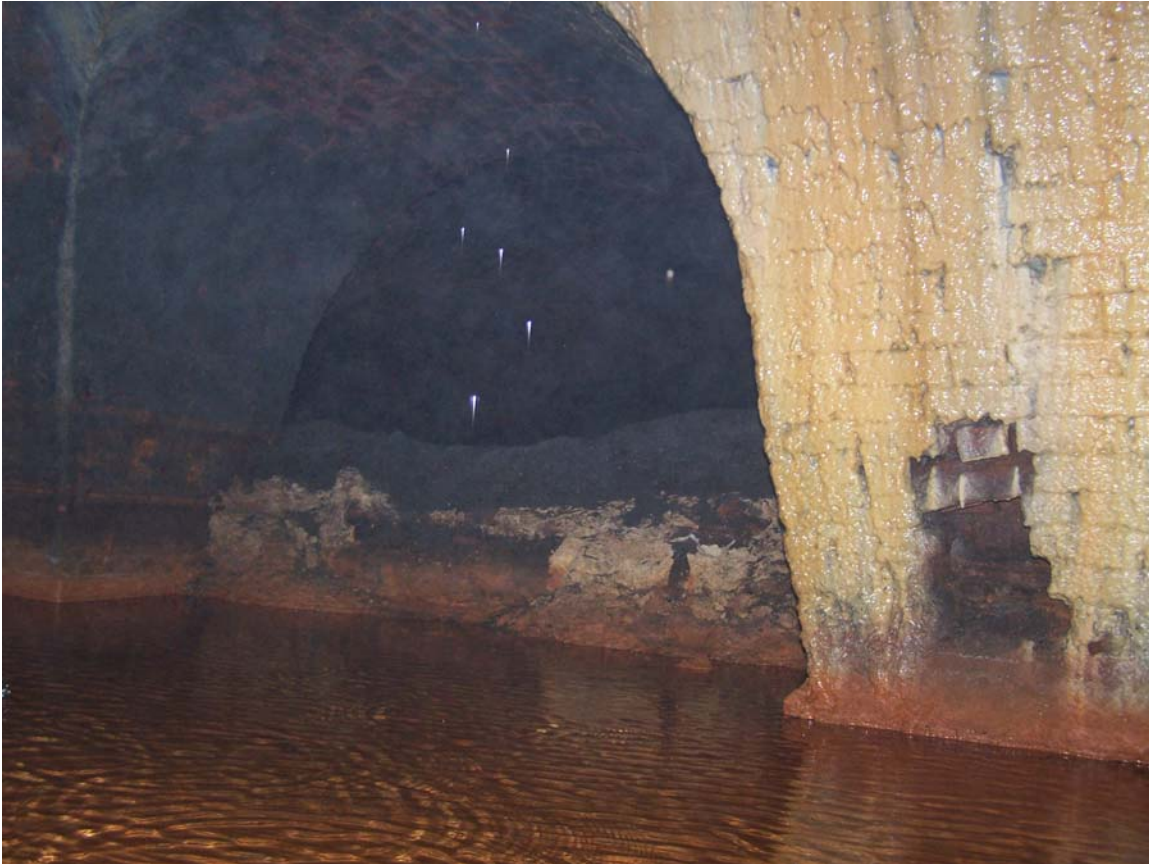
Main loading point on South side of Wide Hole. This shown as point 'B' on the accompanying diagram.

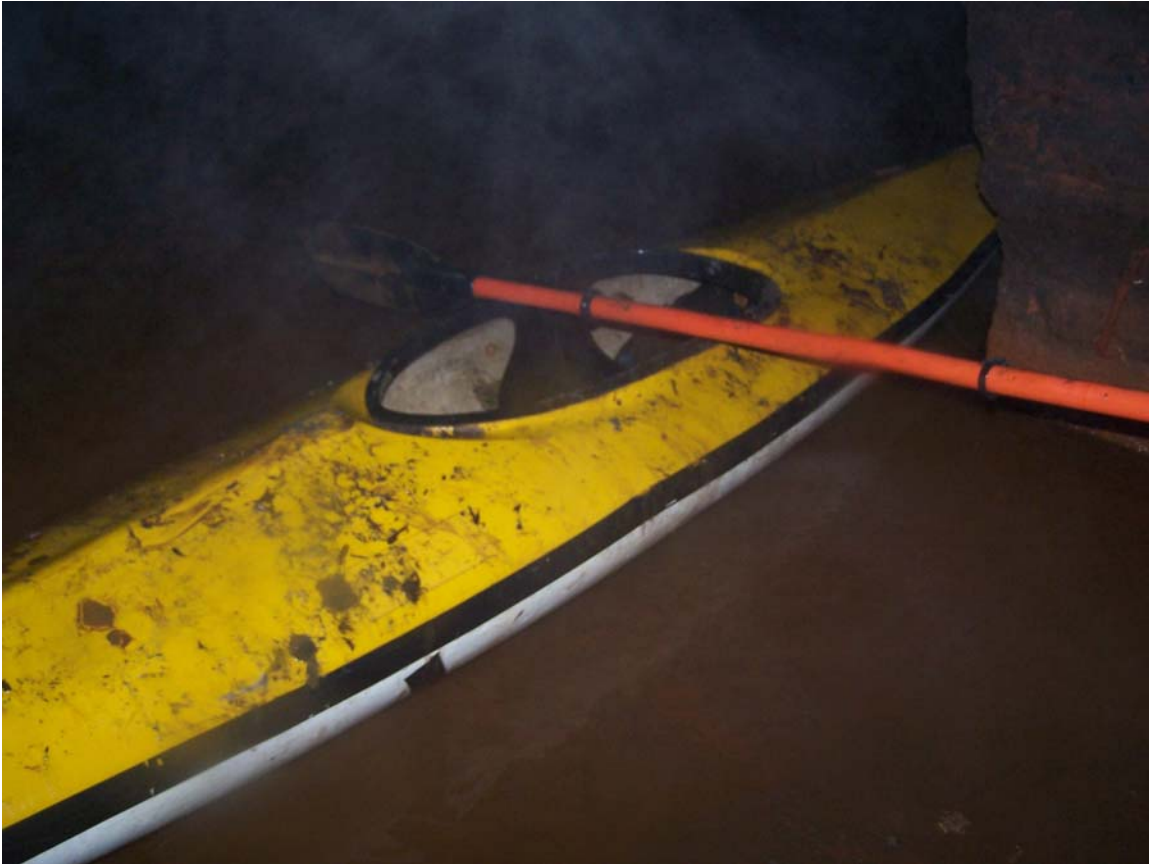
Very narrow boats still dock at the underground wharf. Photo taken from point 'B'

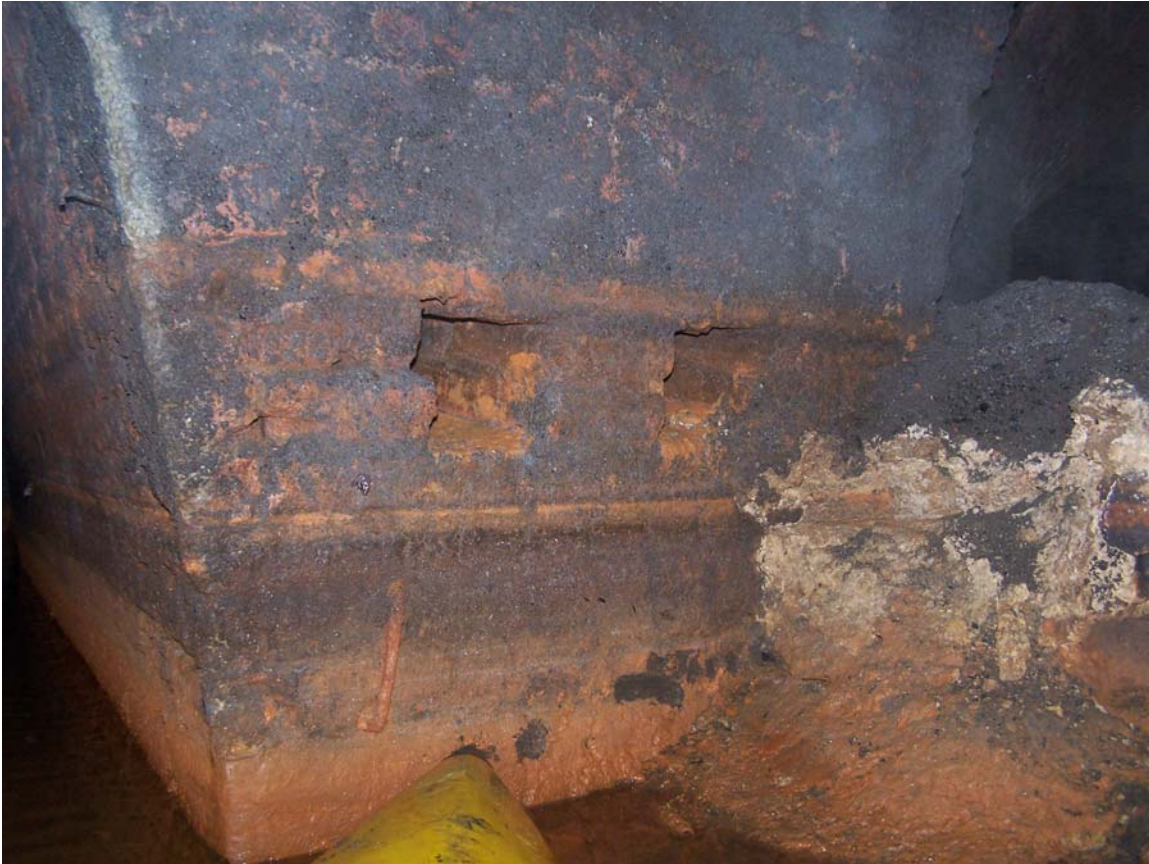
The two recesses in the wall next to the wharf are at about the level of the rubble on the wharf. There are two in the Western wall as well. These could have supported timbers to allow loading. At point 'B'.

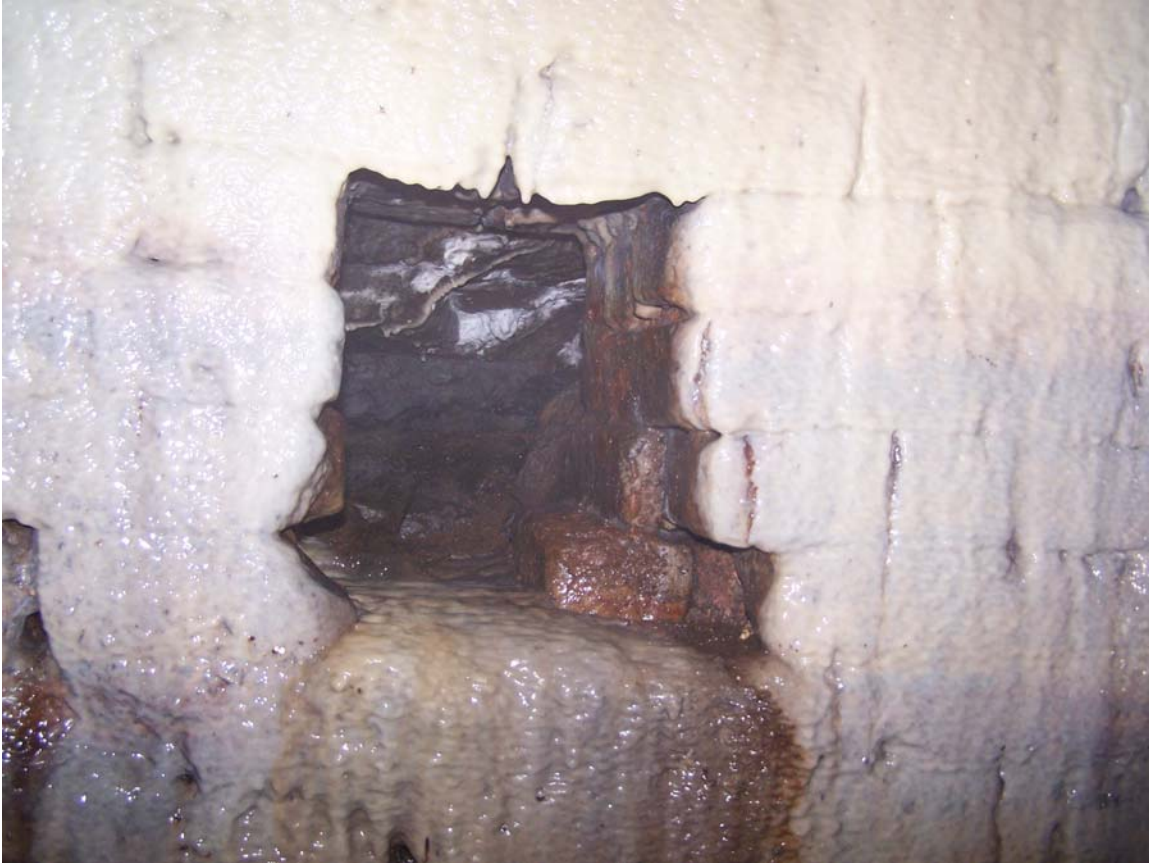
This is a close up of the aforementioned hole. It looks deliberately made. There are several along the walls on both sides of the wharf.

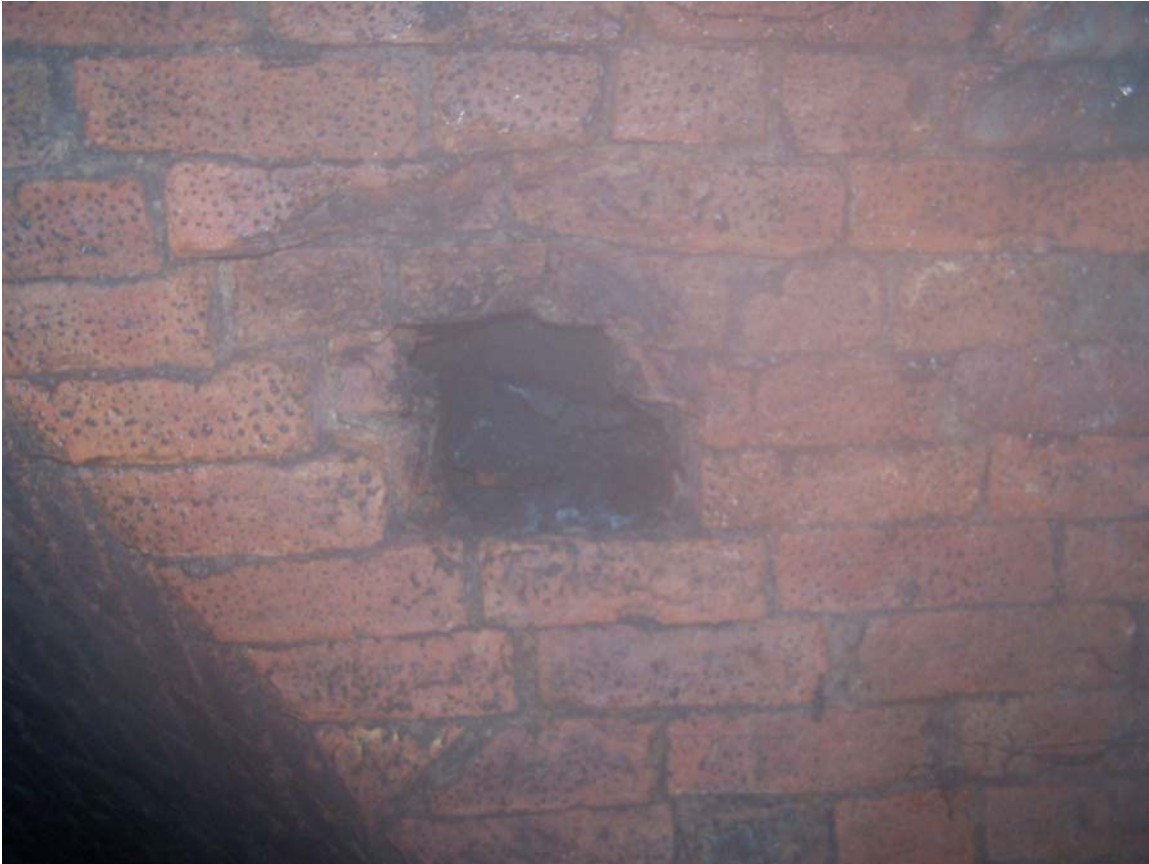
This opening in the arch in front of the bricked up shaft can be seen high up on the preceding picture. A similar opening can be seen in the Western part of the arch. The bricks above it appear distorted. At point 'E'.

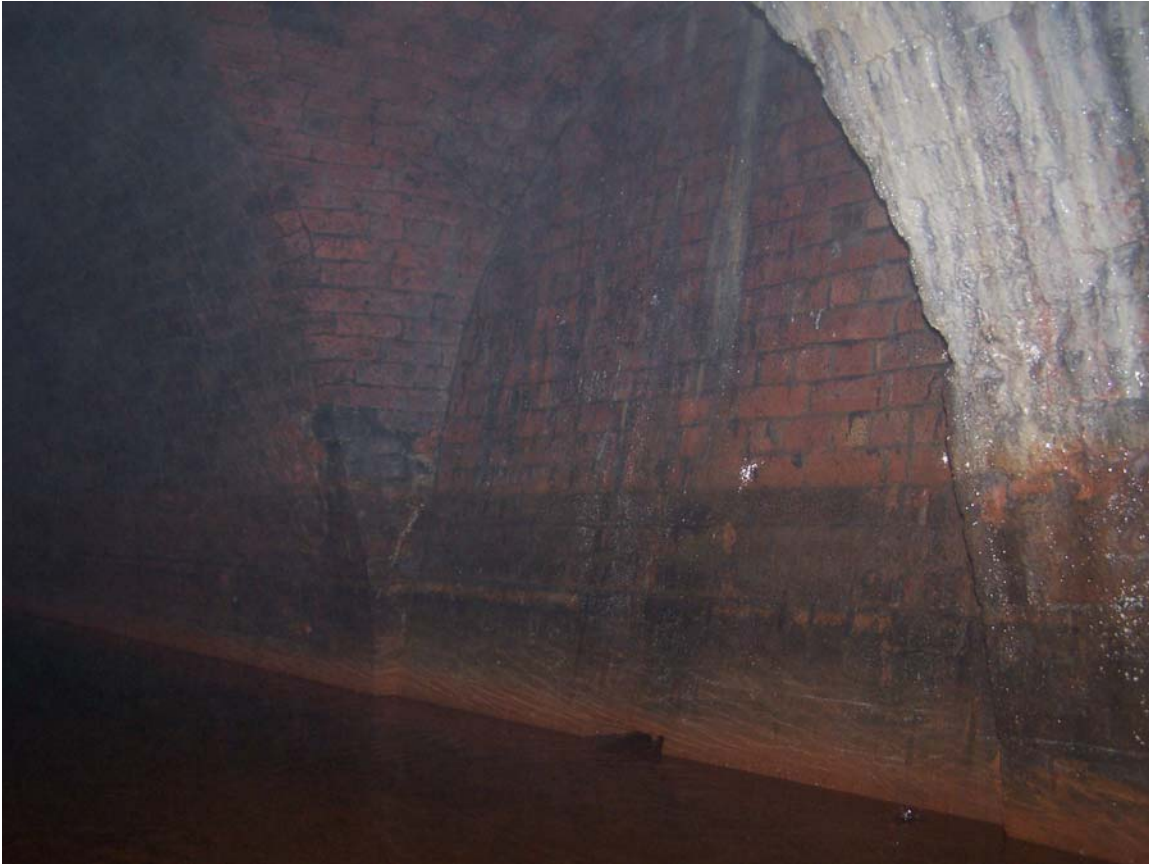
At the bottom of the bricked up entrance is an outlet to the canal shown on the detail drawing of point 'E'.

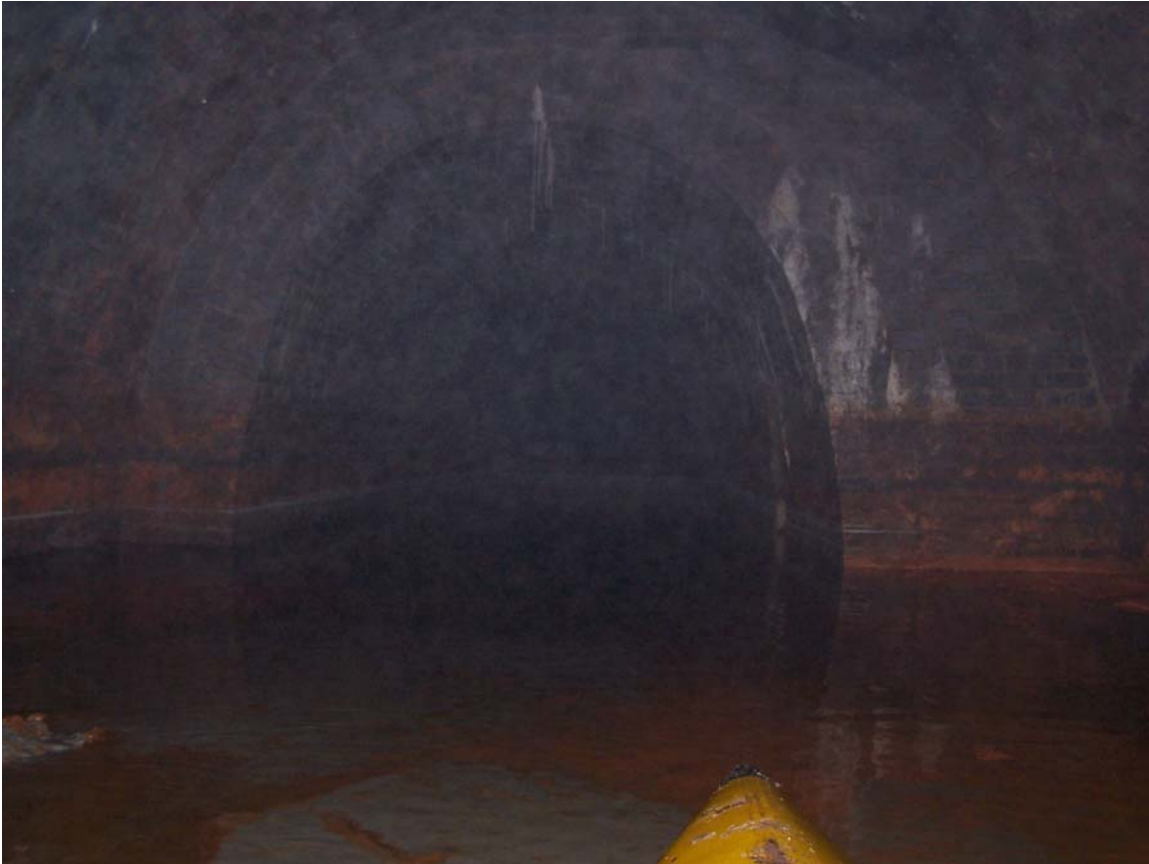
Another view of the new tunnel lining for the shortened Wide Hole. The canoe here is resting on the silt just below water level. This silt does not support a person's weight. By assuming that this new tunnel section is 9' wide at water level and then scaling to find the total width I get a width of about 15' 4". I don't know where figures of 25' came from.

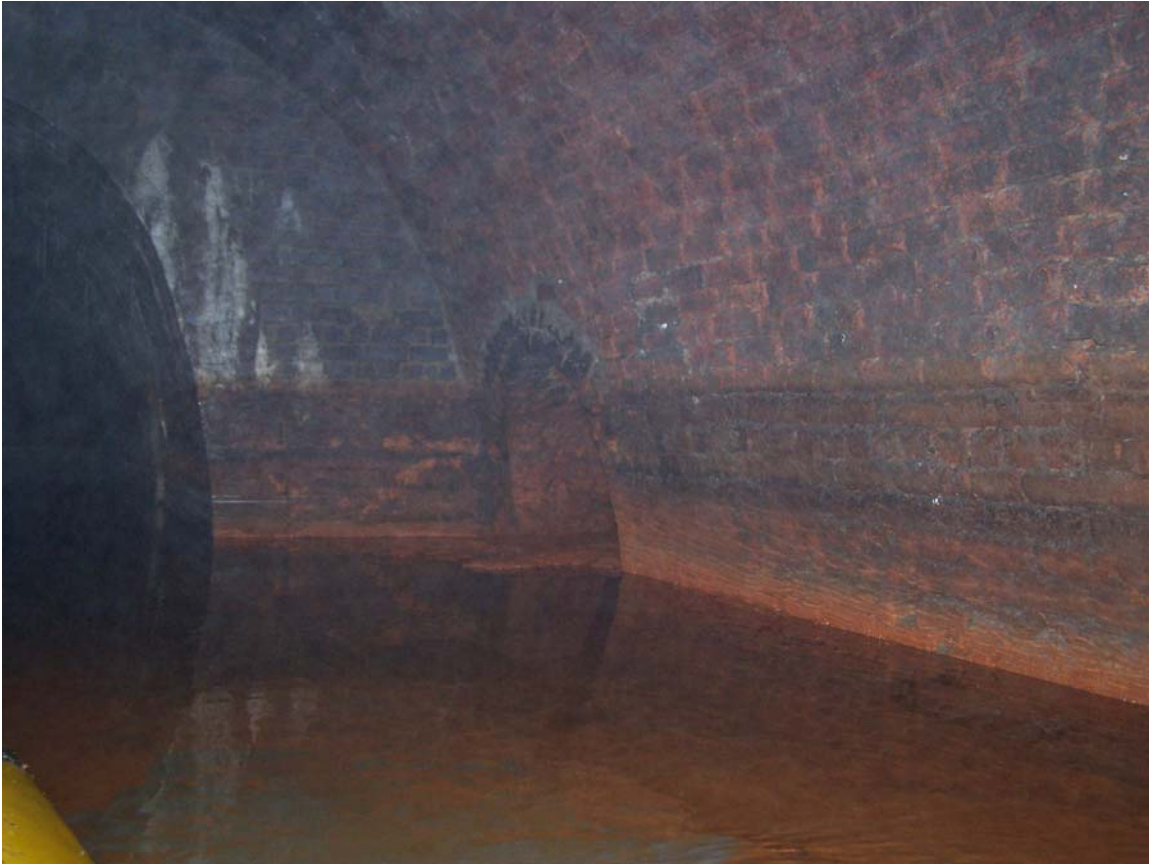
To the right of the new brickwork is the remaining entrance to the Carr Pit heading labelled as point 'L' on the accompanying diagram.

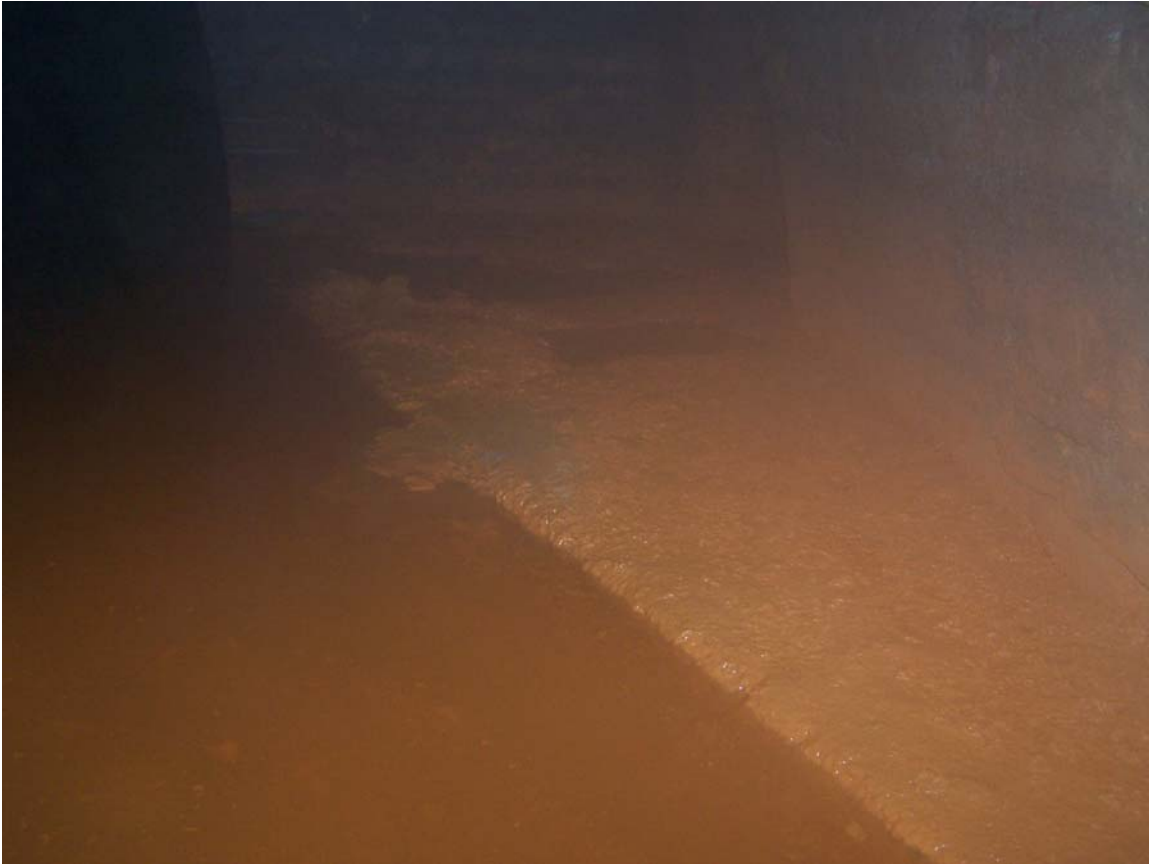
There is a stone barrier in front of the Carr pit heading's exit. There is a path for water under this barrier. This is at point 'L' on the associated diagram.

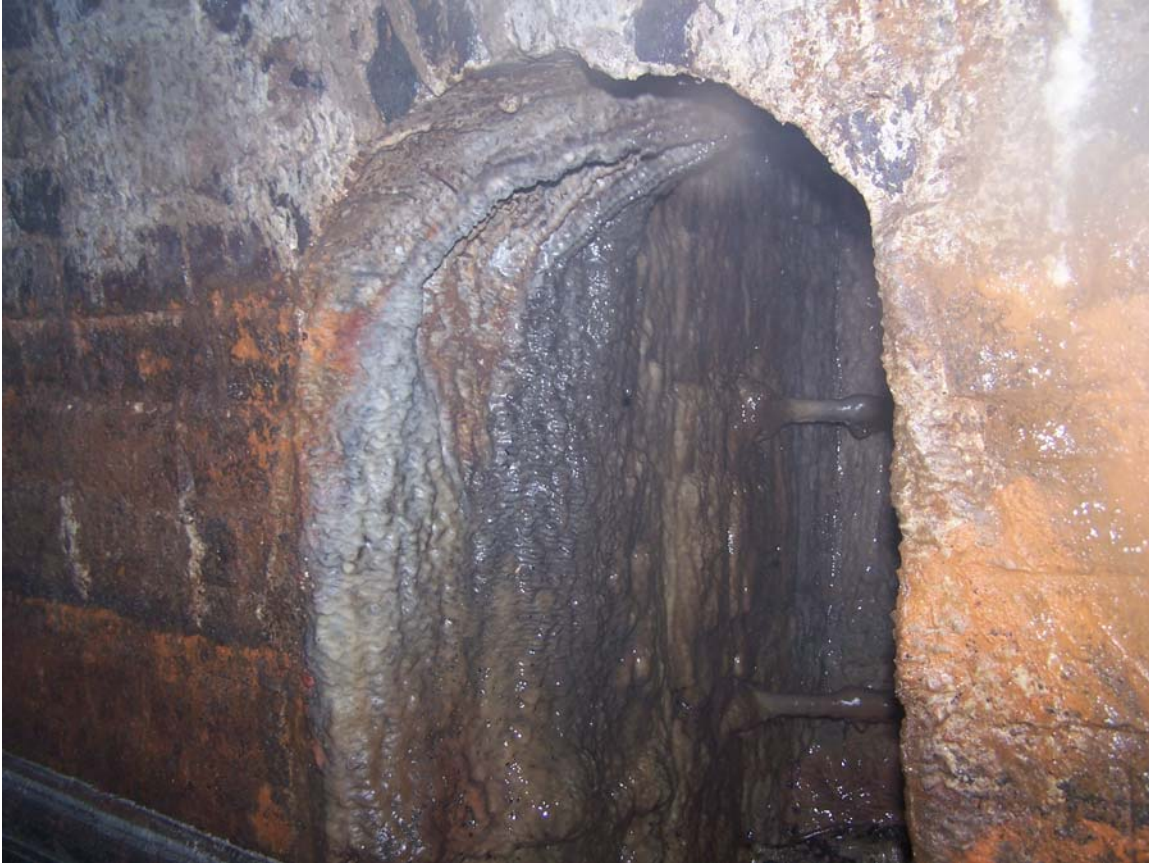
Just inside the new brickwork placed to shorten the Wide Hole is this vertical shaft with steps on the South wall. This is marked as point 'C' in the diagram below.

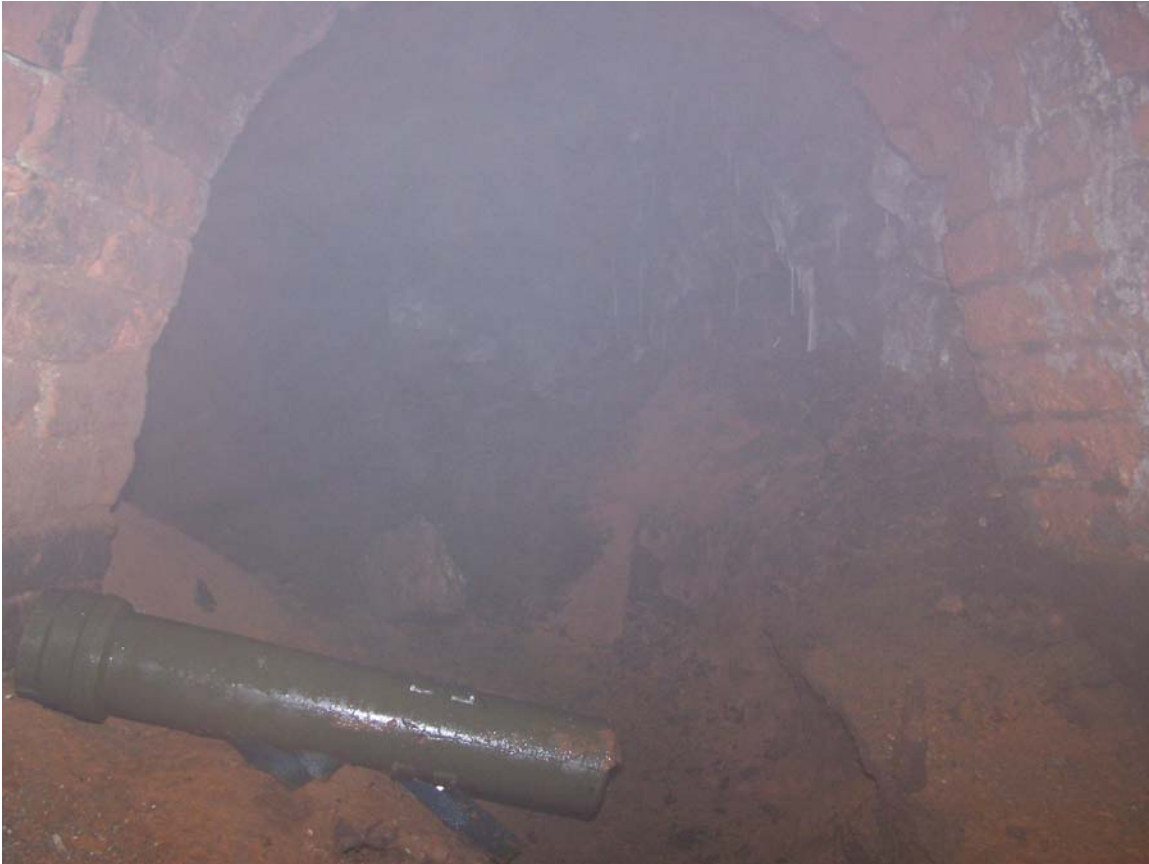
This picture is looking out of the heading behind the main arched gangway towards the arched gangway. The ammunition tube is 1' 10" long therefore this tunnel is about 3' wide at the dirt level.

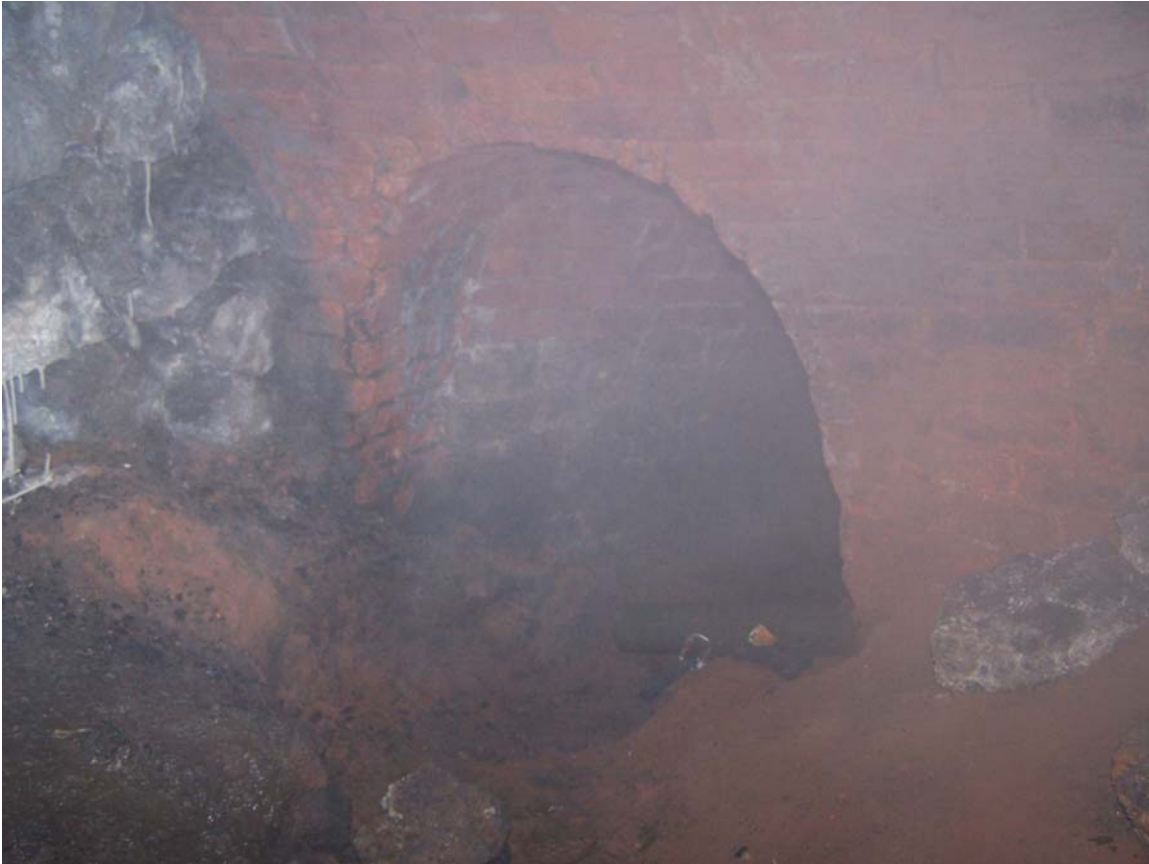
This is the heading behind the arched gangway pictured from the arched gangway. To the left is the stacked stone closing the rear of the shaft shown as a bricked up entrance earlier.

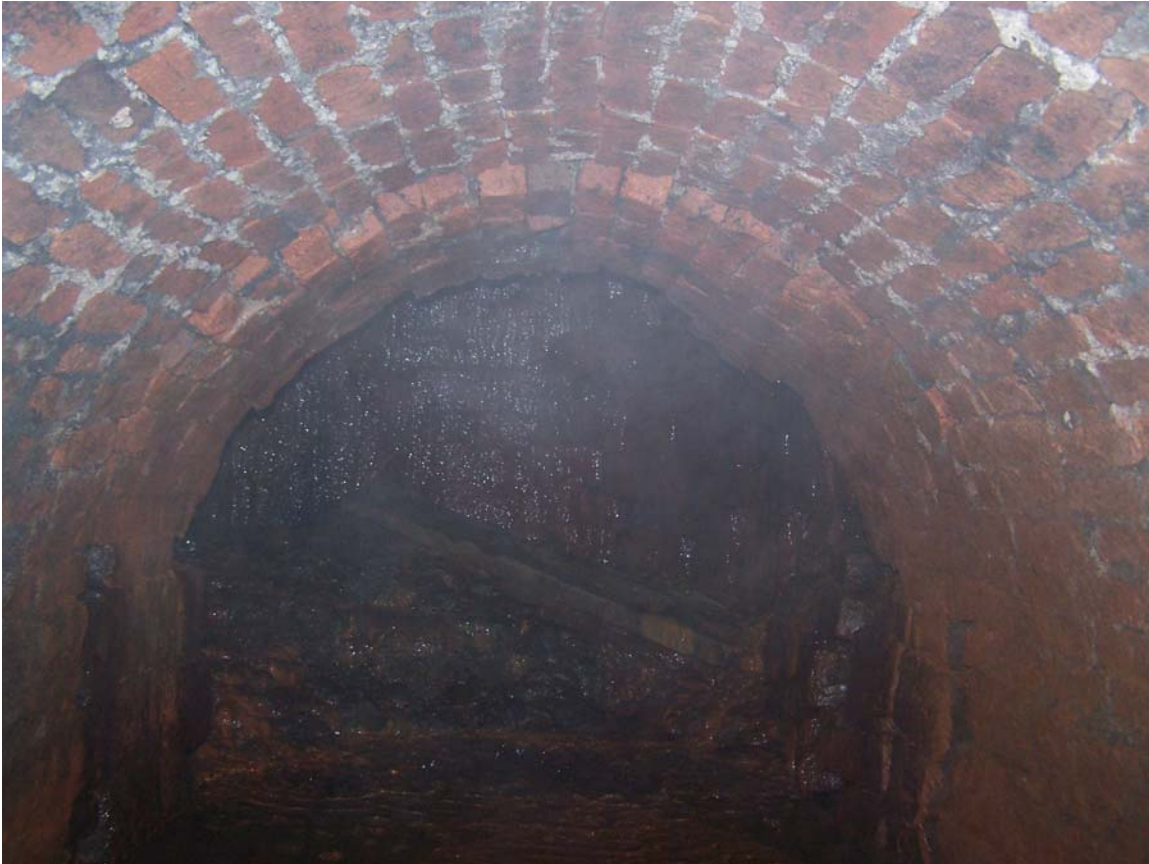
Short tunnel leading to a shaft. This is the shaft opposite the old heading labelled on the “Proposed Shortening of Wide Hole” diagram in Hugh Potter’s book “The Cromford Canal”. This shaft is labelled ‘N’ in the following diagram.

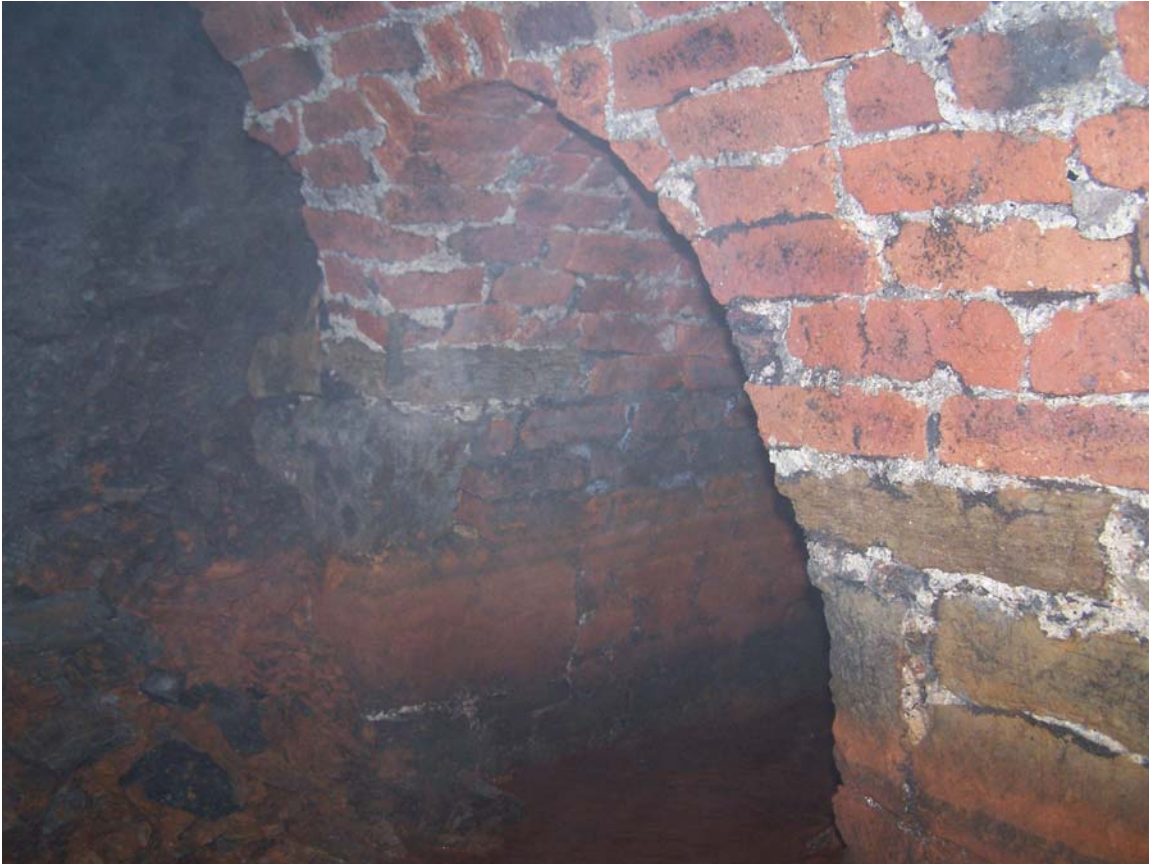
This heading is at the junction with the short “shaft” tunnel at point ‘P’. It continues on to the Carr Pit heading. The base of this heading has stone flags spanning the tunnel just below water level.
