Butterley Tunnel

Written by and using photographs taken by Tina Cordon between 15th October and 9th November 2006

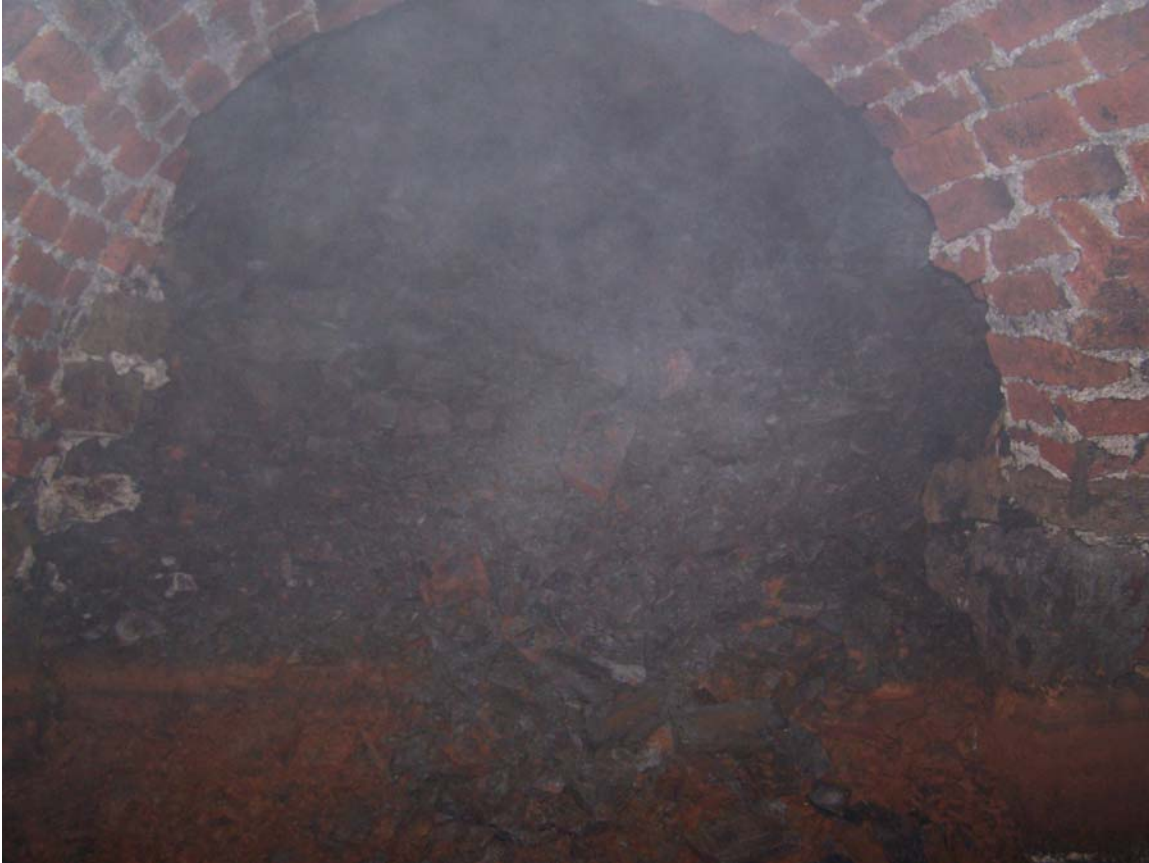
This is the entrance to the “old heading” labelled ‘O’ in the above diagram.

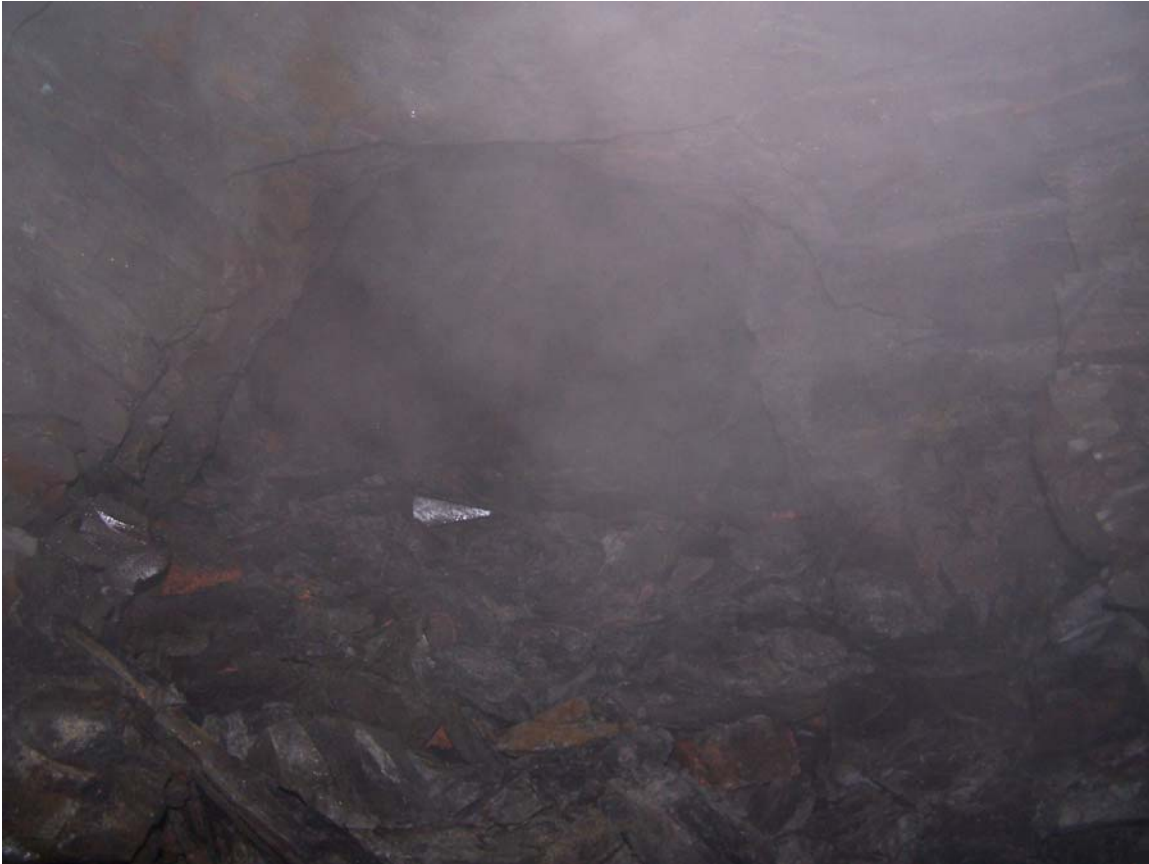
The old heading is not brick lined but in native rock. I kept a sample for identification. According to my eldest brother Ryan Cordon who just happens to be a geologist, the rock is micaceous, carbonaceous siltstone. I also retrieved samples of coal and Blast Furnace Slag from the Wharf. Labeled 'O' on the accompanying diagram.

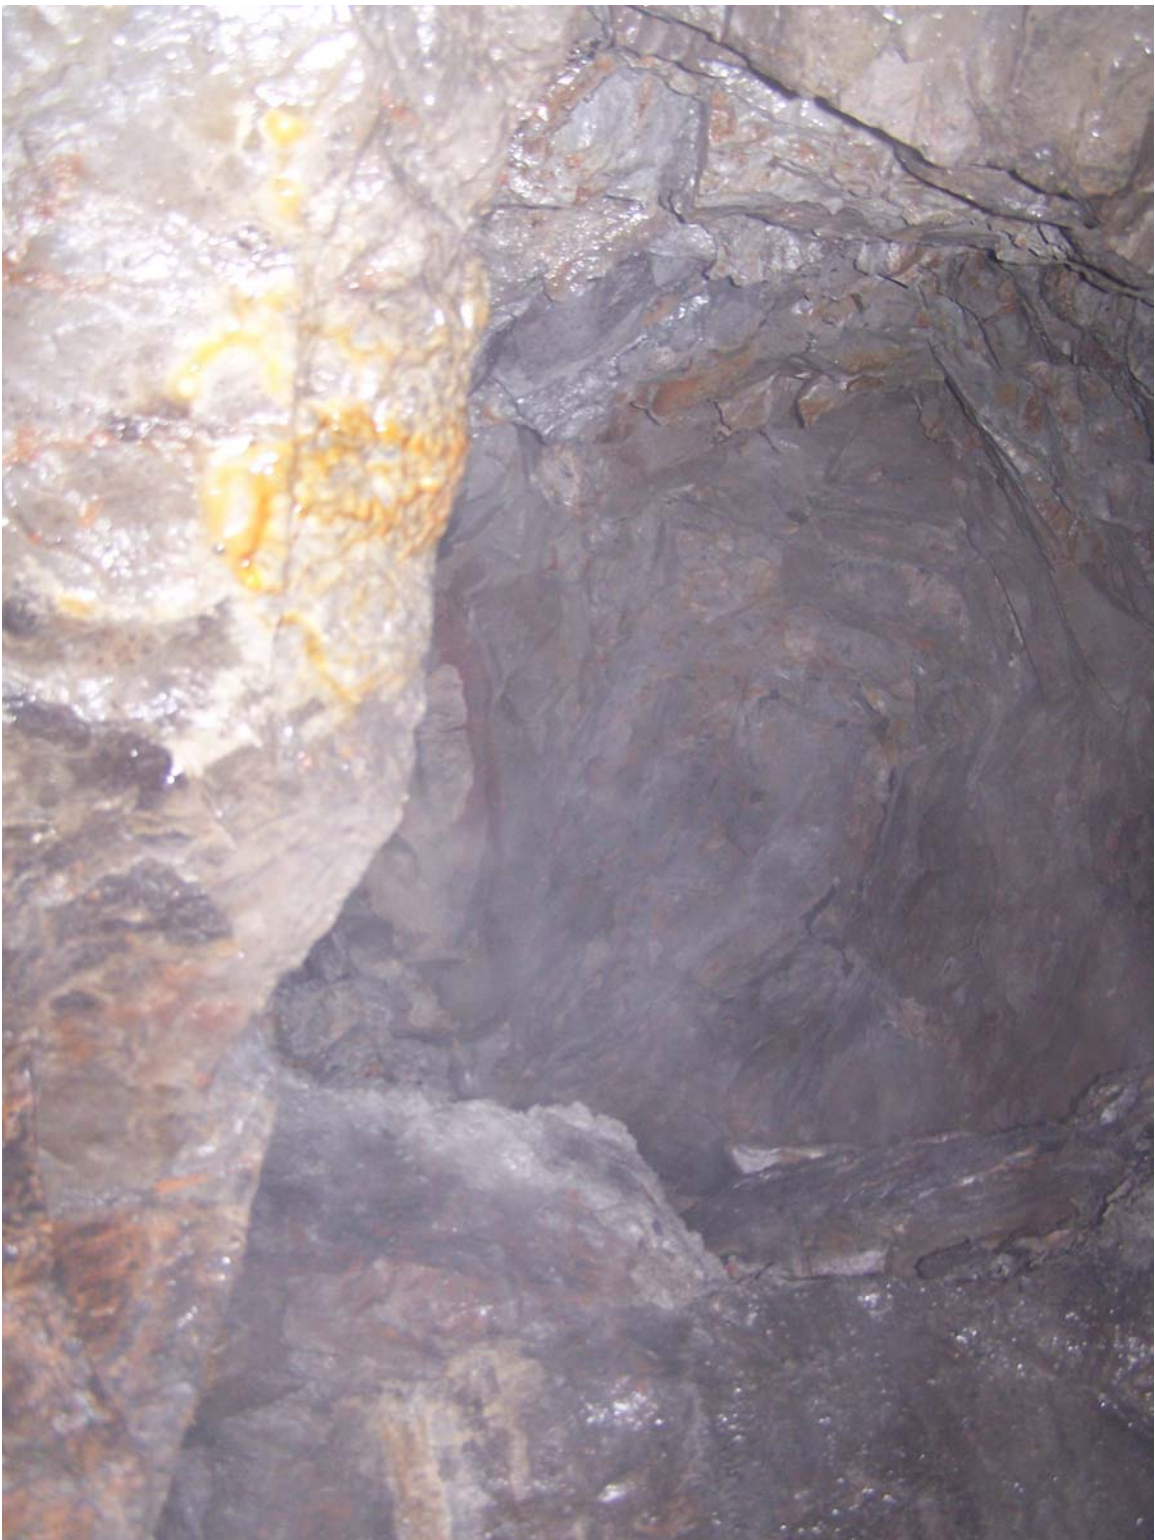
And another view of the old heading 'O'.

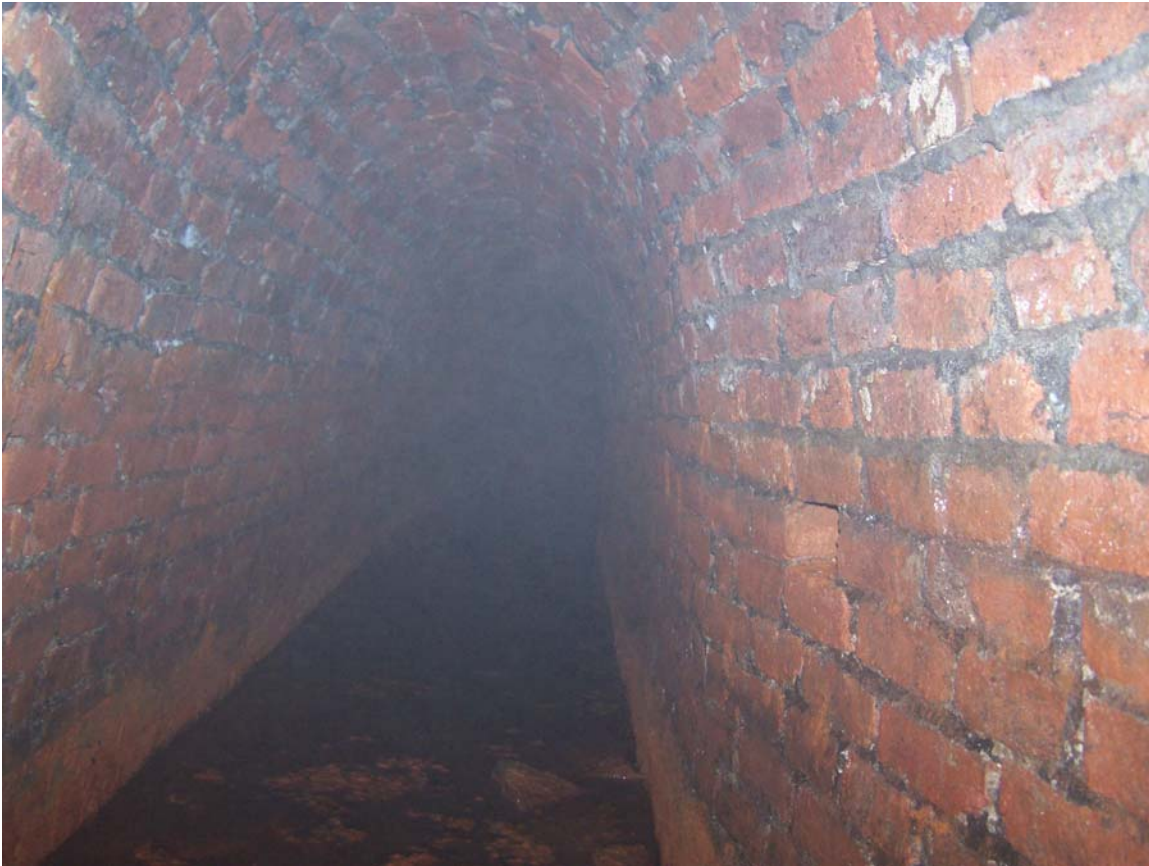
Inside the heading traveling towards Carr Pit heading looking towards point 'Q'. This section had stone flags spanning the tunnel just below water level. My impression is that this heading provided access for people to the Carr Pit heading, not goods. If the shaft behind and to the right of this tunnel was indeed part of the counterpoise system mentioned by Des Greenwood in "Portal to Portal", water from the counterbalancing tubs could be emptied at the shaft's base and would have flowed under the flags in this tunnel to the Carr Pit Heading.

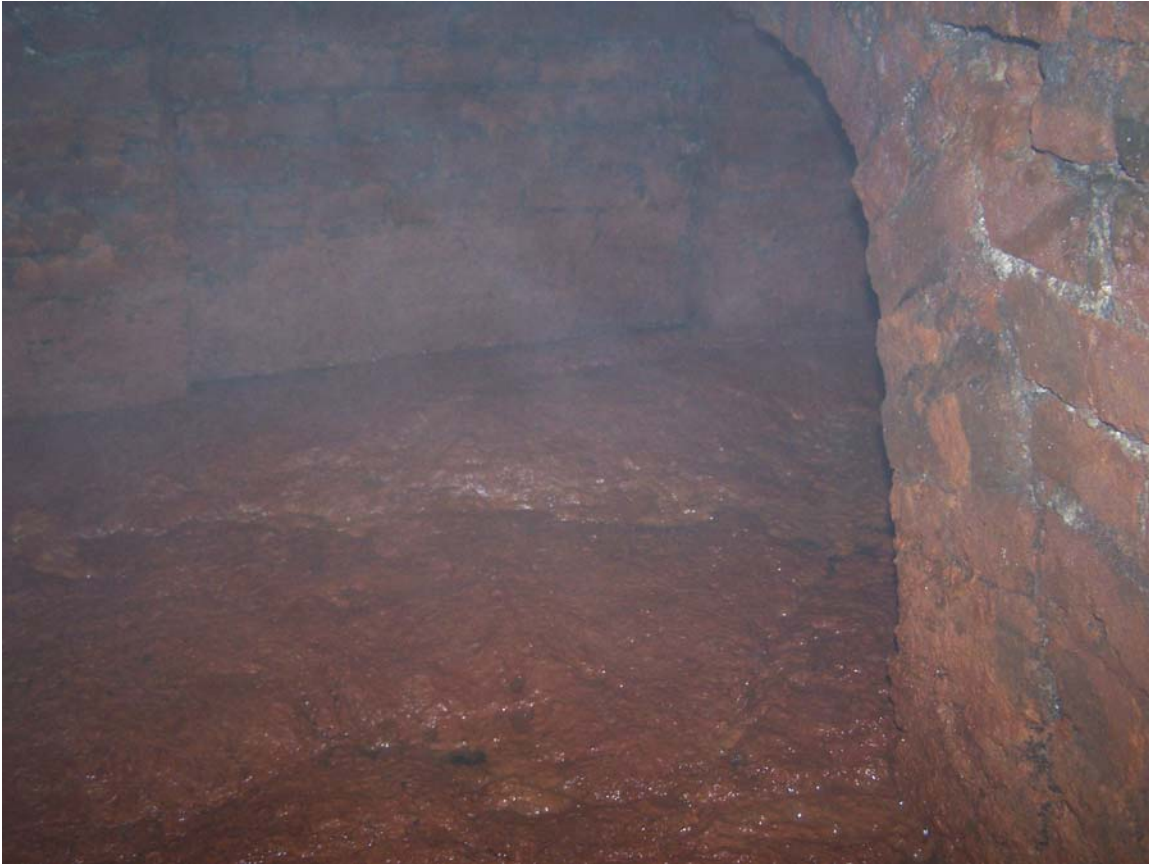
The Carr pit heading shown here at 'Q' is both waist deep in water and covered in a thick layer of ochre scum. I did not enter. There are no stone flags spanning the Carr Pit heading at this point. This is a larger tunnel (about 4' 6" wide) than the flagged heading, I doubt that this tunnel was spanned by stone flags. On the opposite wall the brickwork is recessed another tunnel that has been bricked up maybe.

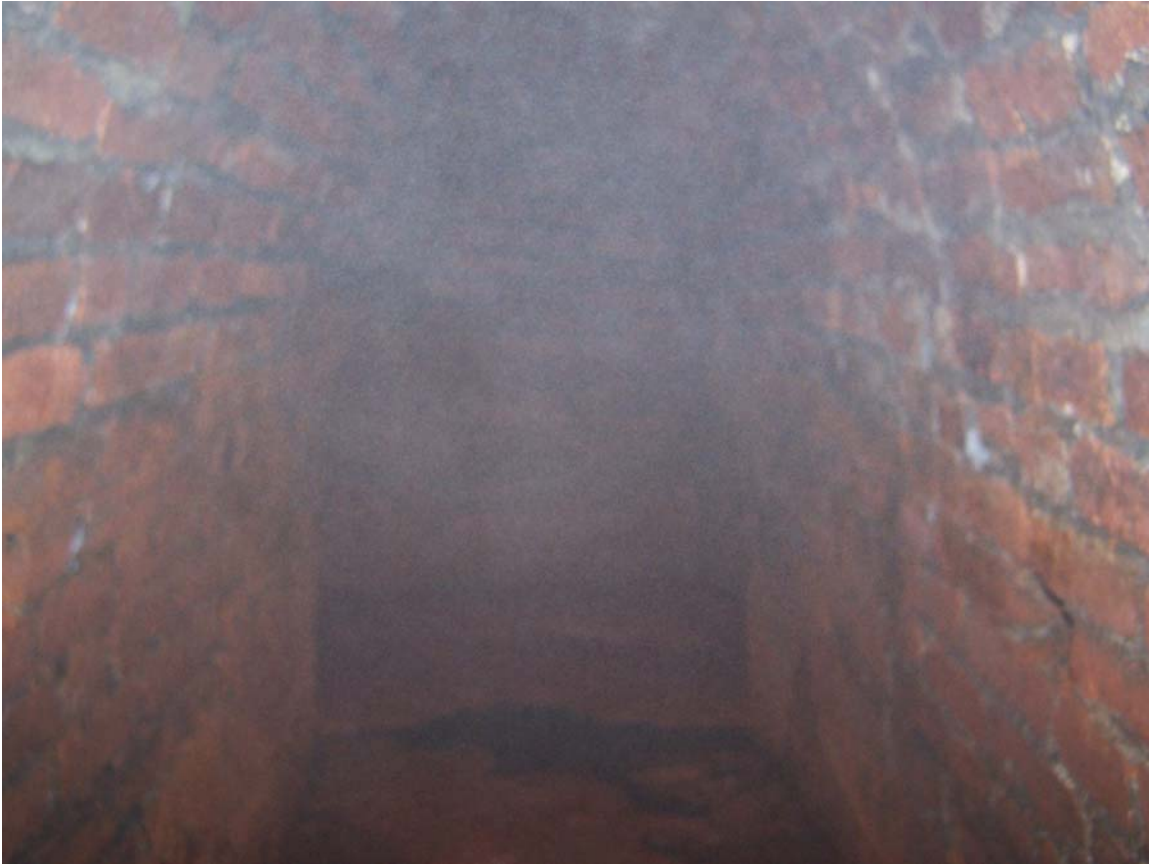
A few steps back from Carr Pit heading at point 'Q'. I can't do much about the steam, it is coming from me.

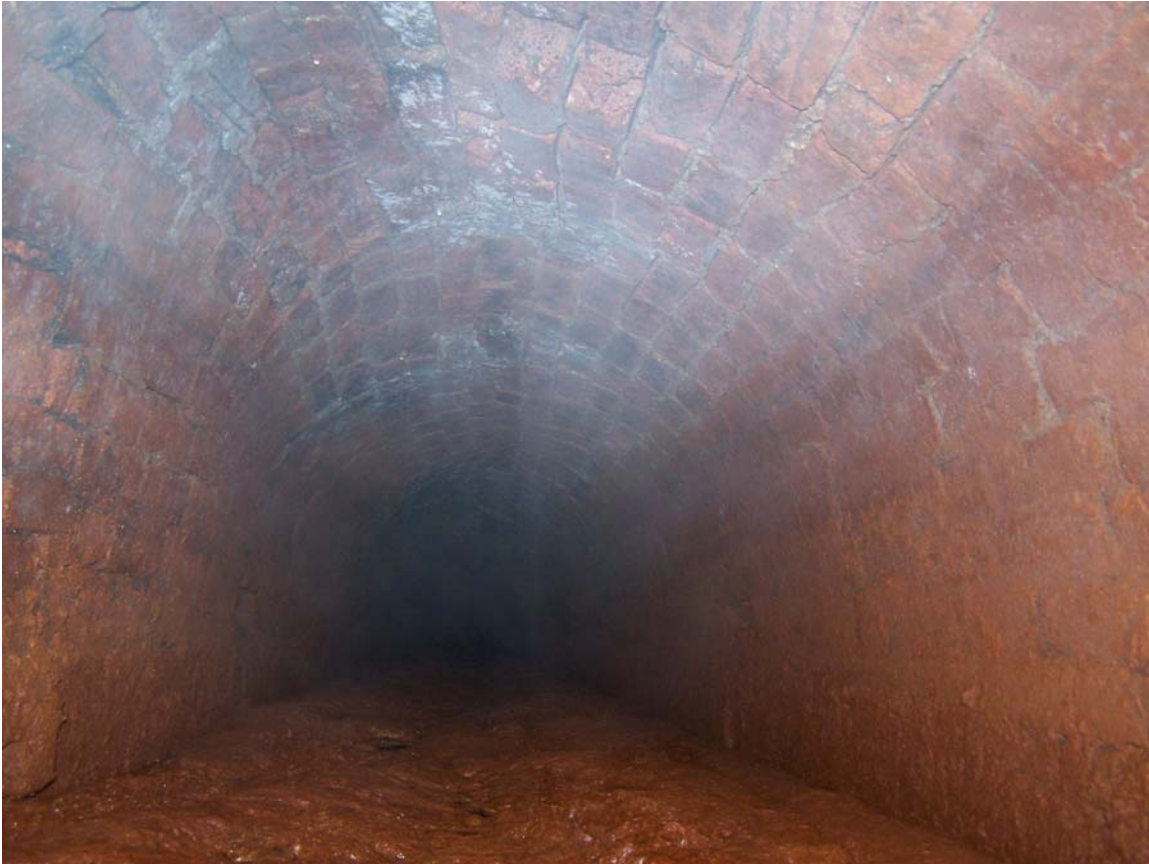
And there is more again at point 'L'.

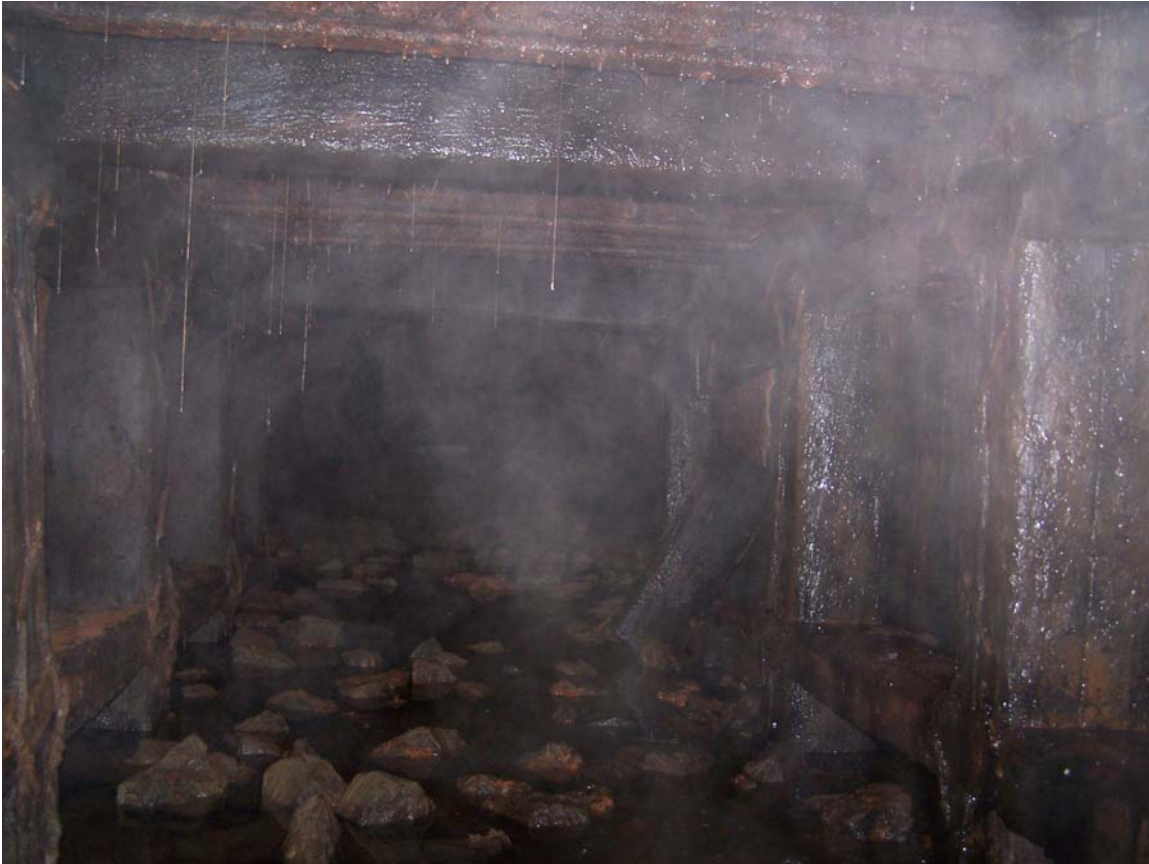
Some of the shoring is easier to negotiate than others. Iron beams and wooden shoring are used here.

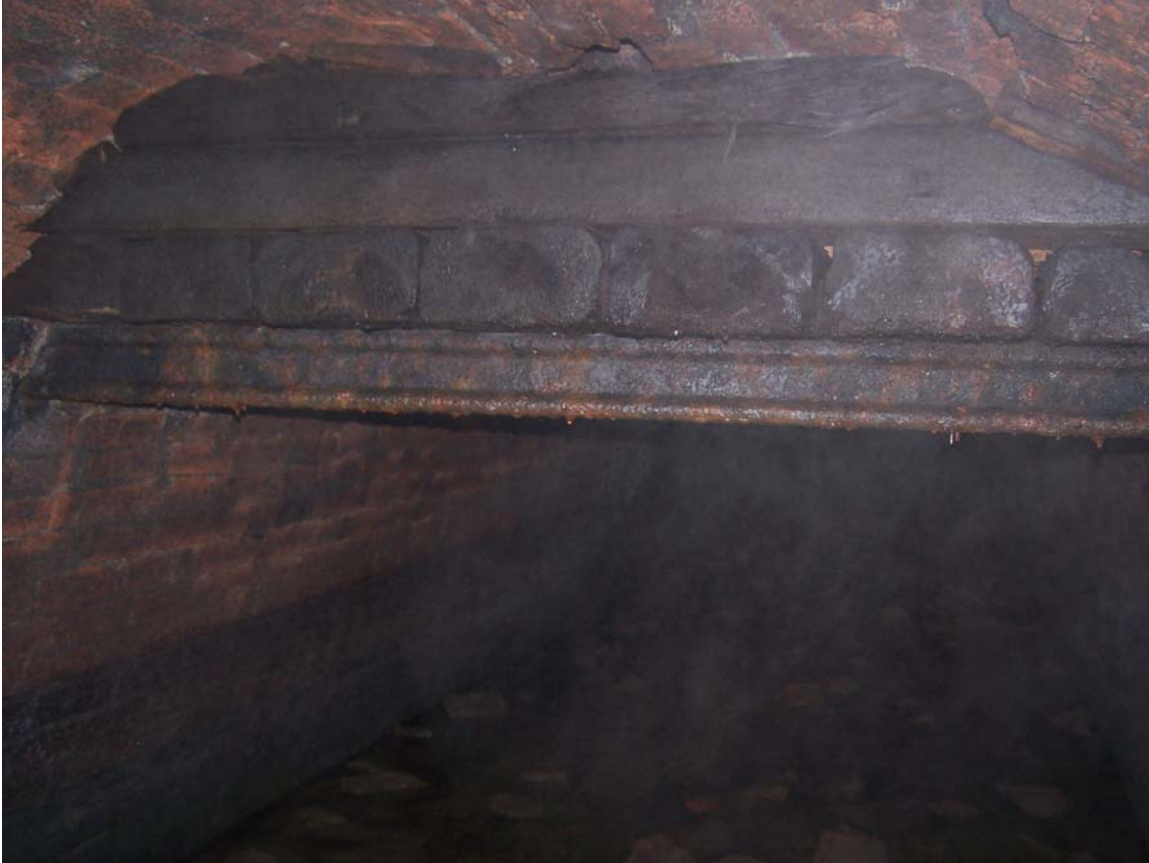
This example may have passed boats at some time.

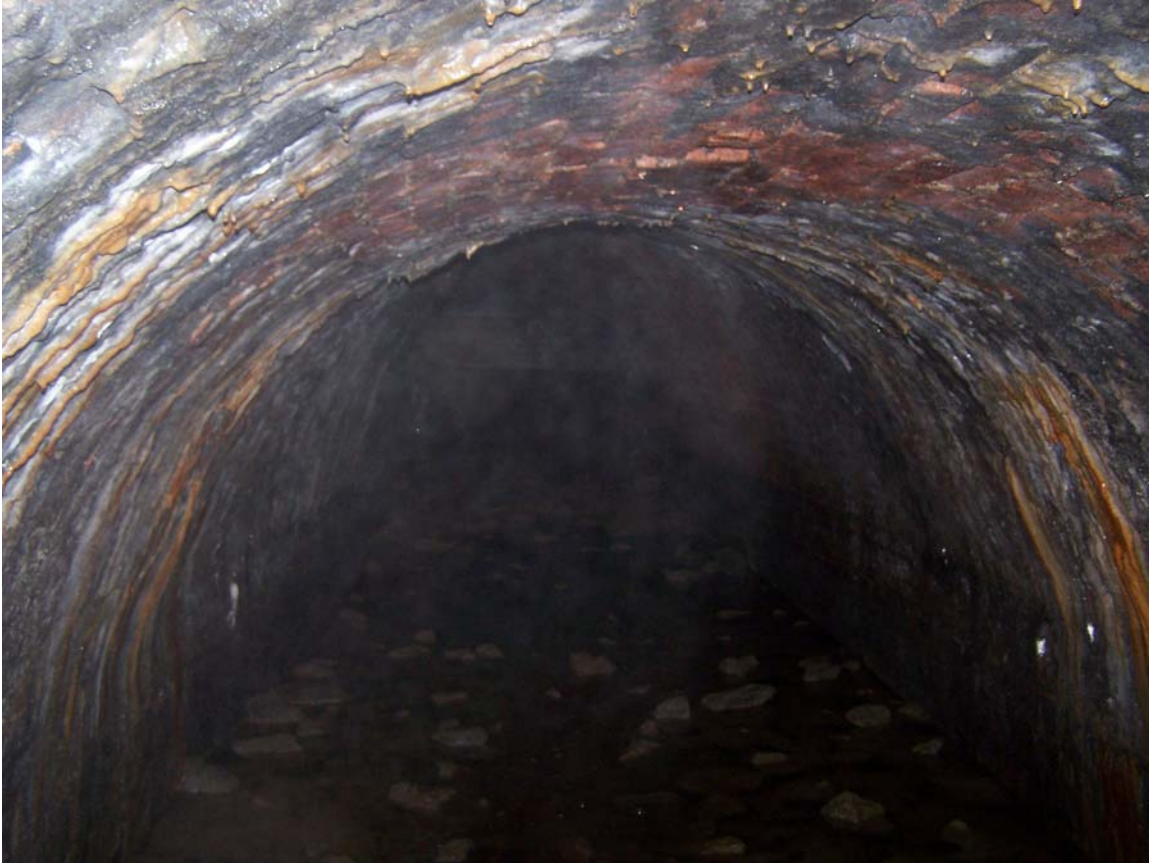
There are short sections without shoring.

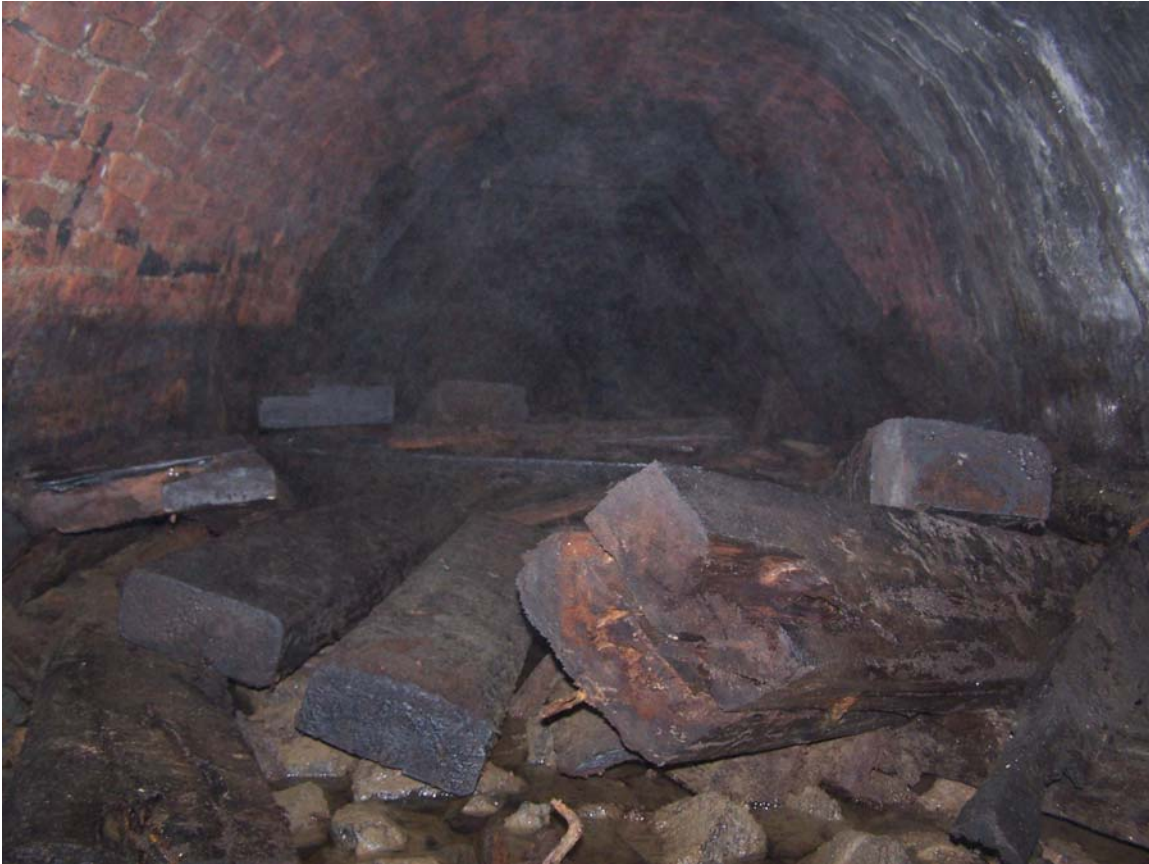
And sections in which the shoring has collapsed.

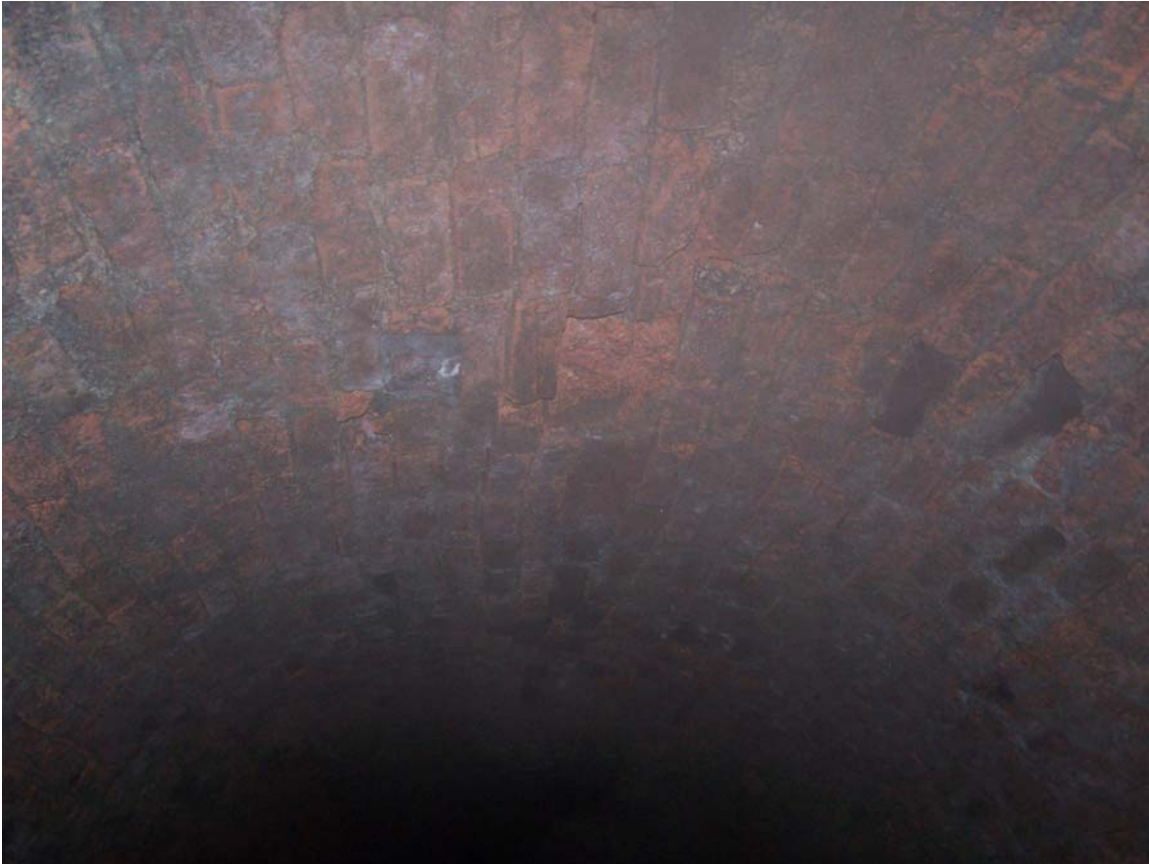
Robin Witters bulge at about marker 50.

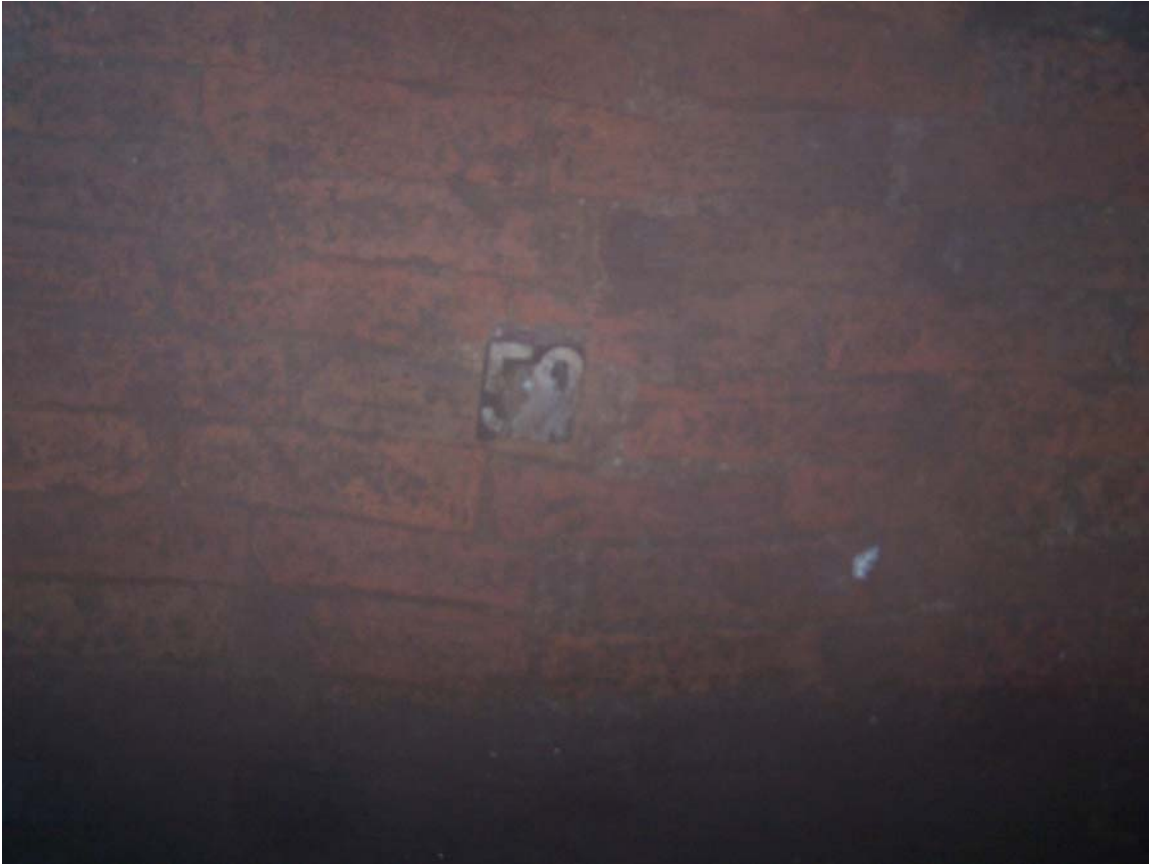
Despite the smears I am sure this says 50.

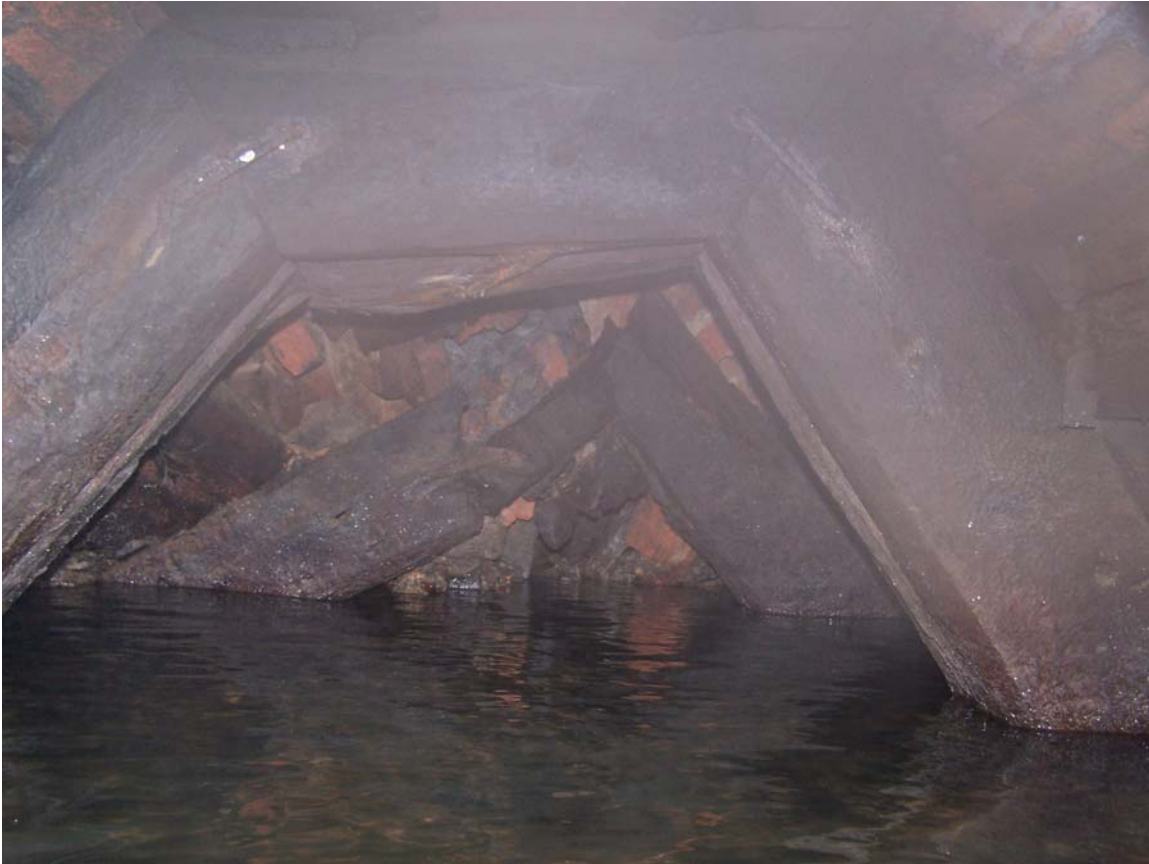
The tunnel is blocked just after marker 55. The markers from 51 onwards are illegible so I counted back.

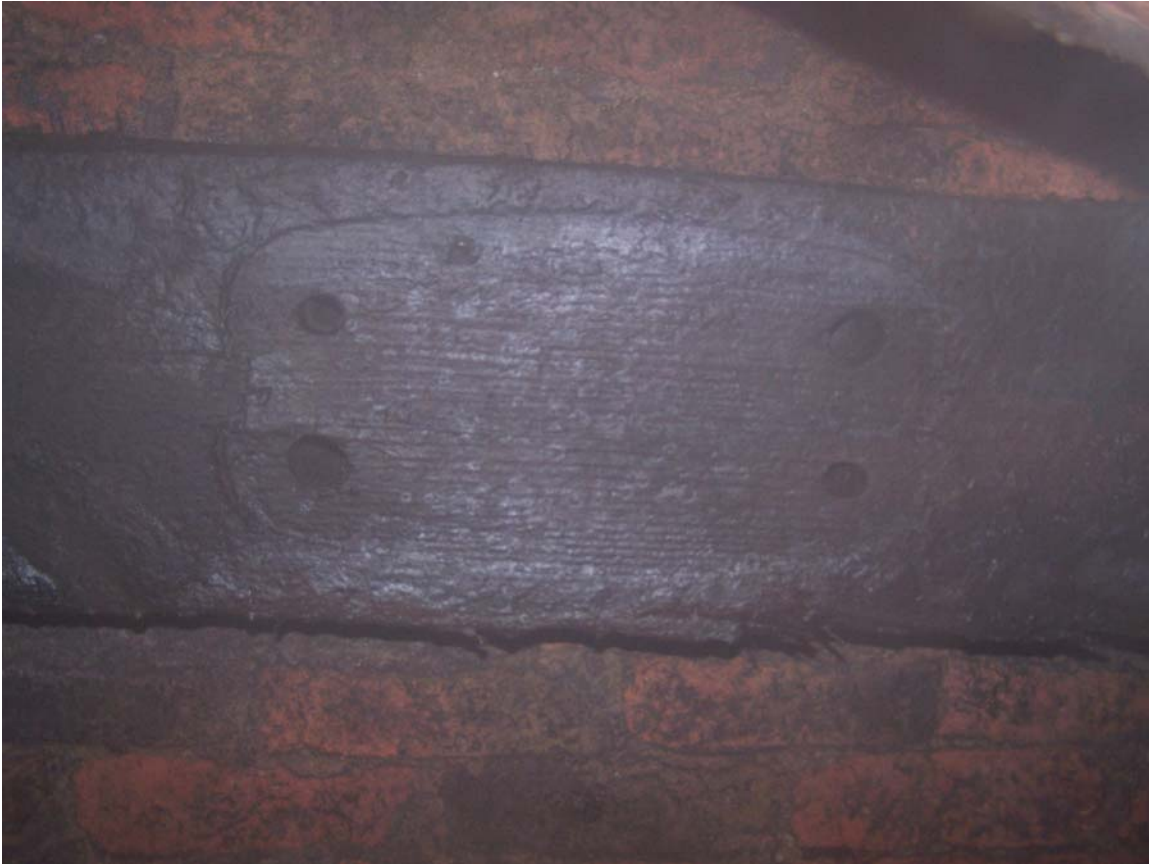
The roof shoring has these marks suggesting that the timbers came from a railway line.
